Report No. ABTR/RD/TM –02/06	Subject Area	Project No.	Report Date February 2006
Title Study of Snowplowable Raised Pavement Markers			Type of Report Final
Author(s) Joe Filice, R.E.T. , Materials Technologist			No. of Pages 75
Performing Organization Name and Address Avery Dennison Highway Safety Division 6565 West Howard Niles, Illinois 60714, USA		Sponsoring Agency Name and Address Alberta Transportation Technical Standards Branch 2 nd Floor, 4999 – 98 Avenue Edmonton, AB T6B 2X3	
Supplementary Notes The author would like to thank the following individuals who assisted in this study: Roger Skirrow, Director, Geotechnical and Material Section, Alberta Infrastructure and Transportation Richard Chow, Traffic Operation Specialist, Alberta Infrastructure and Transportation Beata Bielkiewicz, Traffic Standards Engineer, Alberta Infrastructure and Transportation			
Abstract Traffic markings used in Alberta consist primarily of alkyd and waterborne paint. Supplemental delineation such as Snowplowable Raised Pavement Markers (SRPM) may improve driver preview distances at night and in adverse weather conditions in high collision rate areas. A study of SRPM's was undertaken to determine the

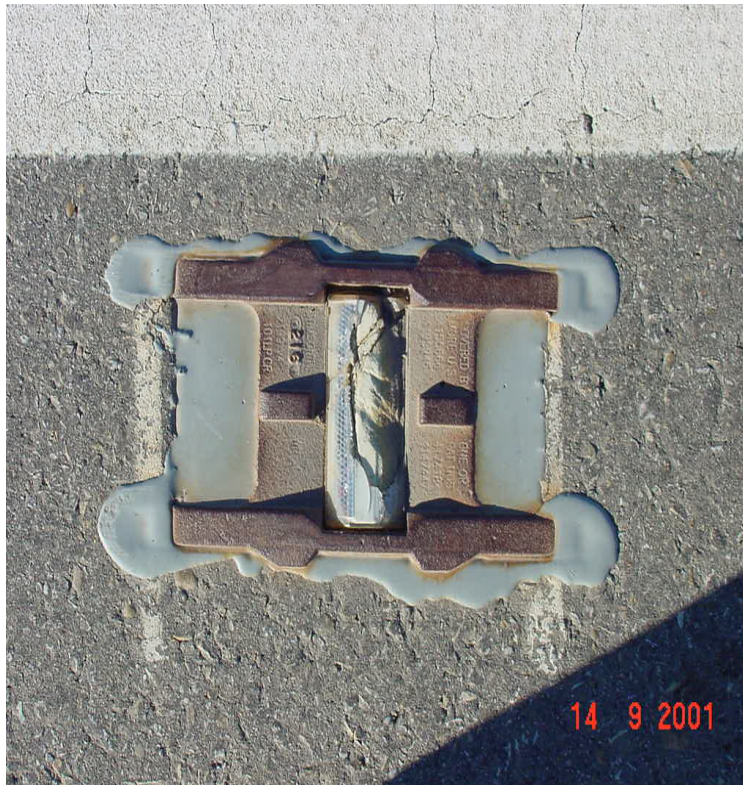
Photo 1

Broken reflector

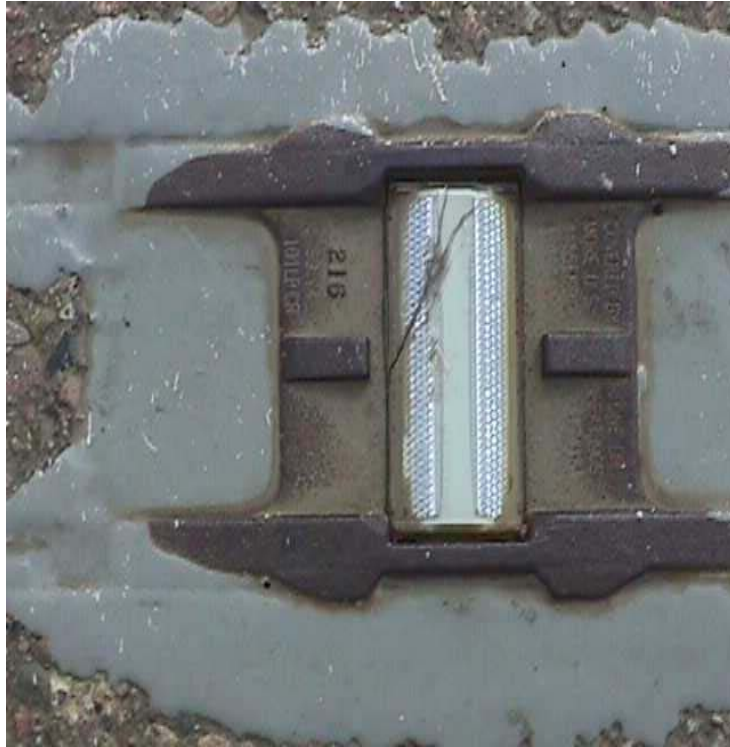
Photo 2

Cracked reflector

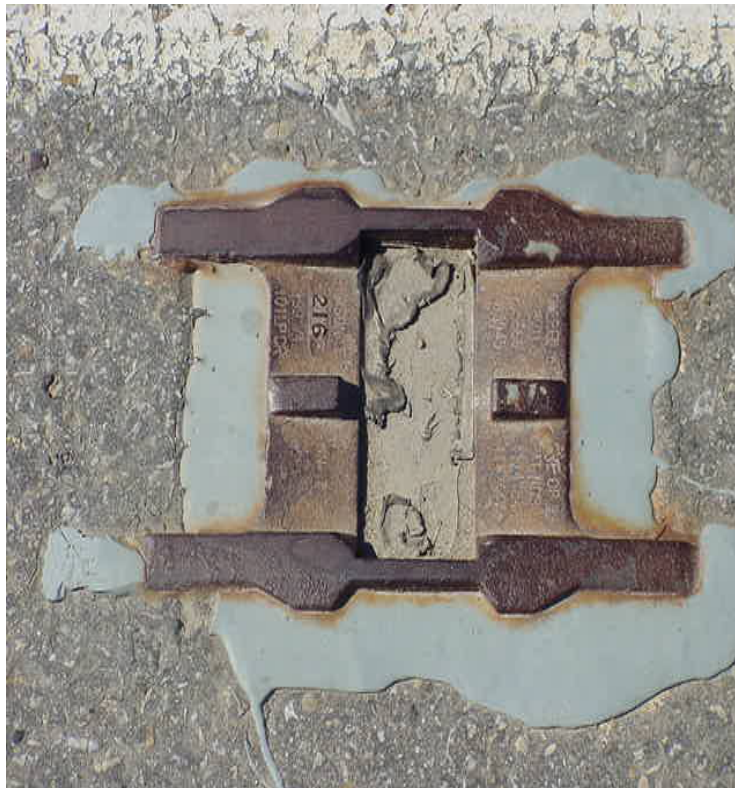
Photo 3

Missing reflector

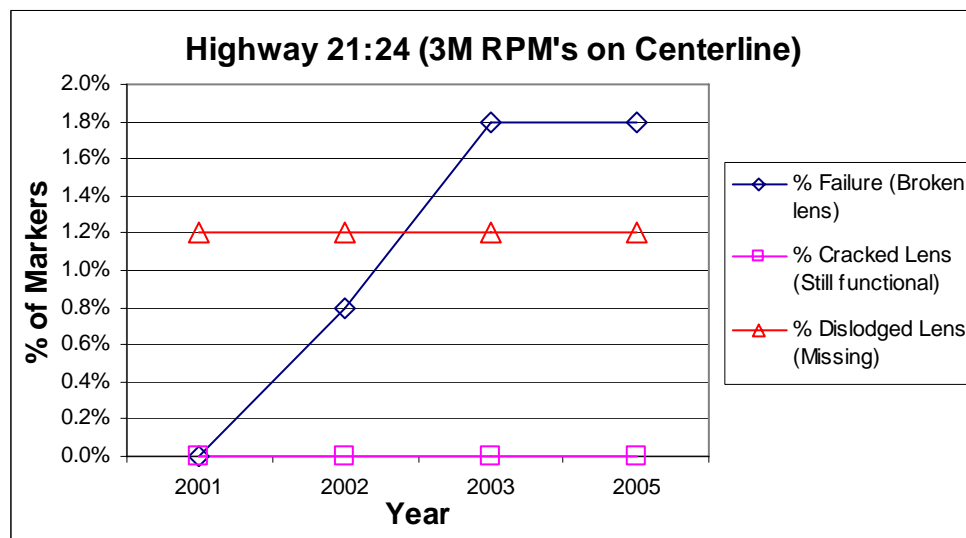
Chart 1

Note: There were only 30 3M-raised pavement markers placed on shoulder lines. 7 of the 3M reflectors have become dislodged from the marker shoe some time during the first year of service (see Chart 1).

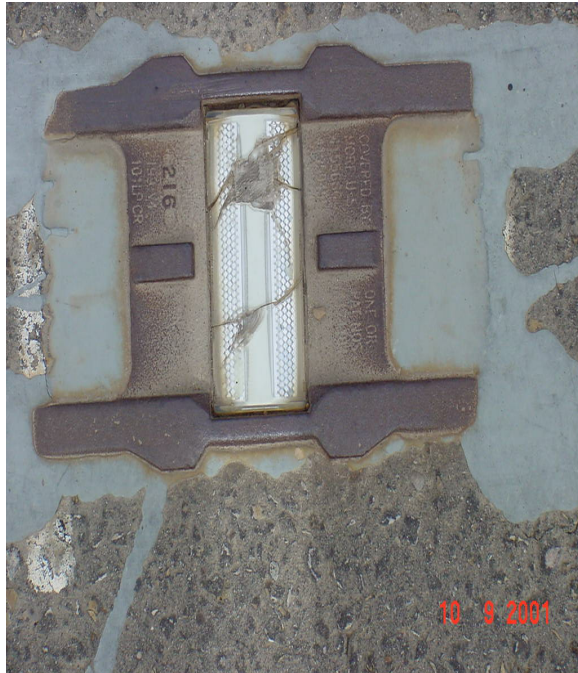
Damaged Stimsonite marker

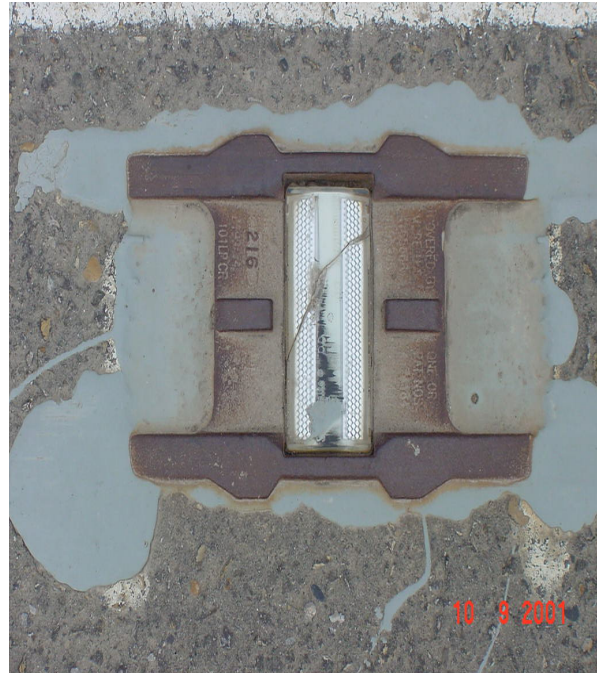
Cracked Stimsonite marker

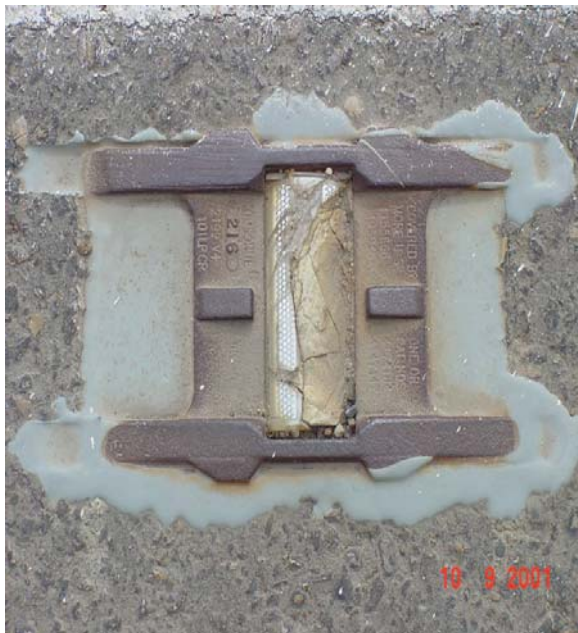
Broken Stimsonite marker

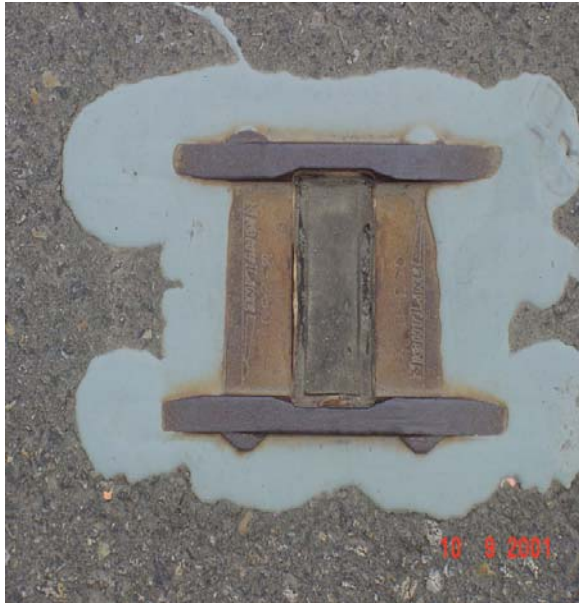
There were no visual damage observed to the 3M reflective markers. However there are 9 – 3M (3.5%) reflective markers dislodged from the cast iron housing. The centerline markers are out performing the edge line markers, only 2 centerline markers are dislodged with no centerline marker damage observed.

3M reflective marker dislodged from nightline shoe

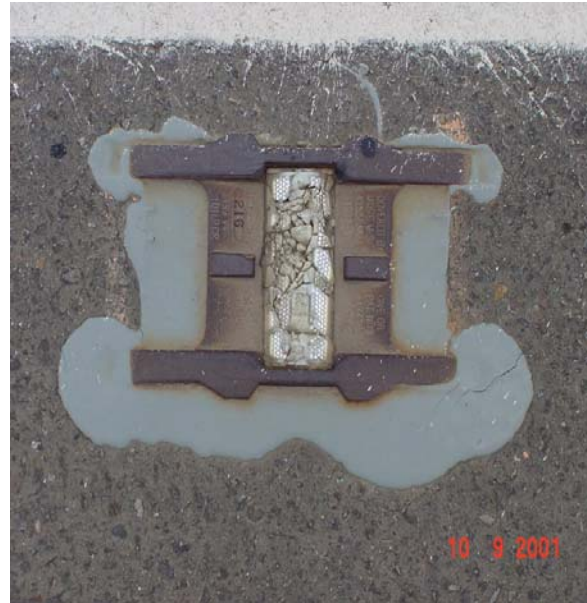
Stimsonite broken marker

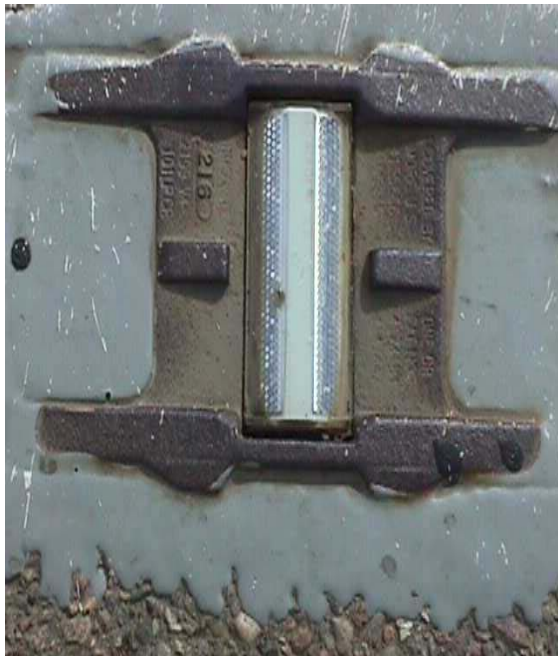
Scuff mark on Stimsonite marker

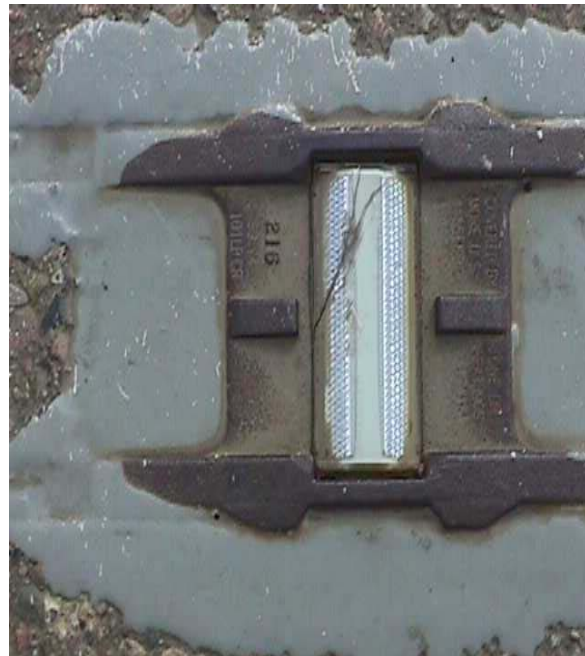
Cracked Stimsonite marker

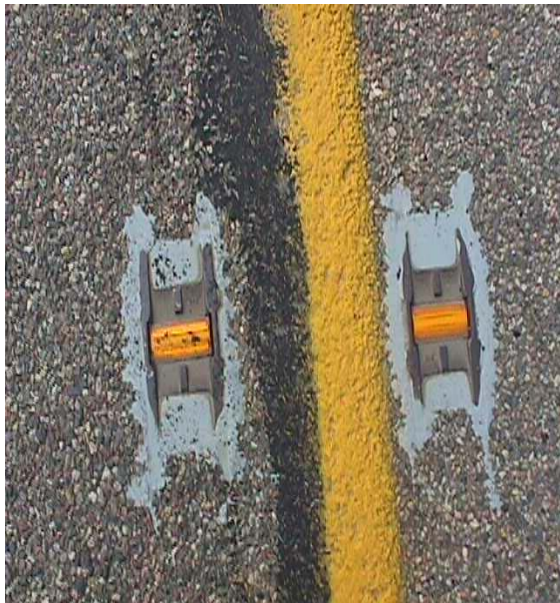
Stimsonite centerline yellow markers
Showing crack sealant

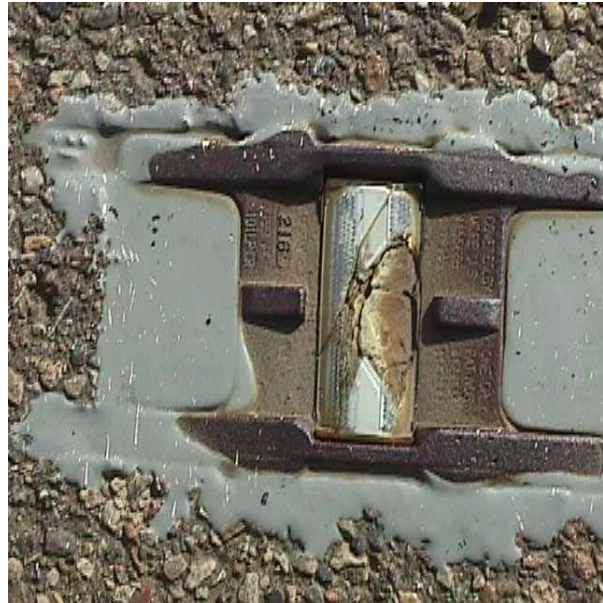
Broken Stimsonite marker

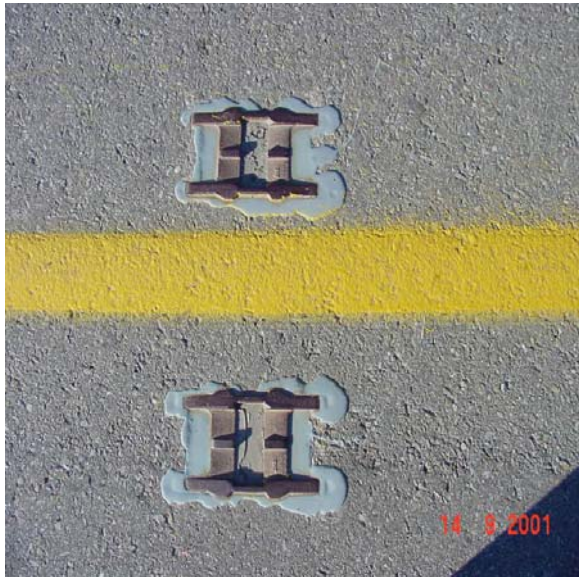
Stimsonite Dislodged reflectors

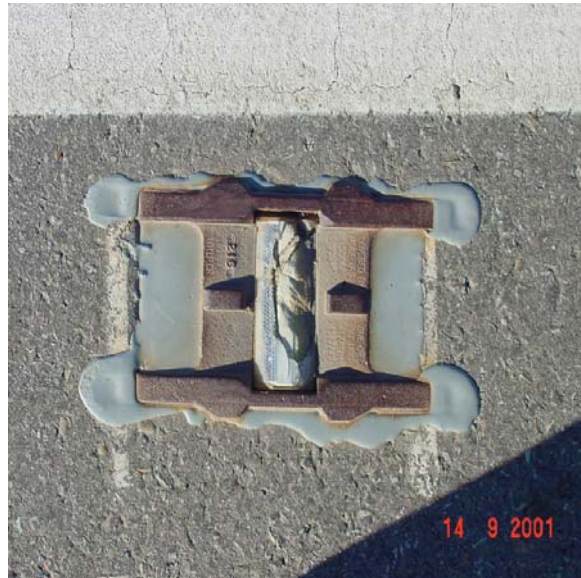
Stimsonite Broken marker

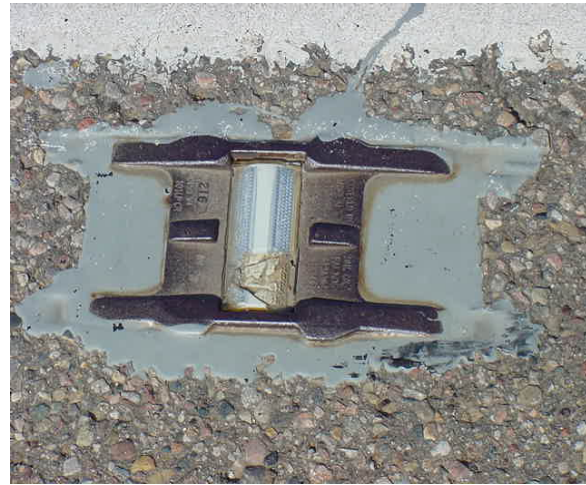
Damaged Stimsonite reflector

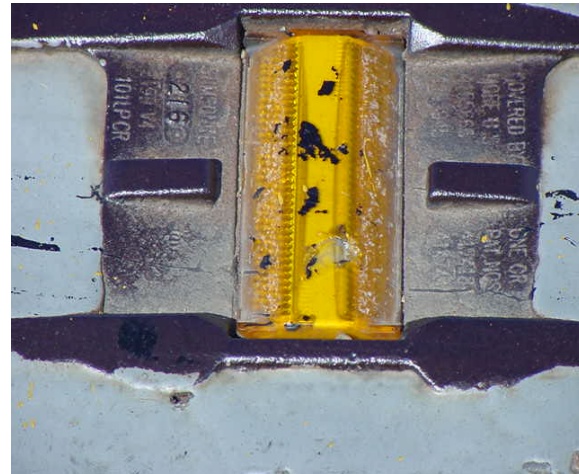
Centerline marker with chip and crack sealer

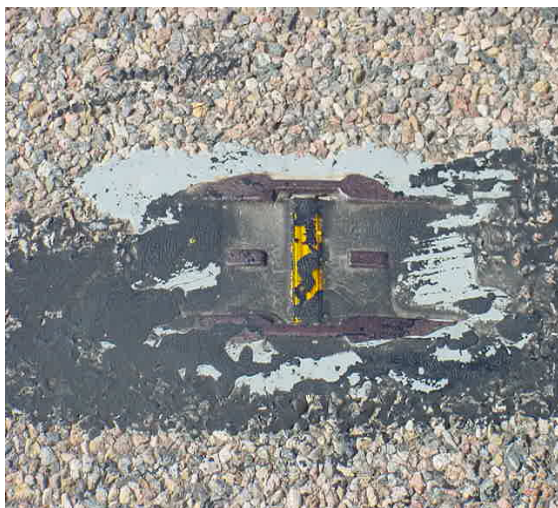
- One centerline marker was covered with crack sealant.

Centerline marker covered with crack sealer

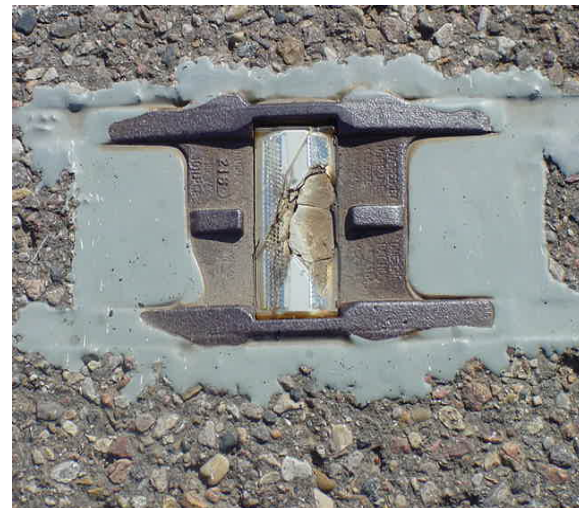
Broken stimsonite marker at shoulder

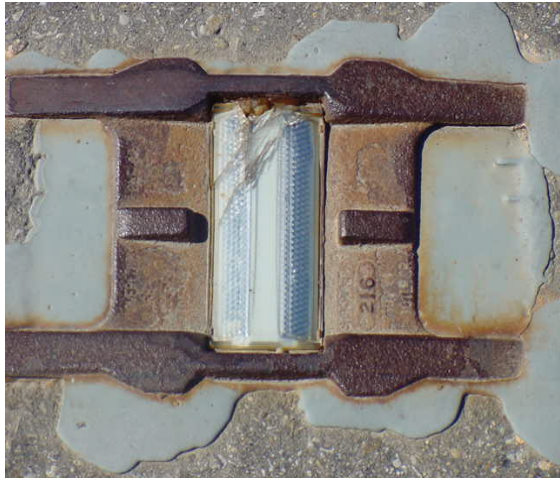
Cracked shoulder reflector

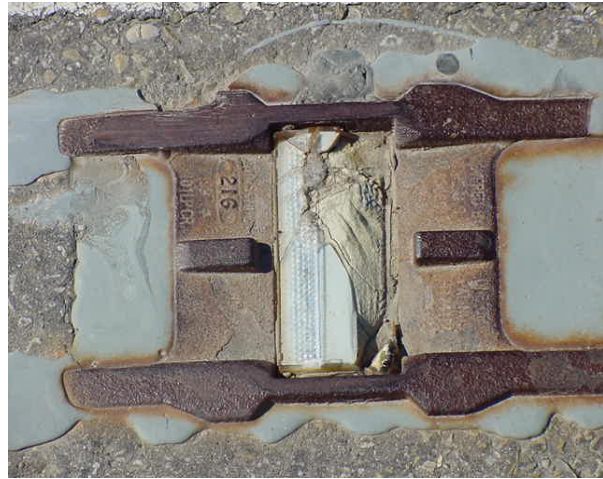
Broken shoulder reflector

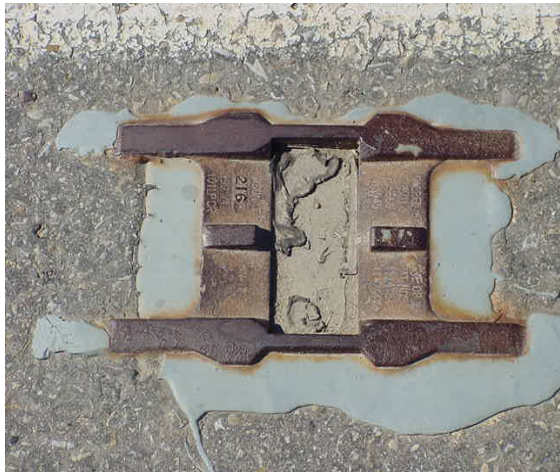
Missing shoulder reflector

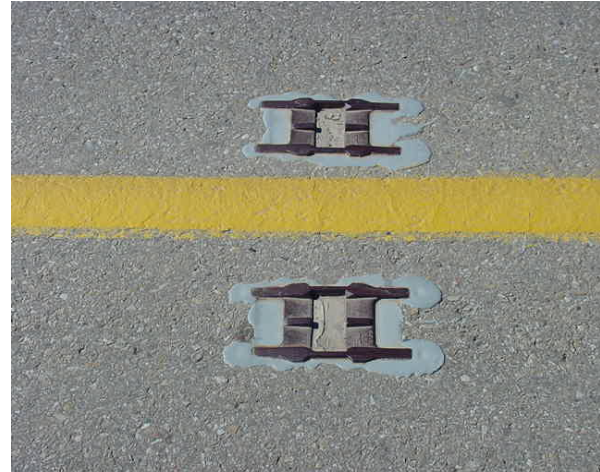
Missing centerline reflectors

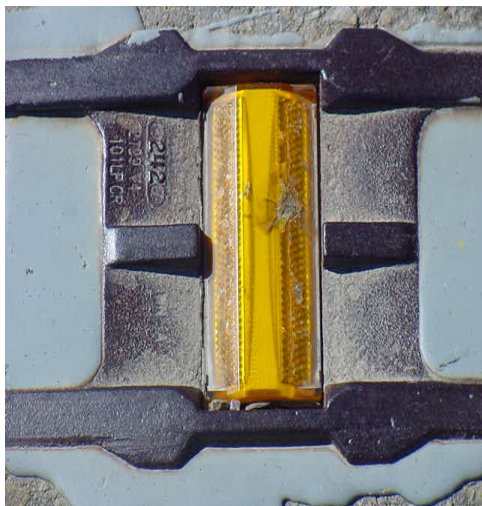
Chip in centerline reflector

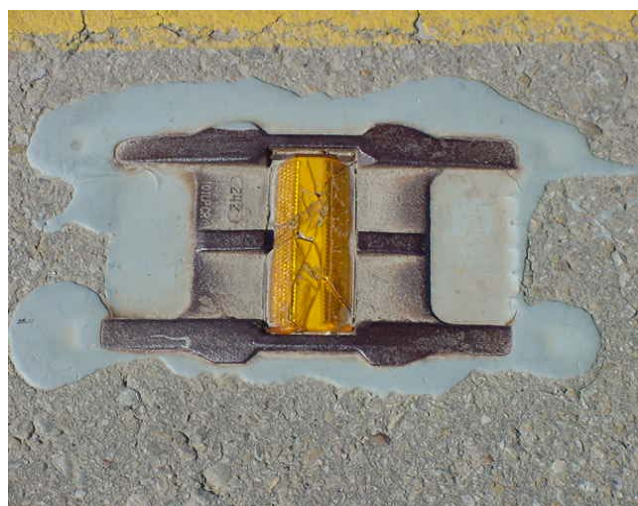
Cracks in centerline reflector

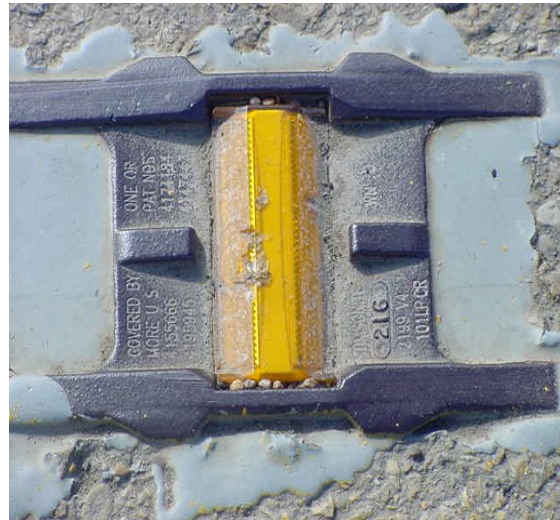
Cracked centerline marker

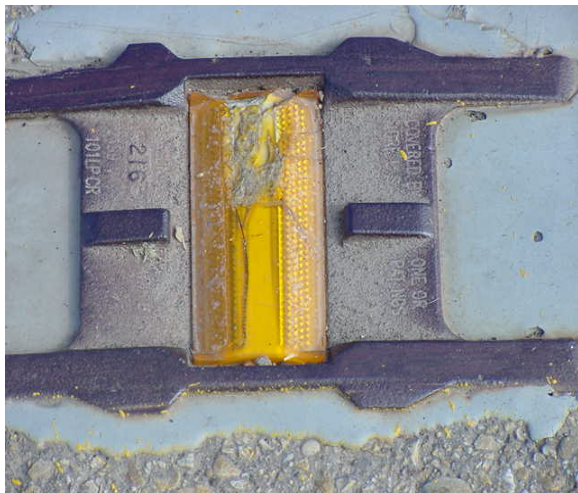
Broken centerline marker

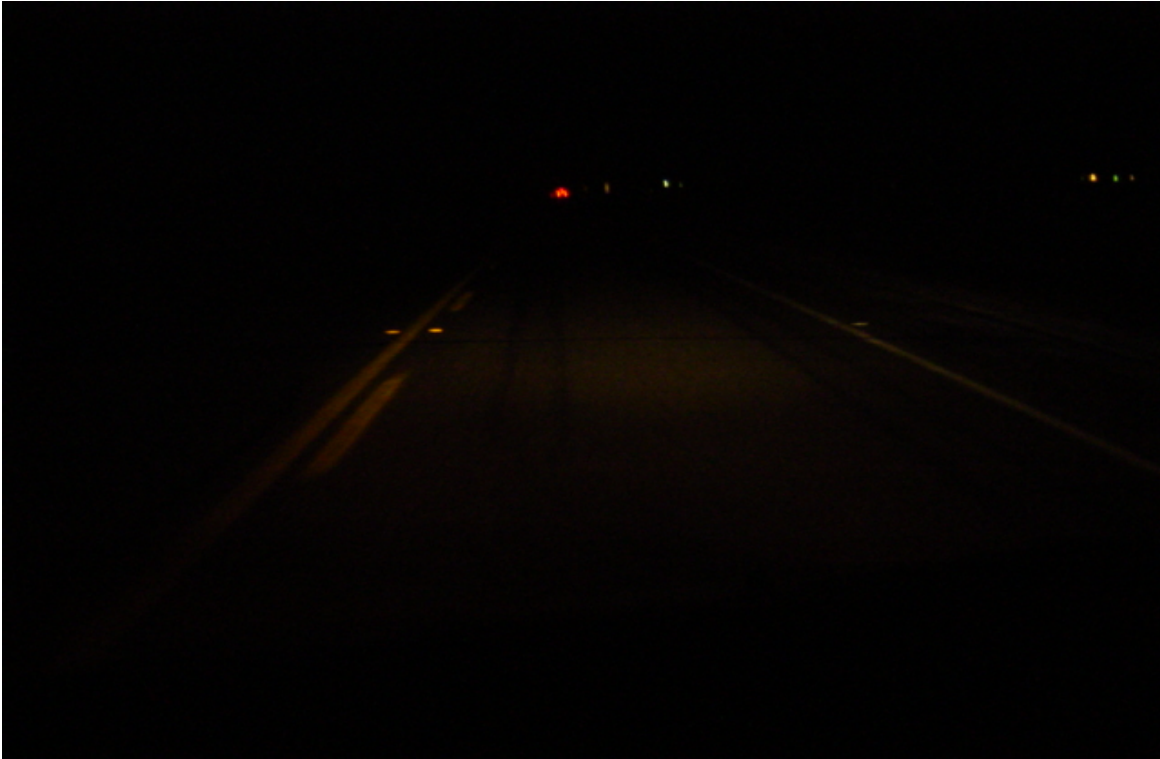
Highway 28 – shoulder markers obstructed by snow/ice

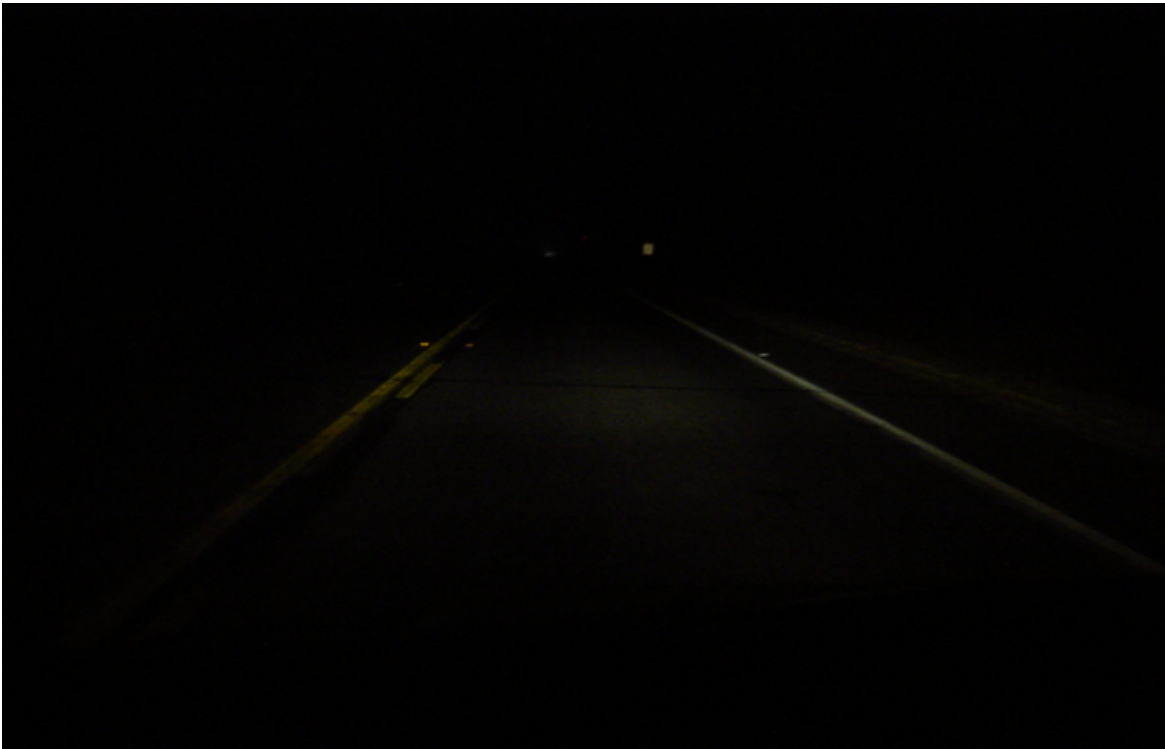
Highway 28 – shoulder markers obstructed by snow/ice

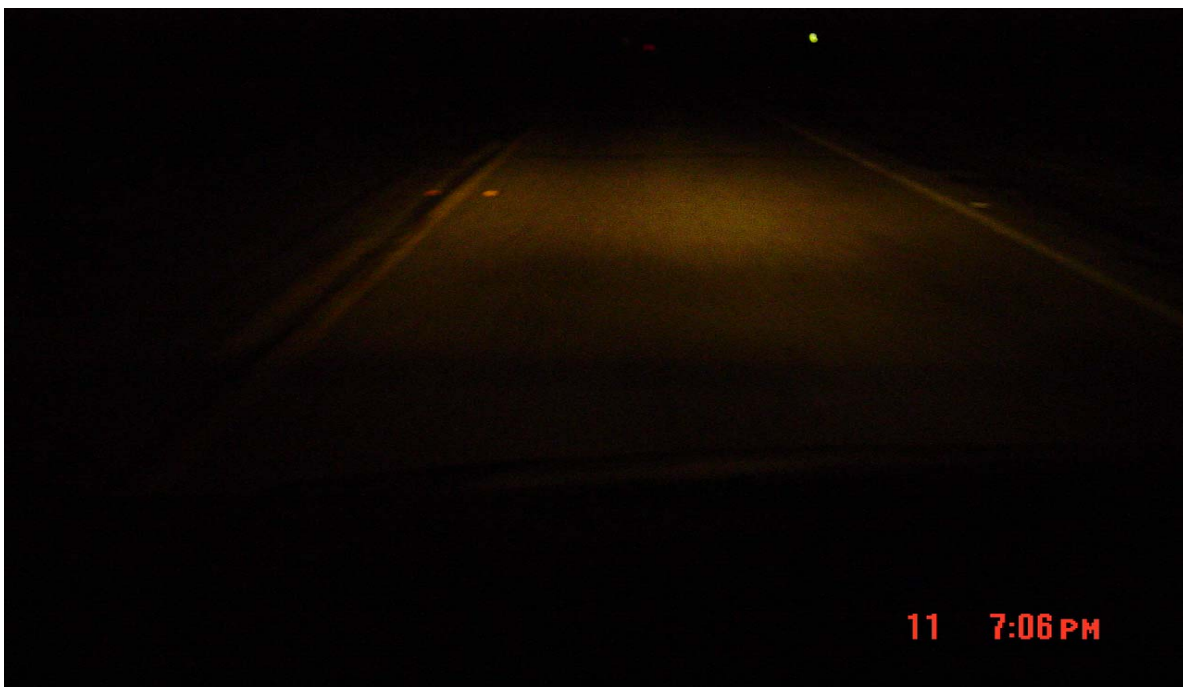
February 11, 2004

Hwy. 28 – centerline marker is visible. Shoulder marker not fully visible due to ice/snow on reflective lens, thus reducing its reflectivity.

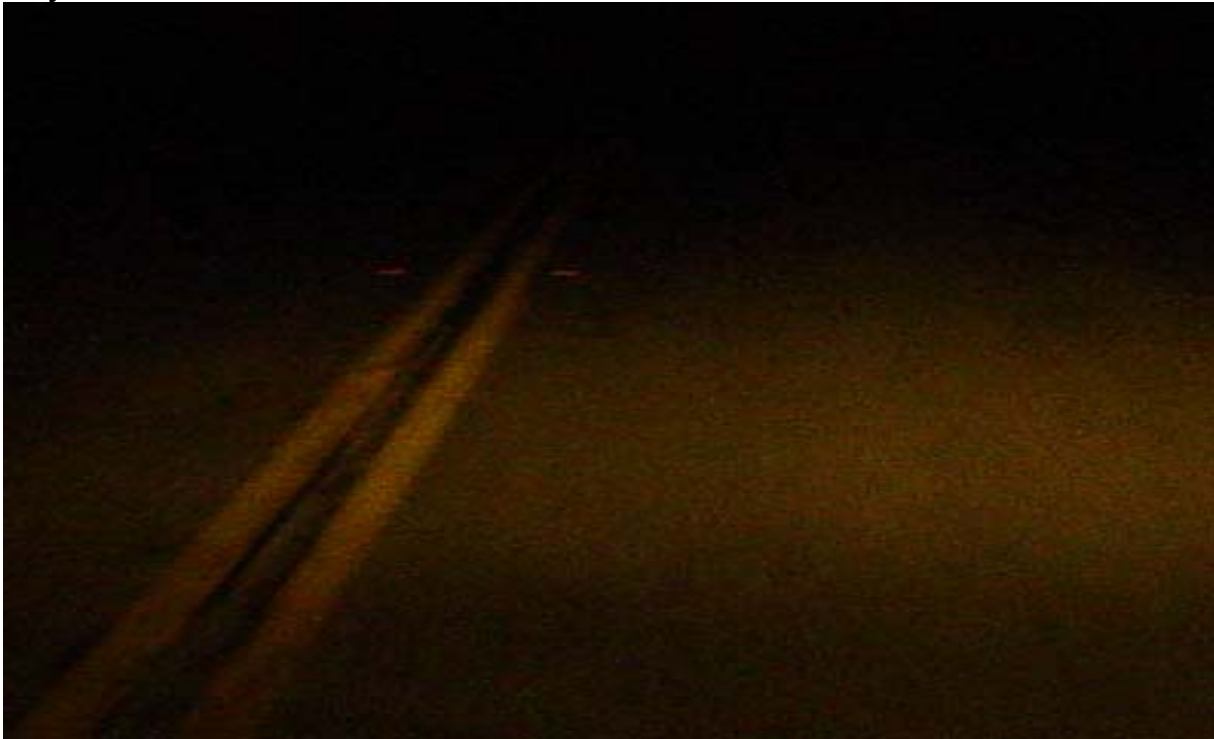
Hwy. 37 centerline markers are visible and providing guidance to the motorist. However there are many markers that were obstructed by the buildup of snow/ice.

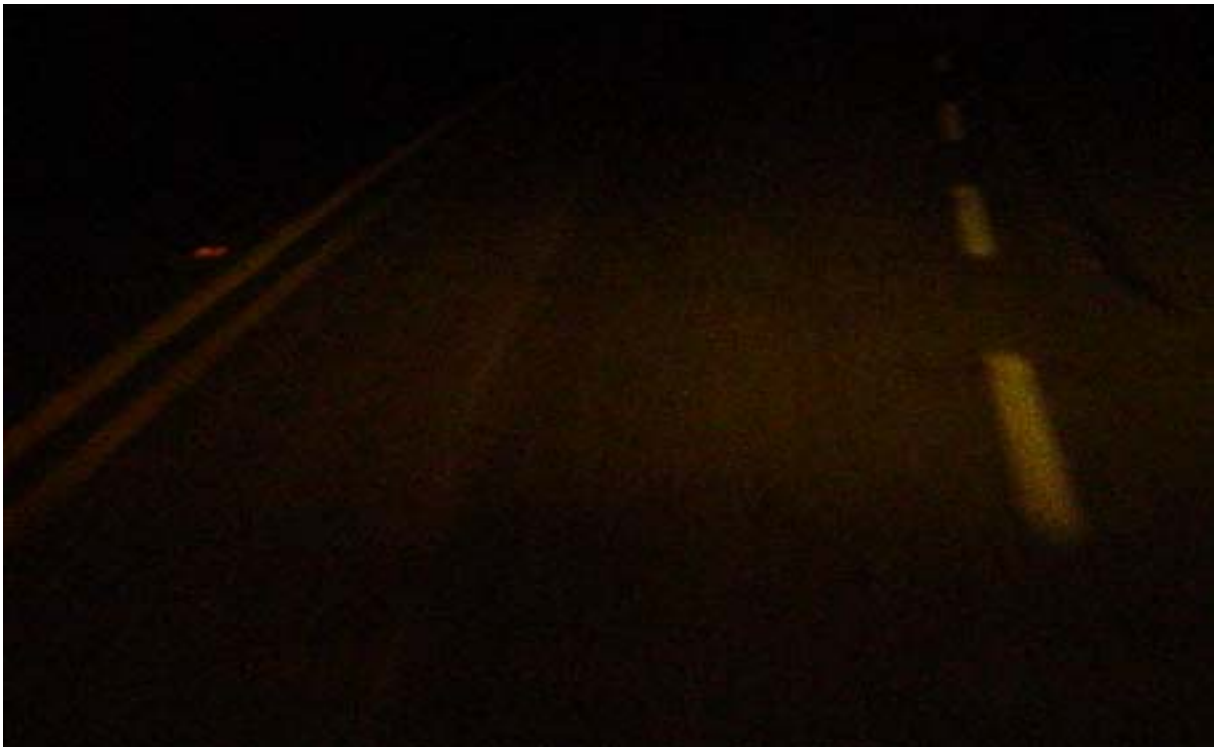
Hwy. 37 centerline marker is visible. There are double centerline markers on this project, at this particular location only one is reflective. The marker on the right is obstructed by ice/snow buildup on the reflective lens.

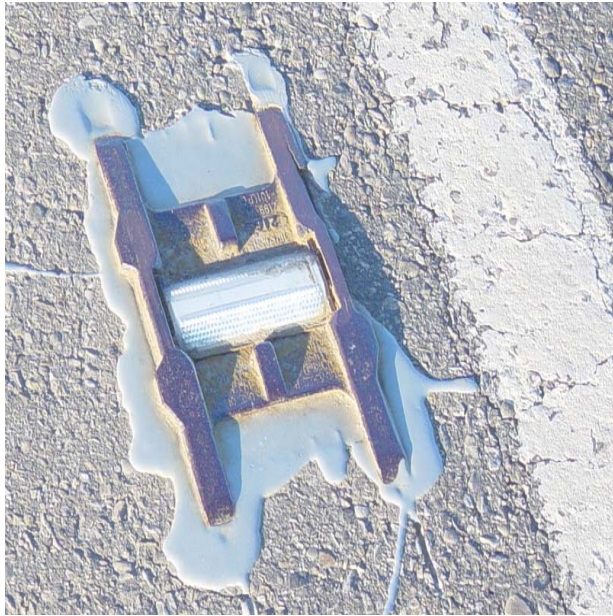
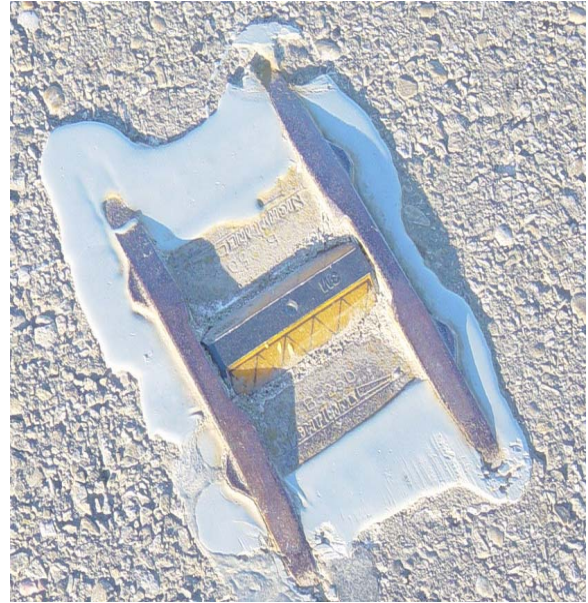
The reflectors are clear of ice/snow. There are traces of sand residue on the reflectors which may reduce the retro reflective properties of the reflectors.

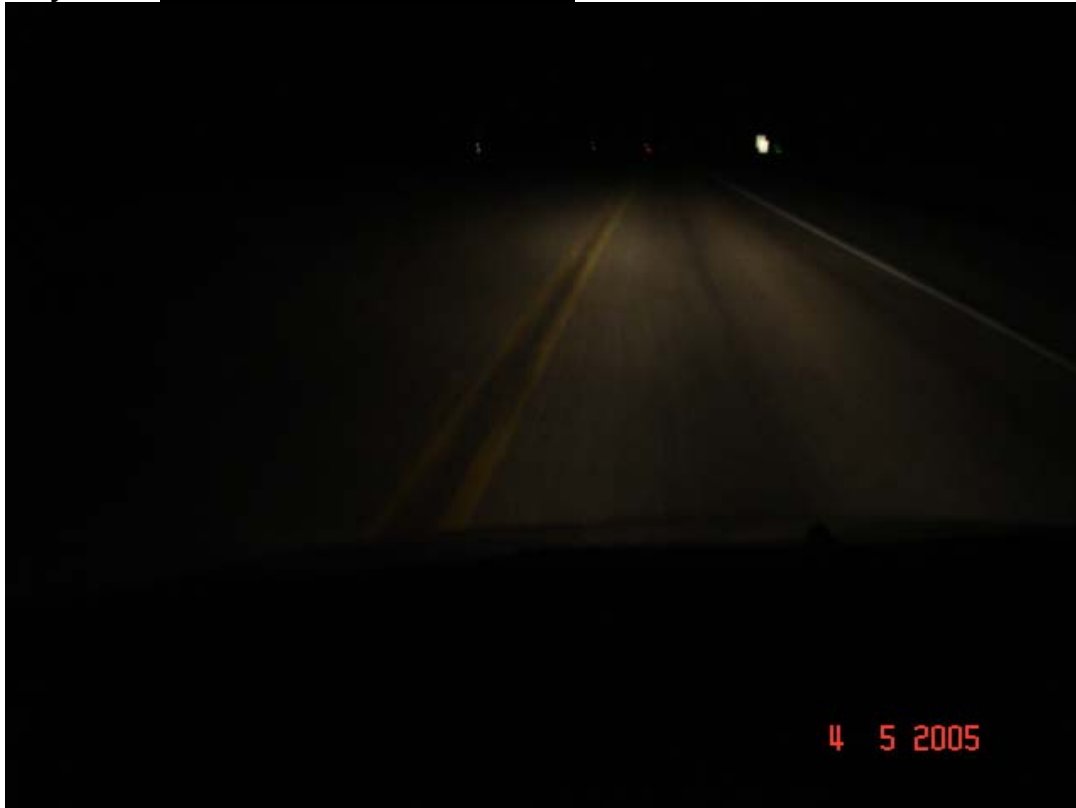
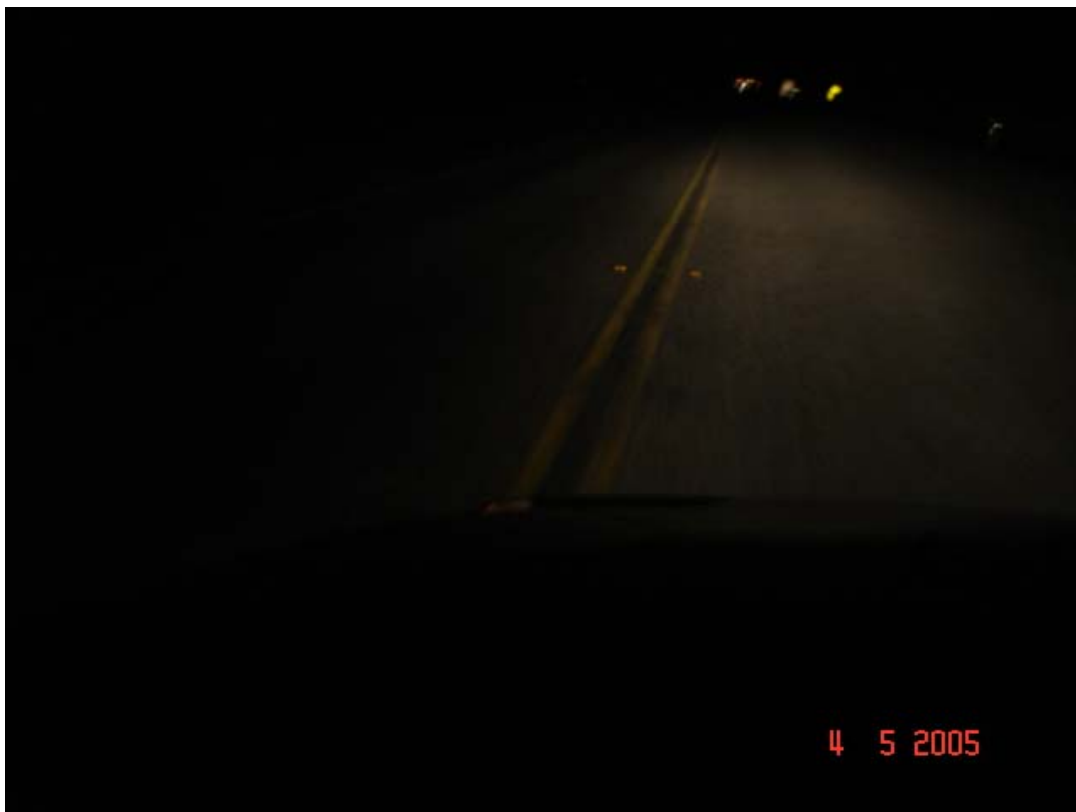
SPRM on this trial section are not visible at a distance, they are only visible prior to crossing them. A closer examination concluded that this stretch of highway was seal coated in 2004 therefore the majority of the markers are obstructed.
