Internal post-tensioning tendons : many problems and sometimes solutions

Ir Pierre GILLES, Ingénieur des Ponts et Chaussées, Direction de l'Expertise des Ouvrages, Service Public de Wallonie, Belgium

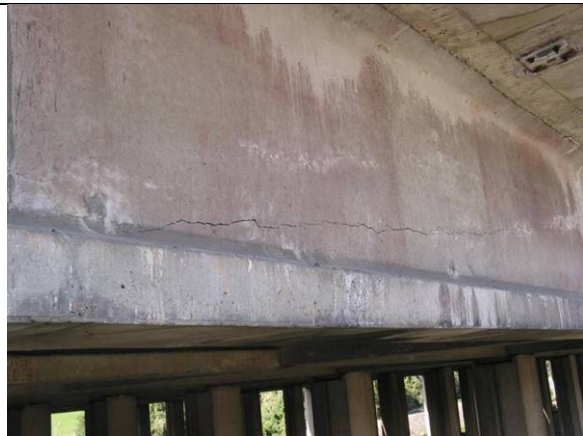
Due to leakage in the waterproofing system, water went into deck anchorages, followed duct with many voids and induced severe corrosion with complete tendons rupture (figures 3 and 4).

Figure 3 : Concrete spalling along tendons

Edge beams and concrete slab have to be replaced. Doing that, a stability problem will occur due to the fact that the transversal post-tensioning in the lower part of the transversal beam will not be compensated by the transversal post-tensioning in the slab. A temporary consolidation would be necessary.

Considering these technical problems combined with time life and economical analysis, it has been decided to replace all the deck, including slab and beams.

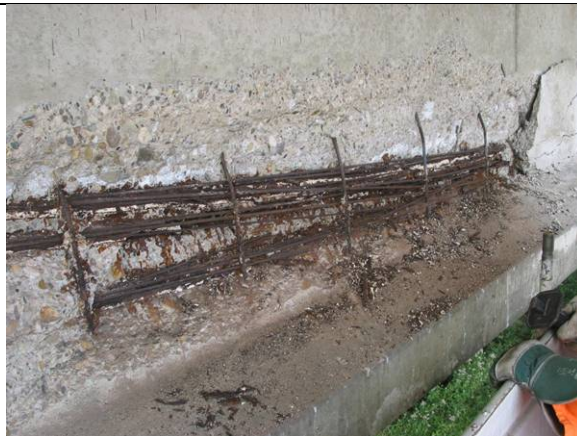
Figure 4 : Corroded tendons after removing of concrete spalling

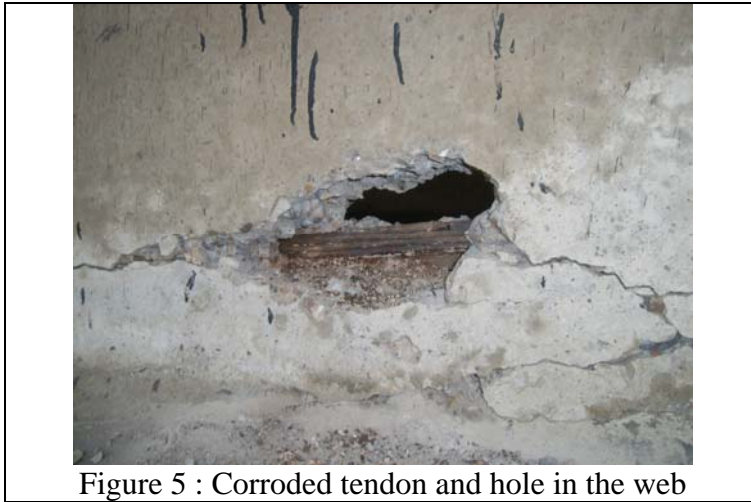
Due to tendon corrosion, concrete delamination and spalling occurred on both side of the web beam. After removing the spalled concrete, easily done due to the light reinforcement, a hole appeared through the web (figure 5).

Figure 5 : Corroded tendon and hole in the web

These defaults concern only the edge beams located under the gutter. A total of 26 beams have to be replaced for a total of 42 edge beams.

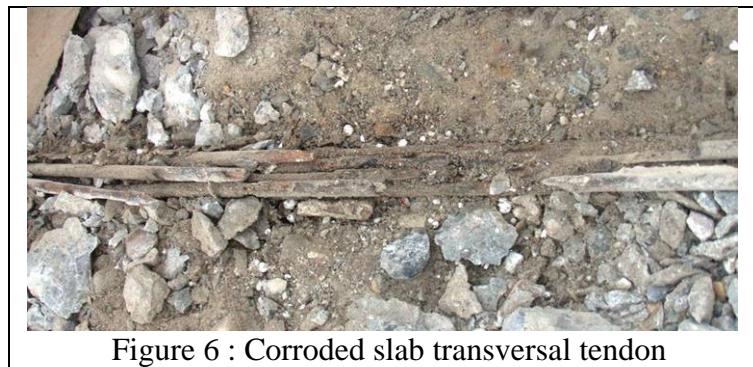
In the slab, water goes also through the concrete up to transversal tendons. Many wires are broken and 20 % of the transversal tendons are considered ruptured (figure 6).

Figure 6 : Corroded slab transversal tendon

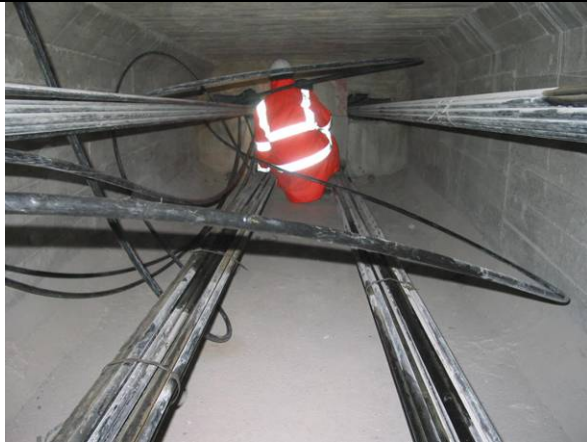
In 2005 sheathed strand ruptures have been observed in the box (figure 9). Rapidly, inspection turned to the anchorages in the cantilever hinge. It appeared that in the downward tendons, a small volume (several litres) of water was locked in the anchorage head. The injected wax floated over the water (figure 12).

Figure 9 : Ruptured tendon in the box girder

In regards of rupture increasing risk, it was decided to replace all downward (relatively to position at hinge area) tendons which represent half of bridge post-tensioning.

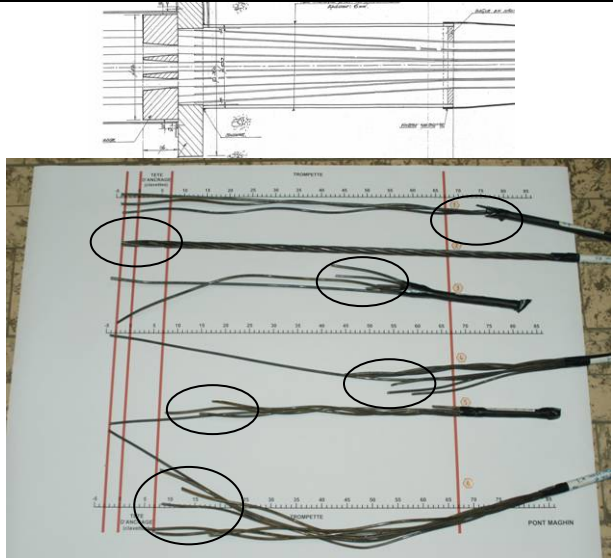
This stuffy environment allowed development of stress corrosion cracking (figure 11) [1] of the strand just behind the anchorage head (figure 10). At this place, the monostrand HDPE sheath was still removed. High steel resistance ($>1920 \text{ N/mm}^2$) and high level working rate (80 %) are factors facilitating stress corrosion cracking development. Indeed, stress corrosion cracking may appear if wire stress is higher than 1200 N/mm^2 .

Figure 10 : Anchorage : rupture localisation

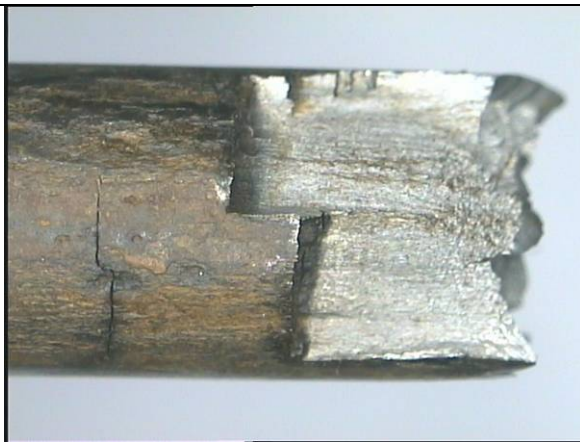
Figure 11 : Strand wire rupture

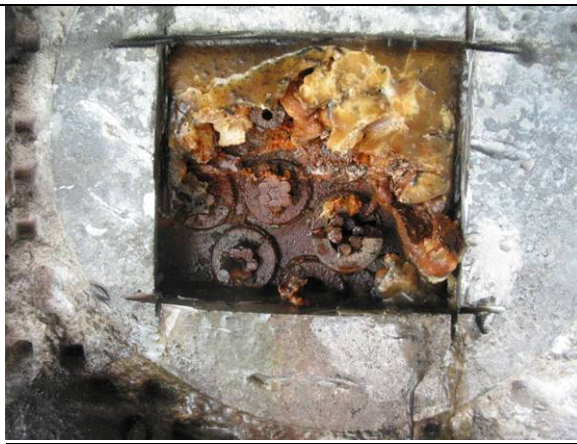
Figure 12 : Anchorage cap. Lower part was full water and wax floated over it.

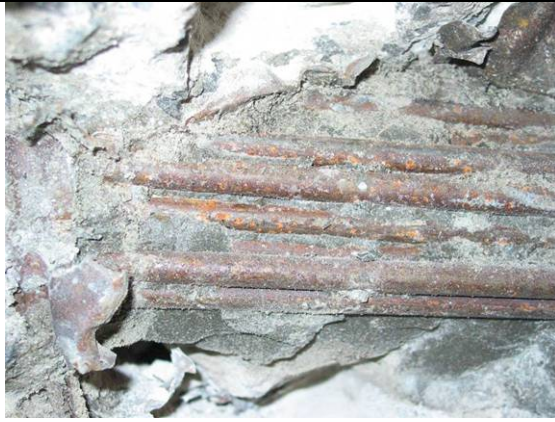
Figure 14 : Tendon opening : very moderate corrosion

Corrosion was moderate but without any action; ruptures may appear due to chloride pollution. It was decided to inject an inhibitor solution in the grout. This is possible using the patented PMD/ATEAV process[©] based on power ultrasonic technology. The calcium nitrite has been selected due to his well known effect against chloride induced corrosion [5].

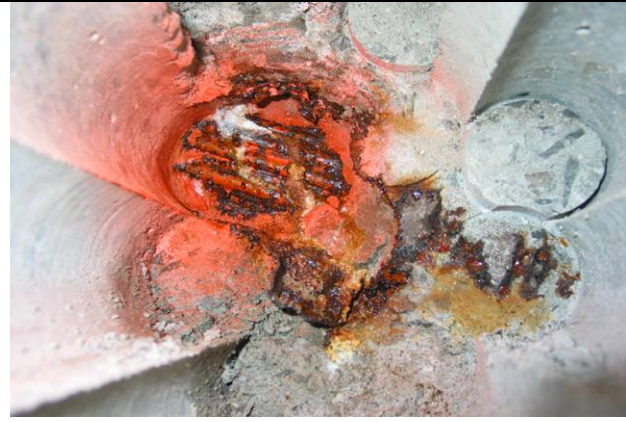
Figure 15 : Opening after 3 months. Calcium carbonate deposit in the upper part. Active corrosion.

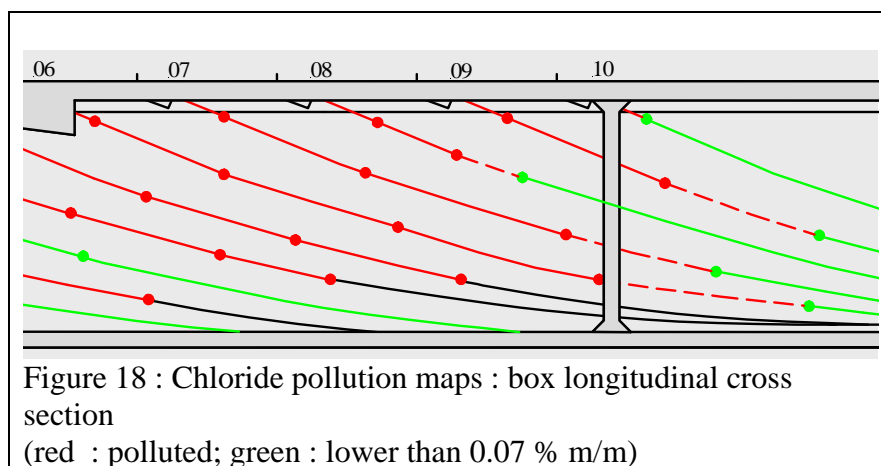
On Bridge C, this following procedure is applied, system based on chloride content measurements prior to injection. In this case, chlorides only penetrate through the anchorages. For economical reasons, the chloride content is determined to treat only the polluted zones. These measurements are performed on the field. If chloride content is higher then 0.07 % (m/m grout, acid extraction), inhibitor (calcium nitrite) solution injection is performed. If it is lower then 0.07 %, injection may be stopped. As a safety precaution, the injection is however continued 1 m farther. The 0.07 % threshold is based on a cement content of 70 % and a chloride content of 0.1 % relative to cement mass. About 315 chloride measurements were performed and gave a precise chloride pollution map (figure 18).

- Chloride contents may reach 0.6 % (m/m grout, acid extraction)
- Chlorides may progress in well injected duct more than 30 meter from the anchorage
