Report SO 94-03

TRANSVERSE PRESTRESSING AND
LONGITUDINAL CRACKING IN
POST-TENSIONED DECKS

**A. Merlo, P.Eng.,
Project Engineer
Structural Office**

Dec. 1993

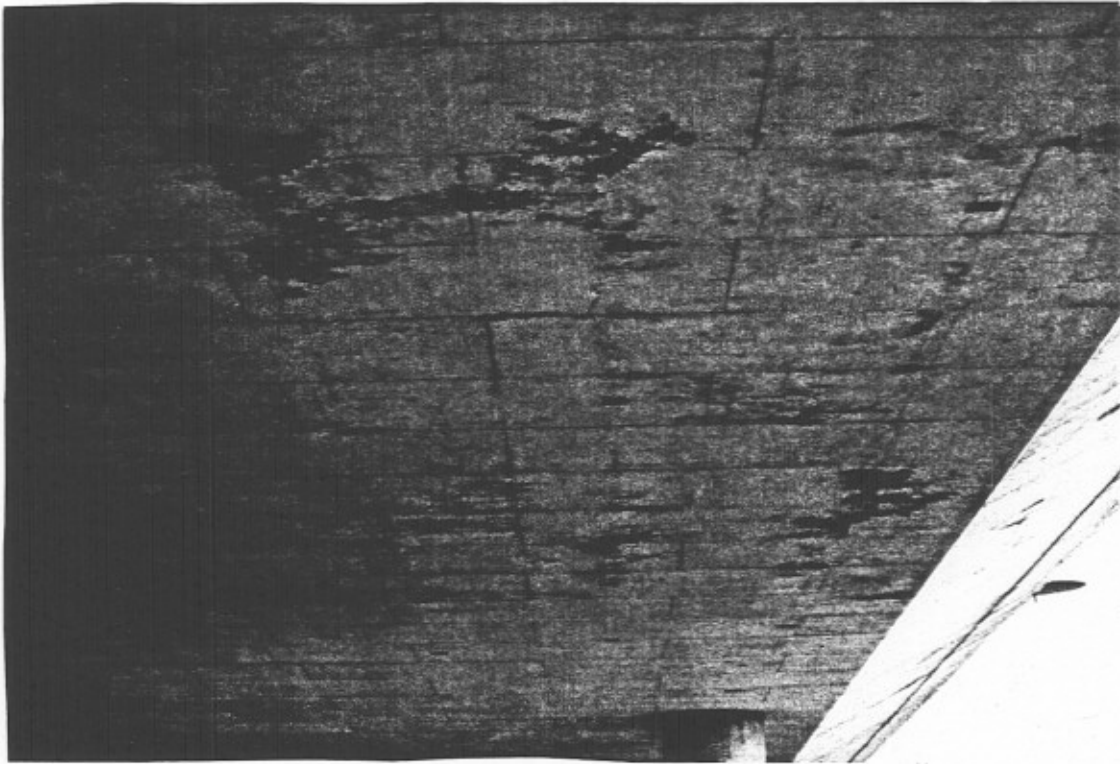
a.) Circular Void Cross-section

cracking in the deck. The extent of cracking is indicated by such terms as "no cracking", "minor cracking", "moderate cracking" and "severe cracking". Severe cracking for circular void structures is indicative of a deck with longitudinal cracks along the entire length of voids at the top or bottom of the voids. In the case of solid section decks, severe cracking is indicative of longitudinal cracks running the full length of a span and these cracks are usually concentrated in the centre of the width of the section. Photographs showing examples of severe cracking are given in Figure 3. Minor cracking is indicative of a deck with a few random longitudinal cracks. In circular void structures, these cracks may or may not follow the bottom or top of voids. A deck with moderate cracking has a number of shorter length longitudinal cracks few of which extend the full length of a span. These cracks follow the bottom or top of voids in circular void structures. The total length of longitudinal cracking was available from each condition survey for both the top and bottom of the deck but was not obtainable from field observations. The data collected for each structure was input into a dBASE IV file. The drawings for each structure were also reviewed in order to identify some factors which may affect the tendency to crack or the extent of cracking. A draft report by Sadler [1] identified the following factors which affect the need for transverse prestressing. These are:

Therefore for this group of structures, the data collected shows that the level of prestress is the primary cause of longitudinal cracks. The data indicates that a value around 5.5 MPa is the critical level. An MTO research study by Csagoly and Holowka [2] on cracking of voided post-tensioned decks found that 4.1 MPa was the critical level. The 2nd edition of the Ontario Highway Bridge Design Code (OHBDC) [3] and the Structural Manual [4] previously limited the average level of prestress to 5.5 MPa (0.16×35 MPa) for circular voided decks. The 3rd edition of the OHBDC has increased this limit to 6.5 MPa (0.16×40 MPa) [5]. The level has been increased due to higher strengths in the order of 40 MPa which have been routinely achieved for 35 MPa concrete mixes in the past. The combination of aspect ratio and sub-structure uniformity also appear to contribute to longitudinal cracking as well. The data showed that structures with aspect ratios less than 2 and which were supported uniformly across their widths tended to have longitudinal cracking problems. It is thought that the restraint provided by the substructure against shrinkage in the transverse direction is one factor contributing to these longitudinal cracks. The other factors considered such as section and prestress uniformity may contribute in a secondary way by accentuating the primary causes such as a high level of prestress.

Figure 3 - Severe Longitudinal Cracking in Soffits

1. The average level of effective longitudinal prestress can result in longitudinal cracks if it is too high. The study found that a level of 5.5 MPa was the maximum that could be tolerated for 35 MPa concrete. Higher average prestress could be allowed for higher strength concretes with the limit tied to the strength of concrete. The expression $0.16x_{fc}'$ used in the 2nd edition of the OHBDC [3] seems appropriate.

4. One method of controlling longitudinal cracks in the soffit is to place transverse prestressing in the bottom of the deck below the voids. This however may be difficult to implement in all cases in that there may not be sufficient room to accommodate the anchors for the top and bottom transverse prestressing. In addition, adding transverse prestressing to the soffit would counteract somewhat the transverse prestressing in the top slab making it less effective and possibly resulting in more deterioration of the deck surface which is more serious than deterioration of the soffit from a durability point of view.
