# Load Test and Evaluation of the 18th Avenue Bridge

Ministry  
of  
Transportation

Research and  
Development  
Branch

**Author(s):** J. Maheu - Associate Research Engineer  
A.C. Agarwal - Research Engineer

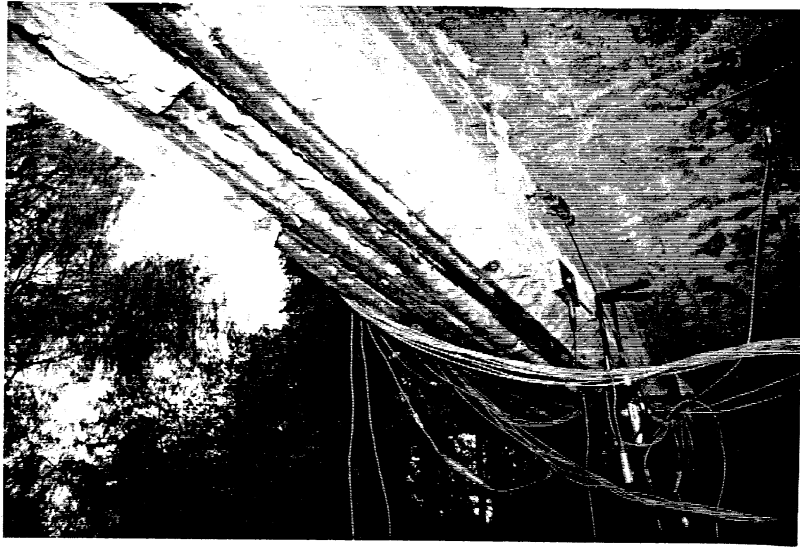
The bridge is in generally poor condition. There has been extensive spalling at the underside of both exterior girders at various locations, exposing reinforcing steel in advanced stages of corrosion. The south girder is in worse condition than the north, with the entire bottom layer of steel exposed at midspan. The deterioration is so extensive that it is not possible to determine the exact size and number of bars originally present, although they appear to have been bundled together. Some have completely disintegrated leaving nothing but a trace of iron oxide on the concrete. Figure 3(a) shows a view from the underside of this girder.

(a) GIRDER A (SOUTH)

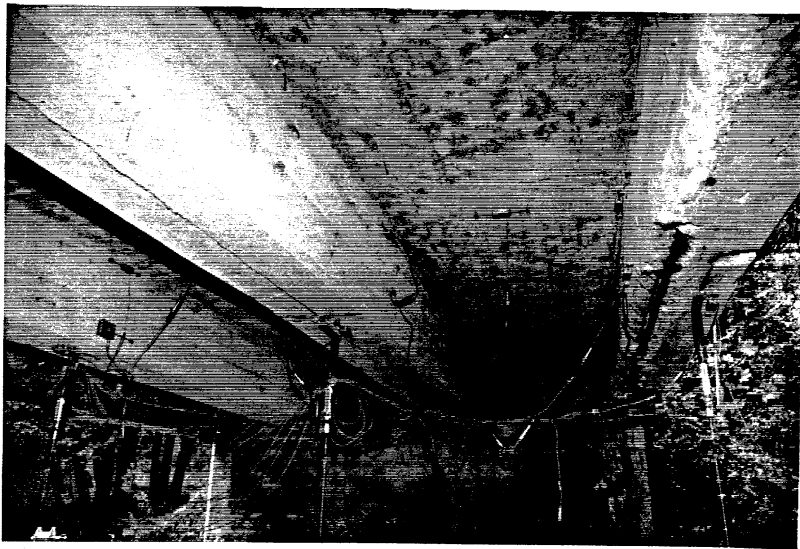
The interior girders are in much better condition as seen in Figure 3(b). The northerly interior girder (girder C) has a small amount of concrete spalled off at each abutment. All four girders have diagonal cracks at the west abutment. They start at the abutment wall near the girder bottoms, rising at an angle of approximately 30° from the horizontal

(b) GIRDERS B, C and D (NORTH)

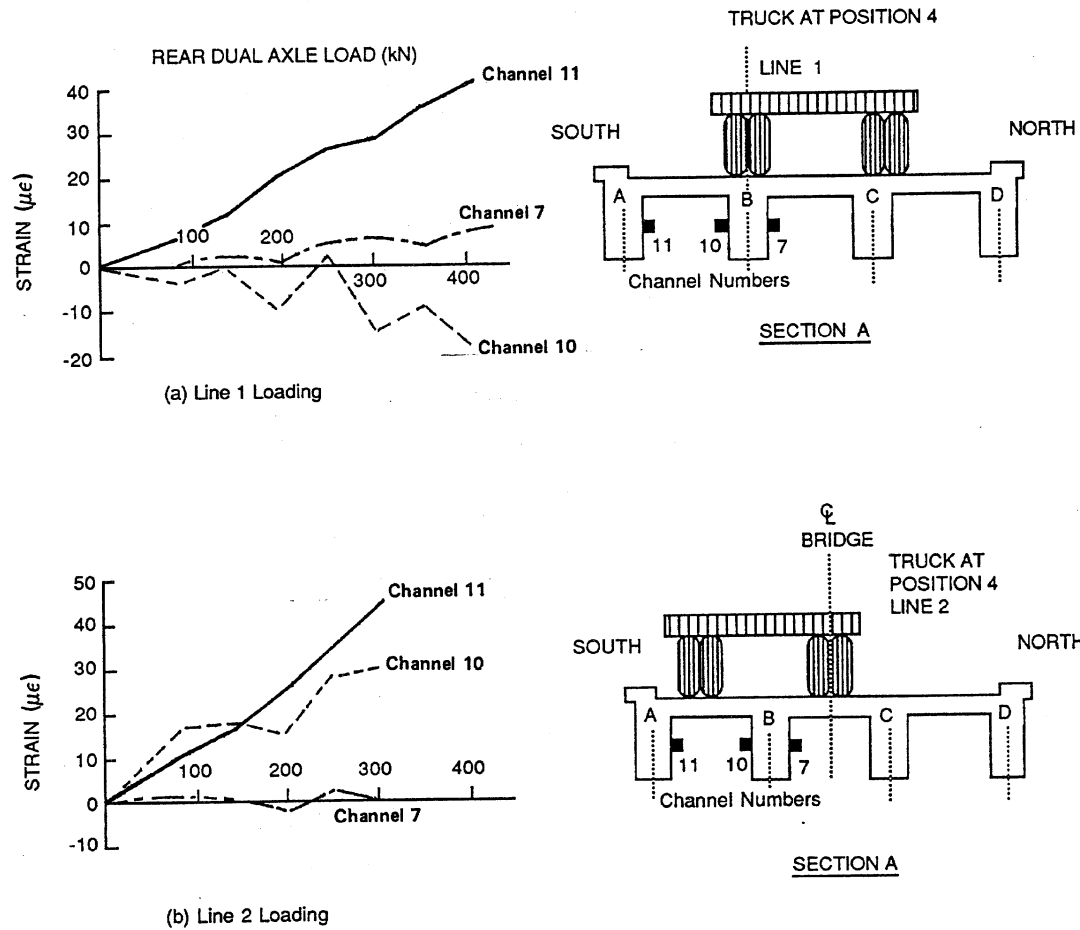
Figure 10/ Strains Across Diagonal Cracks

The strains measured across the diagonal cracks at the west abutment give an indication of the opening or closing of those cracks. As seen in Figure 10, these strains were generally small and they were fully recoverable. The largest strains were measured at the inside face of girder A. If the maximum measured tensile strain of  $42 \mu\epsilon$  was largely concentrated at the crack, it would represent a widening of the crack of approximately 0.008 mm based on a 200 mm long strain gauge.

The strains in girder B are evidence of the combined actions of vertical shear and torsion at the supports. Under central line 1 loading there appears to be a clockwise twisting of the girder at the west abutment with the crack on the north face (channel 7) opening and the one on the south face (channel 10) closing. The direction of the twist is reversed under eccentric line 2 loading.

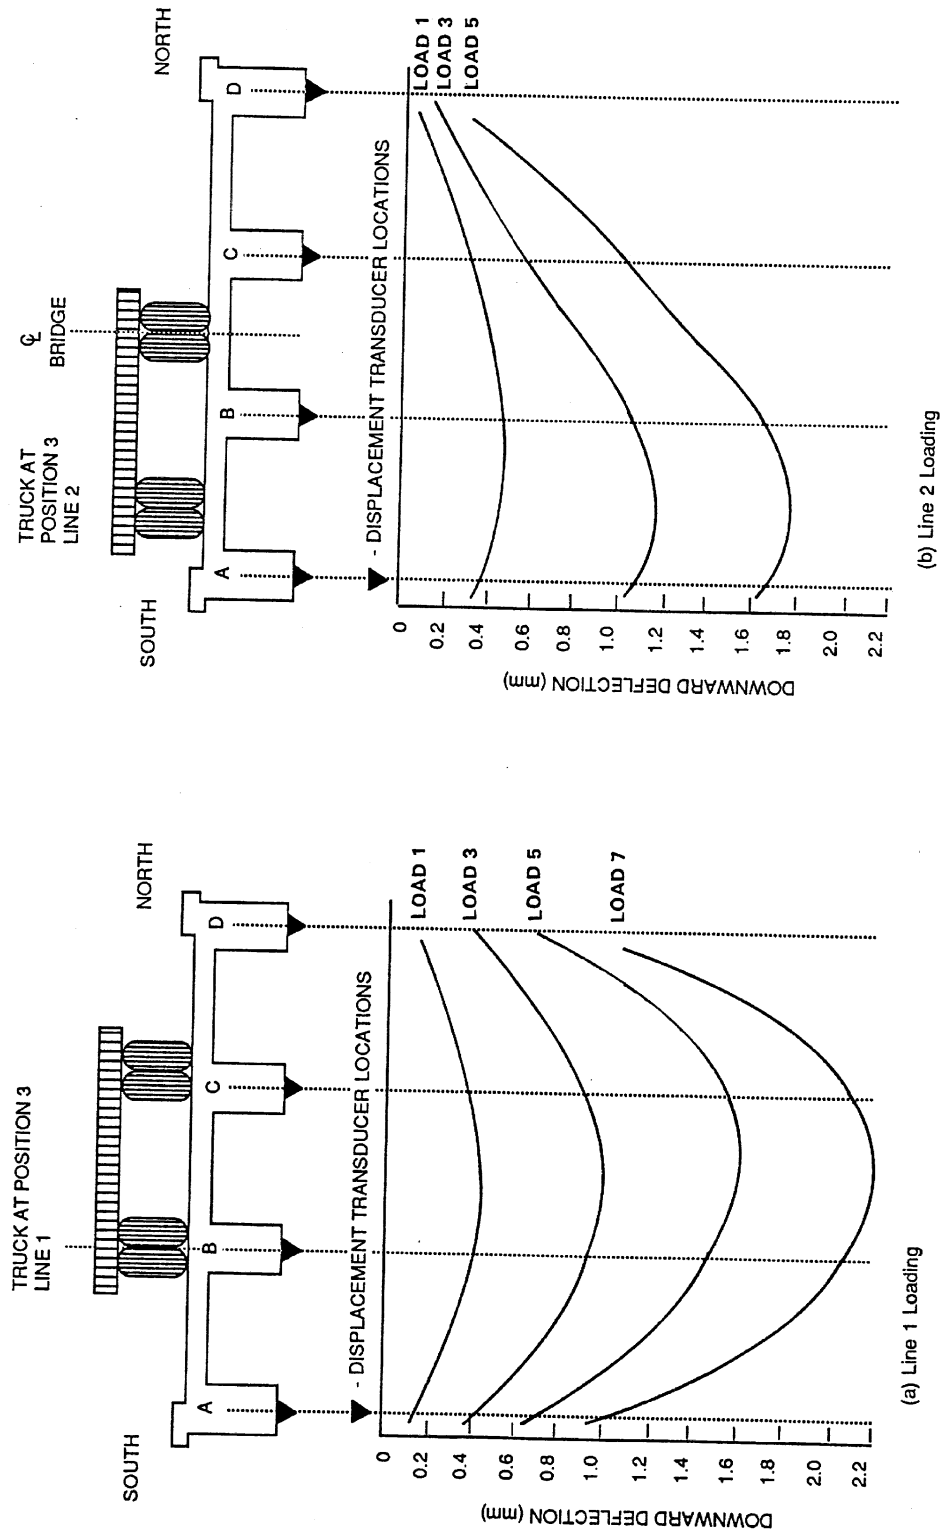
Figure 11/ Vertical Deflections at Midspan

Midspan deflections under different loading configurations are plotted in Figure 11. The patterns generally conform to the transverse position of the truck. Although the deflections of girder B are somewhat less than those of girder C under central loading, they are of the same order of magnitude. Under eccentric loading girder B deflects most as would be expected. These deflections contradict the distribution of strains measured at midspan (Figure 6), which implied that girder B resisted little or no load. However, as mentioned in Section 4.1, tensile strains in concrete may not be a reliable indication of the load being resisted due to the random distribution of cracks. Significant strains could occur across a crack while negligible strains are recorded in the concrete adjacent to the crack. Deflections are a more reliable indication of load distribution since they are related to the accumulative strains over the length of the beams.

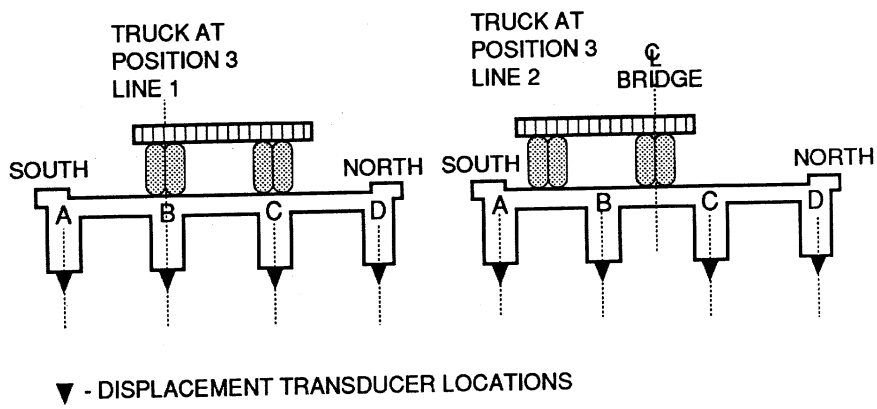
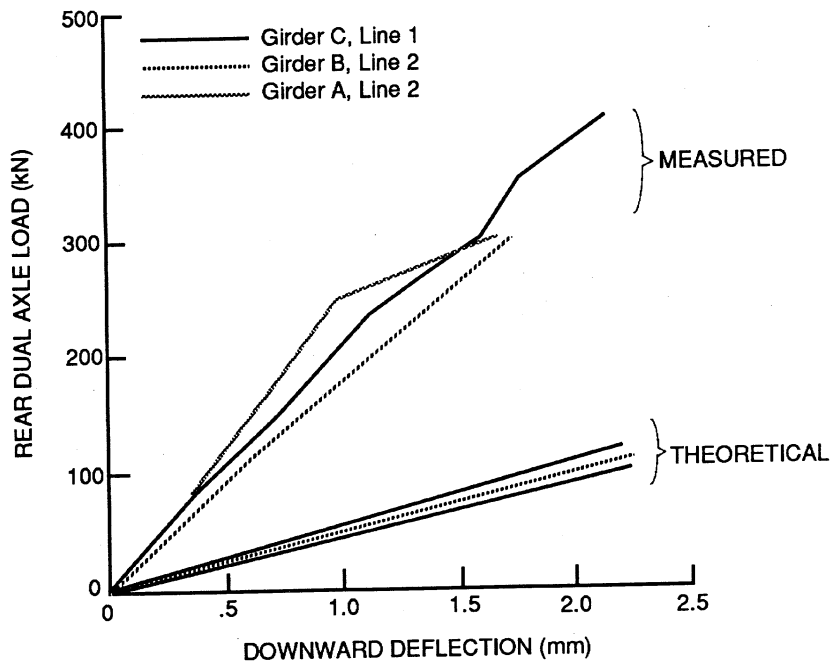
Figure 12/ Load vs. deflection

The maximum deflections are plotted against applied load in Figure 12. The measured deflections were much smaller than the theoretical values calculated from a grillage analysis program assuming a simply supported span and stiffnesses based on the full uncracked concrete section. However, the deflections in exterior girder A under eccentric loading showed signs of becoming non-linear at load level 5. Strains in this girder also appeared non-linear and for these reasons eccentric loading was stopped after load level 6. However, all deflections were largely recoverable.
