Evaluation of Crack Sealing Compounds for Asphaltic Pavements

EMO PROJECT NO. 33

Final Report

Oct. 1983

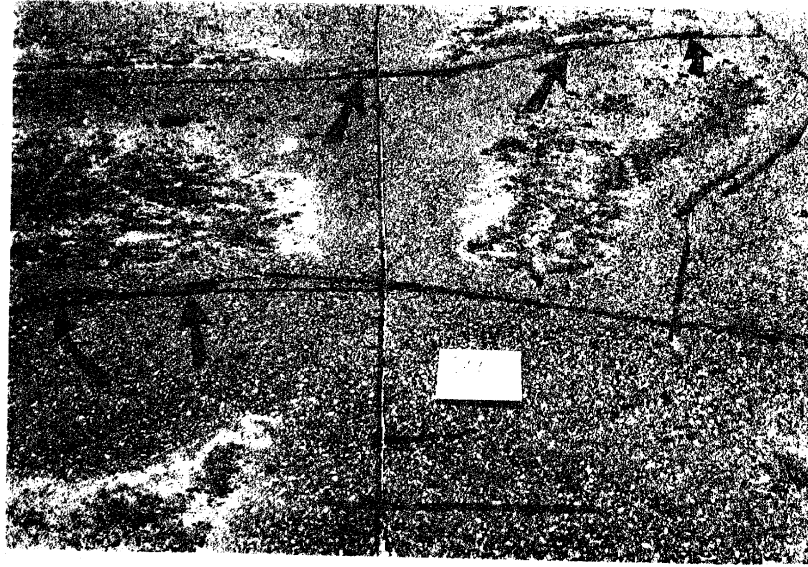
FIGURE 1

All routing was performed to a width and depth of 19 mm. The overall quality of routing this year was improved over that observed in the 1980 trials. It was evident that even with the additional care being taken that the Tennant router was incapable of routing the meandering cracks. When a crack changed direction quickly, the Tennant router would not respond fast enough and would miss the crack, requiring the vertical router to be employed to cut the missed portion. This would result in two cuts side by side which would either create a wide groove or leave an island of pavement between the actual crack and the groove cut by the Tennant router. (See arrows in Figure No. 1). The cutting debris left by the Tennant would often obscure the missed cracks and the operator of the vertical router would then miss cutting some.

ROUTING DEFICIENCIES

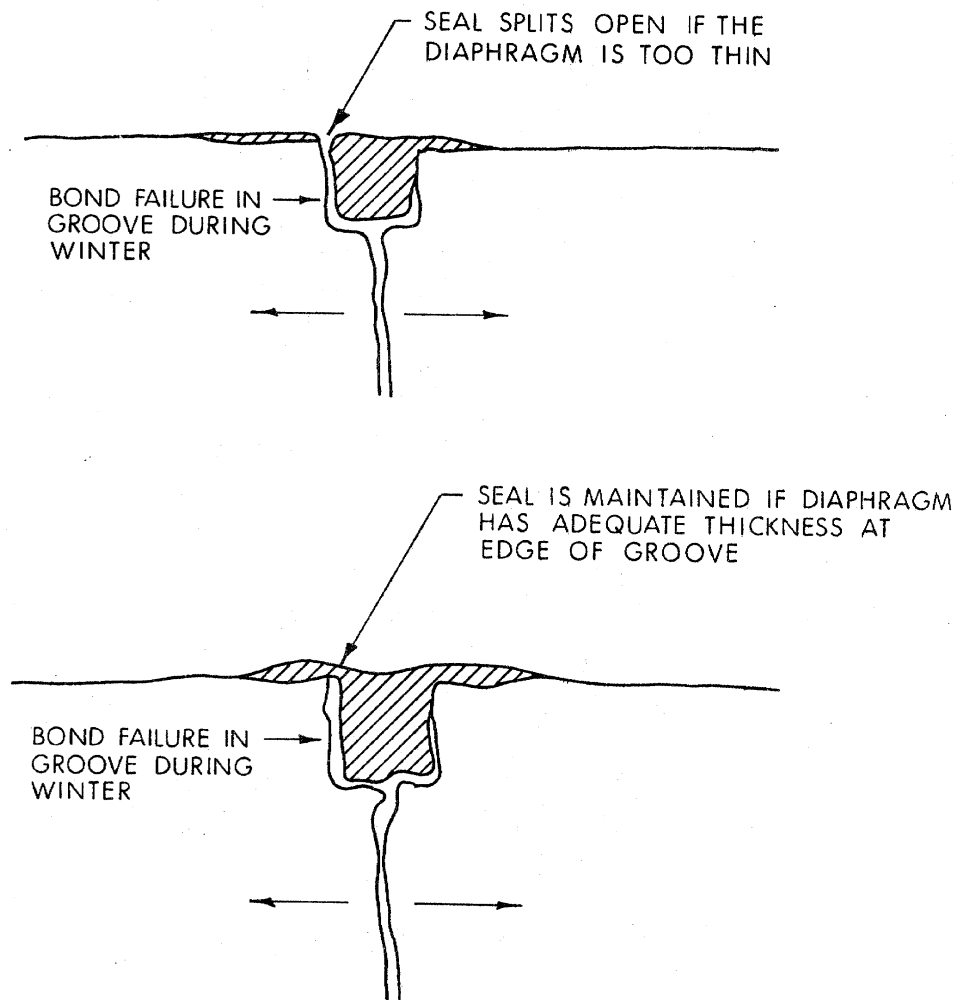
FIGURE 3

During the four appraisals it became evident that splitting of the seals at the edge of the rout was minimized if the membrane at that point had a 2-3 mm cross-sectional thickness. Where the sealant was struck off thin, (less than 1 mm) poor performance was common. In several sections it was noted that an effective seal was maintained even though the material was no longer bonded in the routed groove as confirmed by pinching the seal between thumb and forefinger and lifting it up and down. This occurred when the diaphragm across the rout had enough cross-sectional area to maintain its integrity. Figure 3 indicates how the cross-section of the seal can affect winter performance.

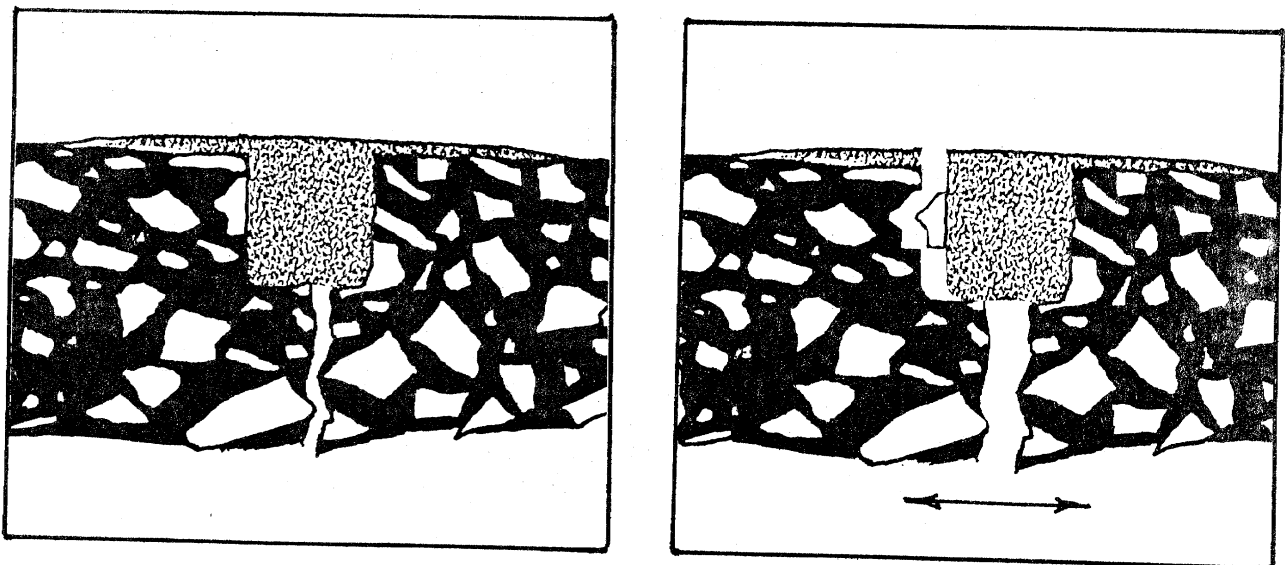
FIGURE 4
GENESIS OF A "BOND" FAILURE

The work in 1981 and 1982 established that seals fail primarily in bond and that if moisture was present at the time of routing and sealing, bond failure was almost assured. To clarify, separation or splitting of a seal at the edge of the routed groove has been identified as a bond failure. This is a somewhat oversimplified description because the actual failure may be a combination of bond/cohesive failure plus a partial failure of the pavement. Sealants with a good bond and high stiffness modules will pull aggregate that have been disturbed in the cutting operation out of the side of the routed groove. This was observed in many of the test sections. Figure 4 demonstrates how a "bond" failure may be a combination of failures.
