# The October 1985 Landslide at Barrio Mameyes, Ponce, Puerto Rico

Francisco Silva-Tulla, Consulting Engineer, Geotechnics  
12 Baskin Road, Lexington, Massachusetts

Committee on Natural Disasters  
Commission on Engineering and Technical Systems  
National Research Council

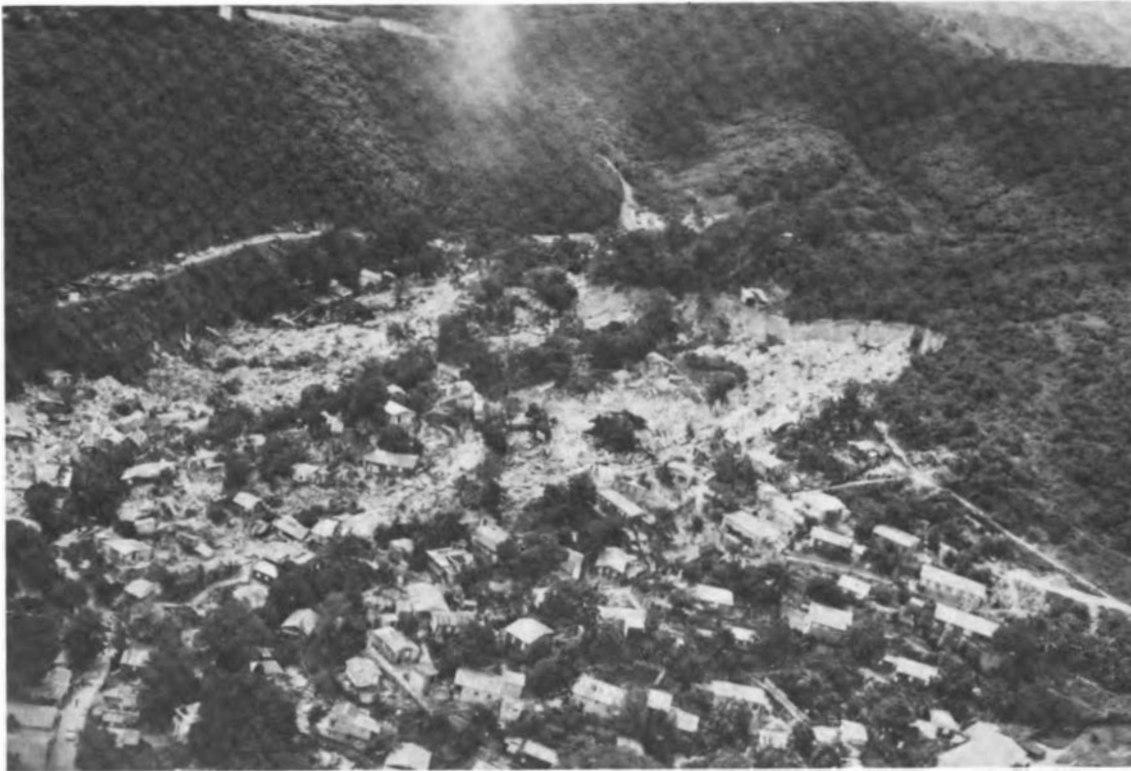
Figures 1 through 3 show aerial views of the Mameyes landslide. The roughly triangular slide covers an area of about 25,000 m<sup>2</sup> (the base of the triangle equals approximately 190 m and the height of the triangle equals approximately 230 m, measured from a 1:1,000 aerial photograph displayed at the disaster operations center). The subsoil consists of weathered Juana Diaz formation, a calcareous sandstone overlain by chalky limestone, with bedding planes striking N 87 W and dipping 20 SW. Before the slide, the ground surface sloped 20 to 25 degrees in the general direction of the bedding planes' dip. Two intersecting joint sets with a nearly vertical dip and strikes of N 63 E and N 60 W define the head of the slide (the apex of the triangle). The scarp at the head of the slide varies in height from 5 to 10 m. A relatively intact soil block dominates the center of the slide area. Slide debris surrounds this soil block, which moved downslope about 30 m. Near the toe of the landslide, debris 10 to 12 m deep accumulated over a reinforced concrete box culvert through which La Colectora Creek flows. The culvert apparently remained functional after the landslide.

**FIGURE 1 Aerial view of Mameyes landslide.**

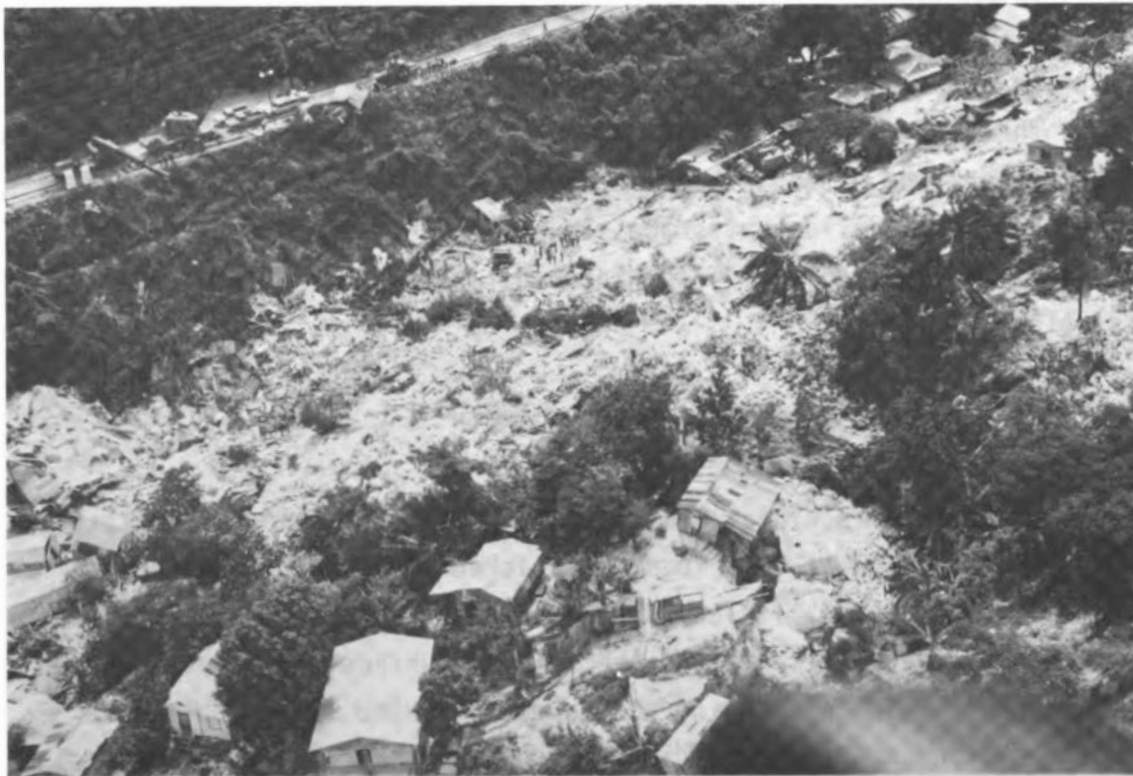
**FIGURE 2 Toe of landslide.**

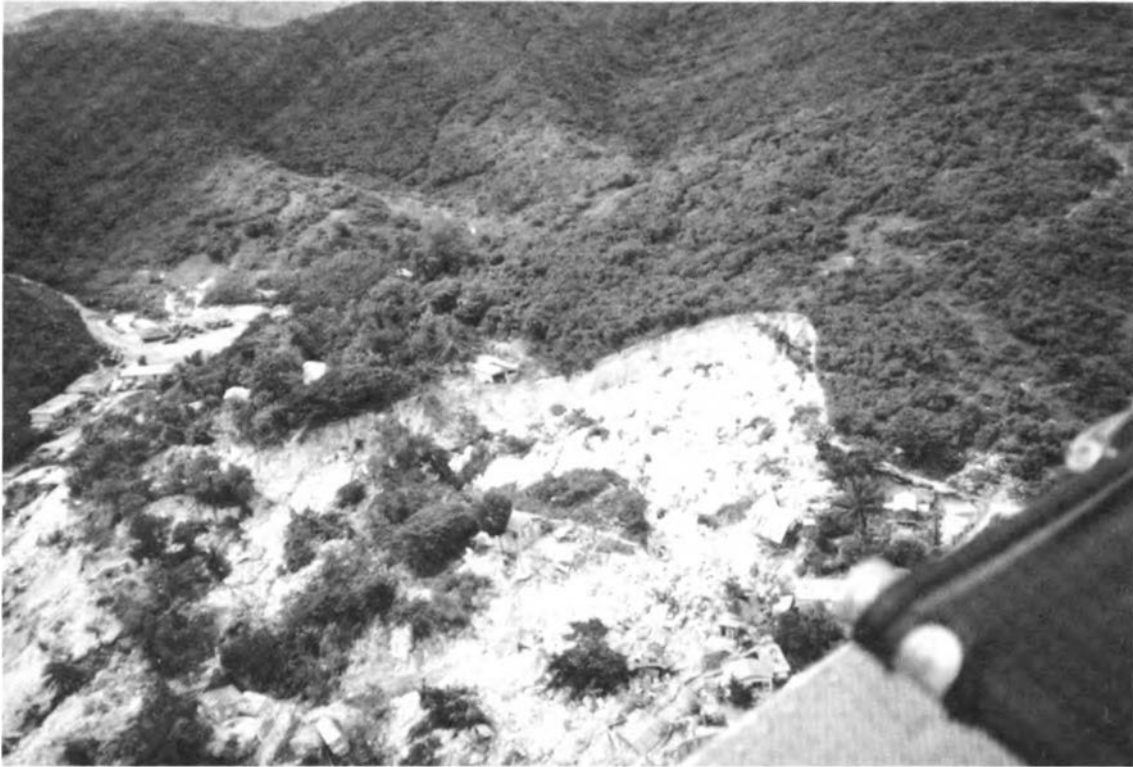
FIGURE 3 Head of Landslide.

The high vertical scarp at the head of the Mameyes slide suggests that the weathered rock at this location cracked along joint planes and probably contributed little resistance to the sliding mass. The shear strength of the material along the sliding surface undoubtedly played an important role in controlling the landslide. The slide could have occurred along a "clean" bedding plane or, more probably, along a clay

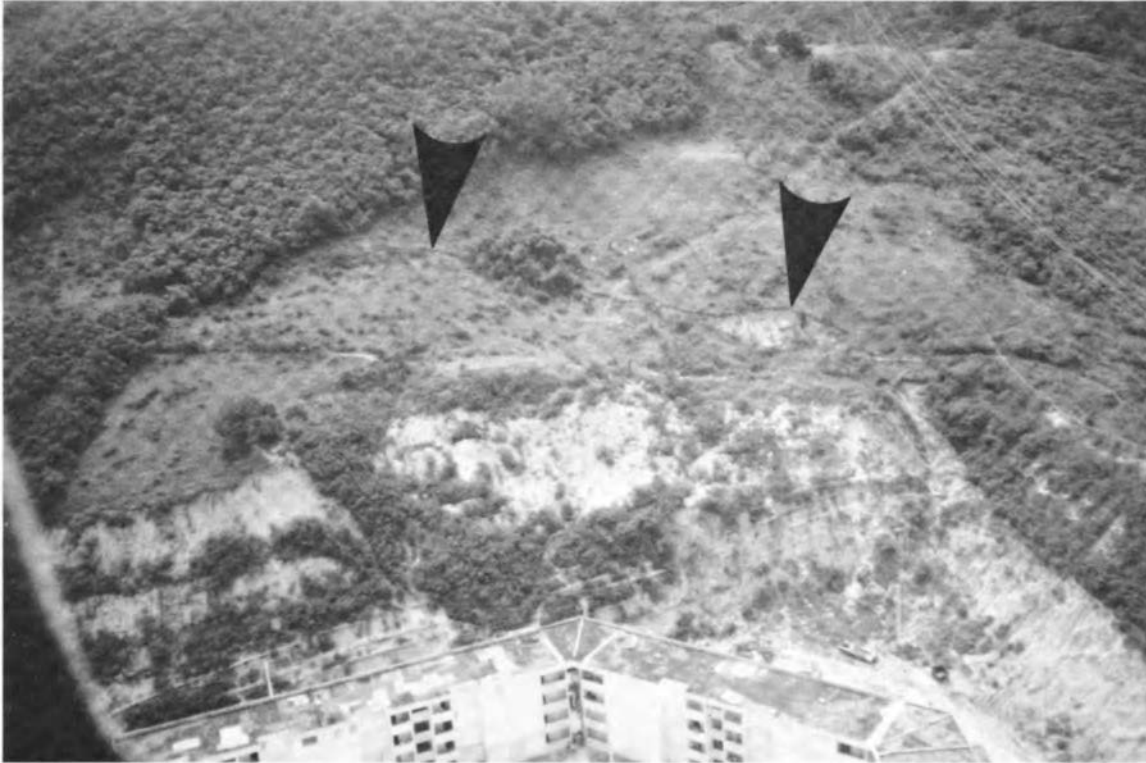
An inspection of the area from a helicopter revealed other slopes that are densely built with houses and appear similar to the slope on which the Mameyes landslide occurred. Figure 4 shows a 140-m-wide active landslide detected behind the Las Terrazas public housing development. The landslide exits the slope 15 m above the ground floor elevation of a four-story building located less than 12 m from the toe of the slope.

**FIGURE 4 Active landslide above Las Terrazas housing development.**

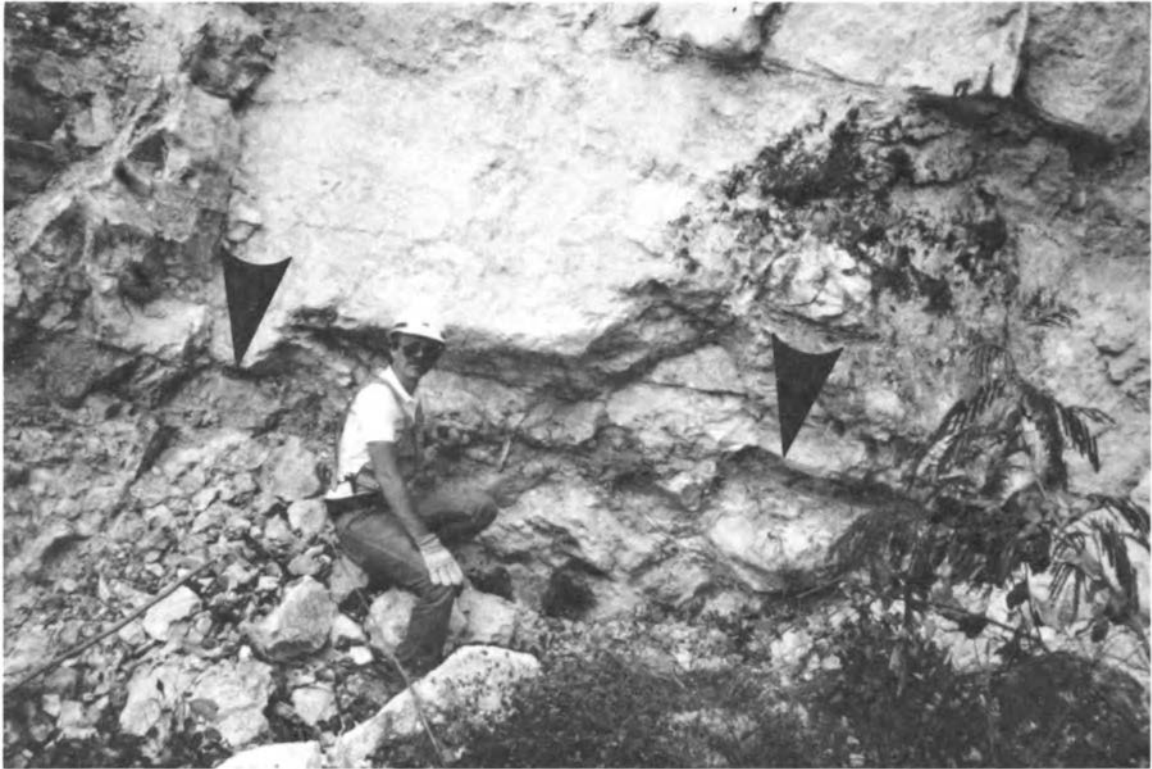
layer like the one shown in Figure 5. This 8-cm-thick layer contained a stiff, fissured, plastic clay. Similar clays frequently sustain large changes in effective stress upon wetting (pore pressures change from highly negative to zero or positive) and experience strain softening. At other locations in the landslide area, boulder-size clay pockets existed and joints and bedding planes contained thin clay deposits.

FIGURE 5 Stiff, fissured, plastic clay layer (8 cm thick).
