# To all users of the: PERFORMANCE OF INTEGRAL ABUTMENT BRIDGES MANUAL

(S)	Ministry of Transportation	Report BO-99-04
Ontario	Bridge Office	
Performance of Integral Abutment Bridges		
ISBN 0-7778-9265 © The Queen's Pri Reproduced with p	nter for Ontario, 2000.	By: Iqbal Husain, P. Eng. Dino Bagnariol, P. Eng.

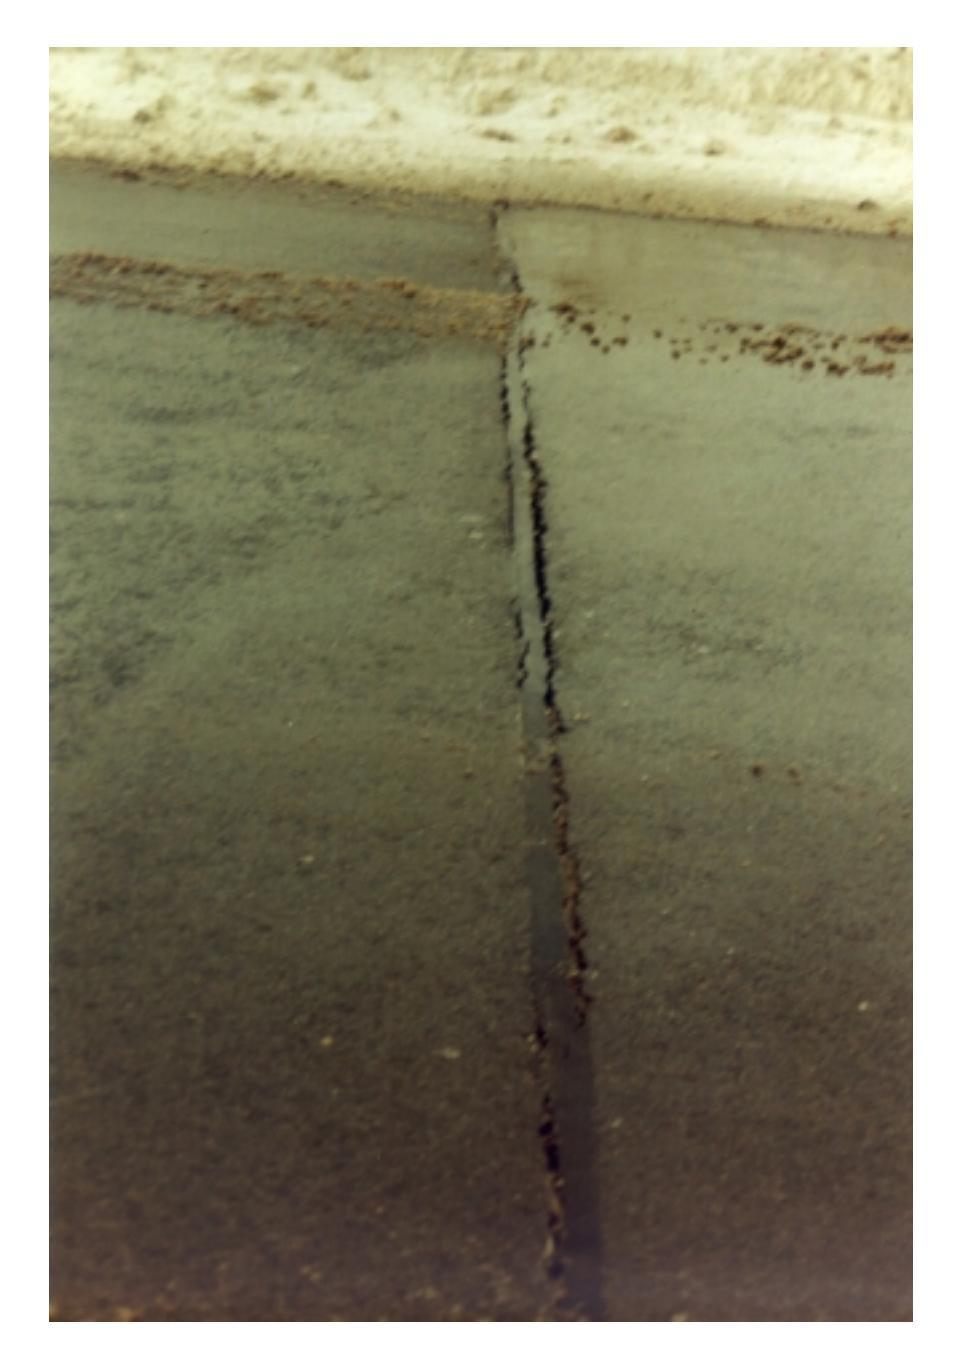
The isolation joint detail as shown in Fig 1 works well where the total length of the structure is less than 75m for steel structure and 100m for concrete structure. The gap widens in the winter and the edges of asphalt pavement appear to separate from the sealing compound, see Fig 2.

This gap, however, closes again in summer and does not result in any loss of riding quality. It is anticipated that after a few years of repeated movements it may become necessary to replace the rubberised joint sealing compound and carry out minor repairs to the edges of asphalt pavement.

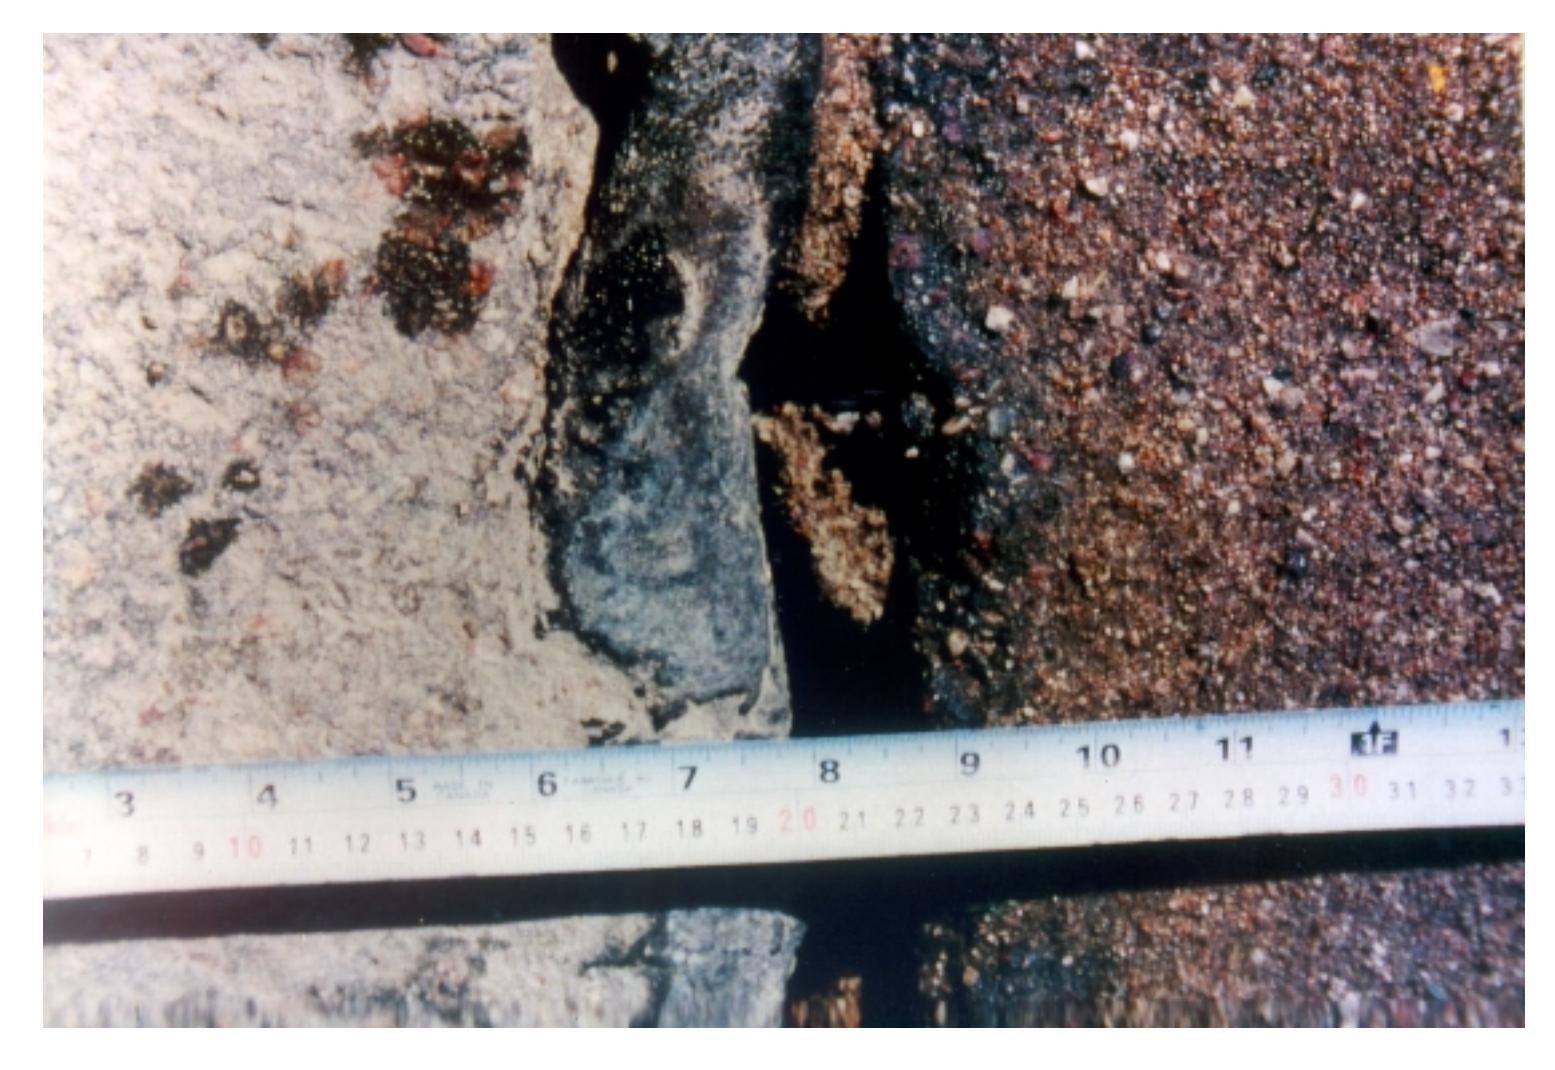
Fig 3

In some cases where the total length of the structure exceeds the above limits, there is evidence of a wider gap at the joint location and distinct separation of sealant during the winter months as shown in Fig 3.

It is felt that this may cause a reduced quality of ride and may require more frequent repair. As a result, MTO has developed a more elaborate movement joint detail for bridges where the total length is more than 75m for the steel structures and 100m for the concrete structures as shown in Fig 4.

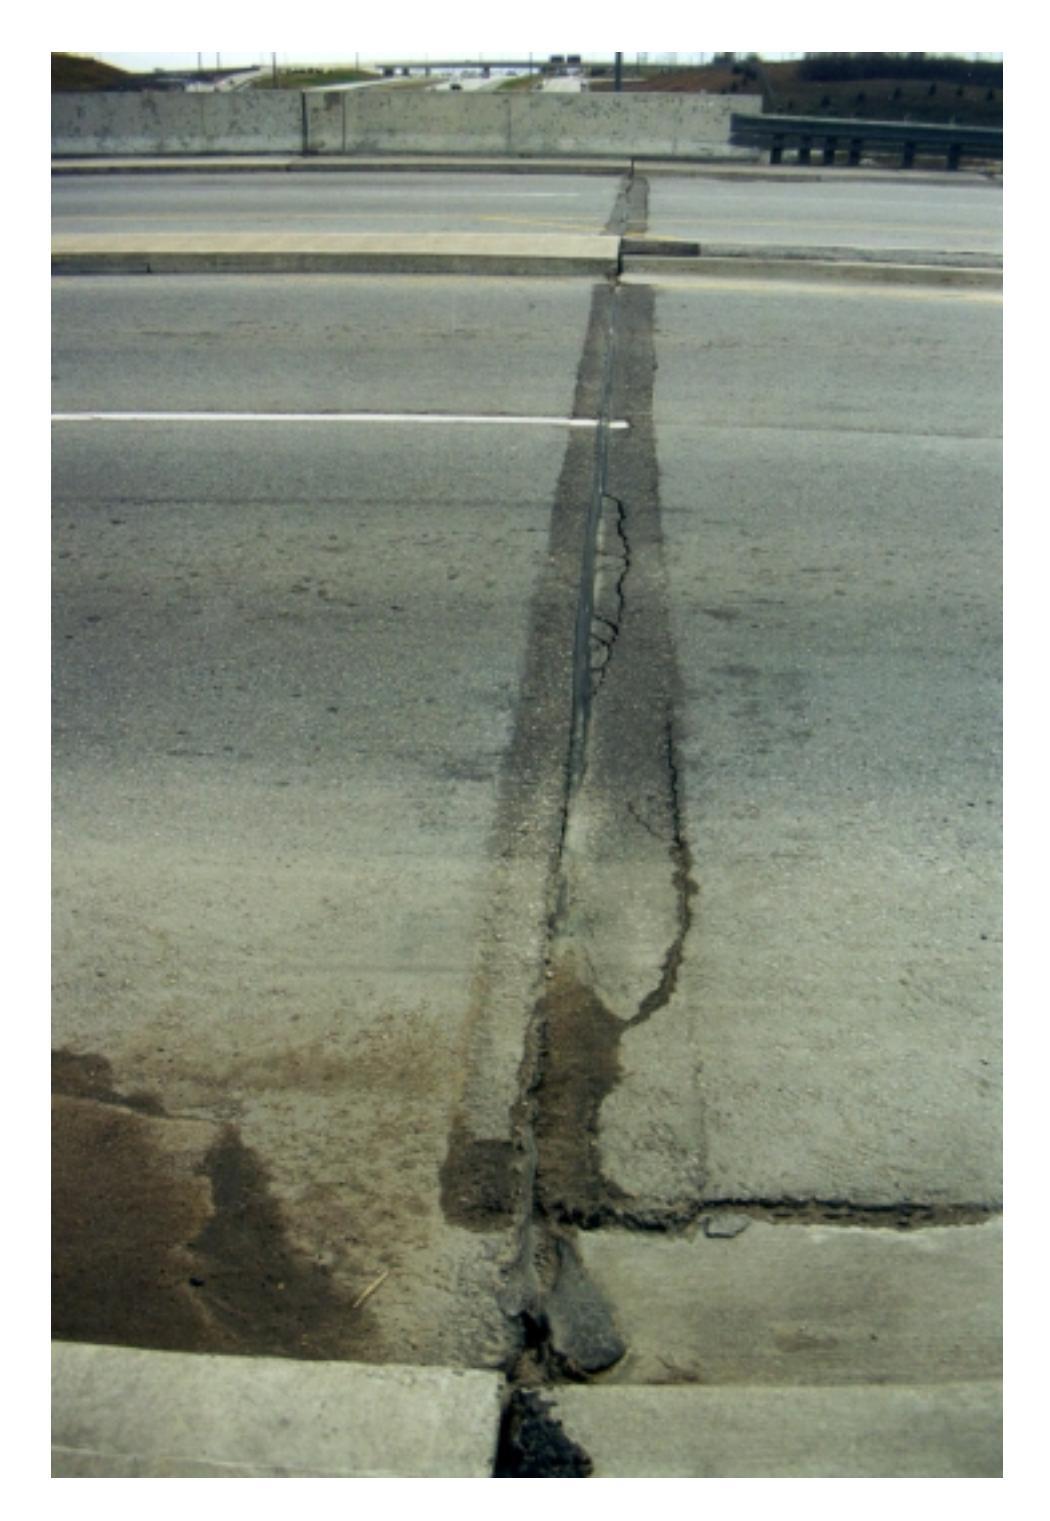
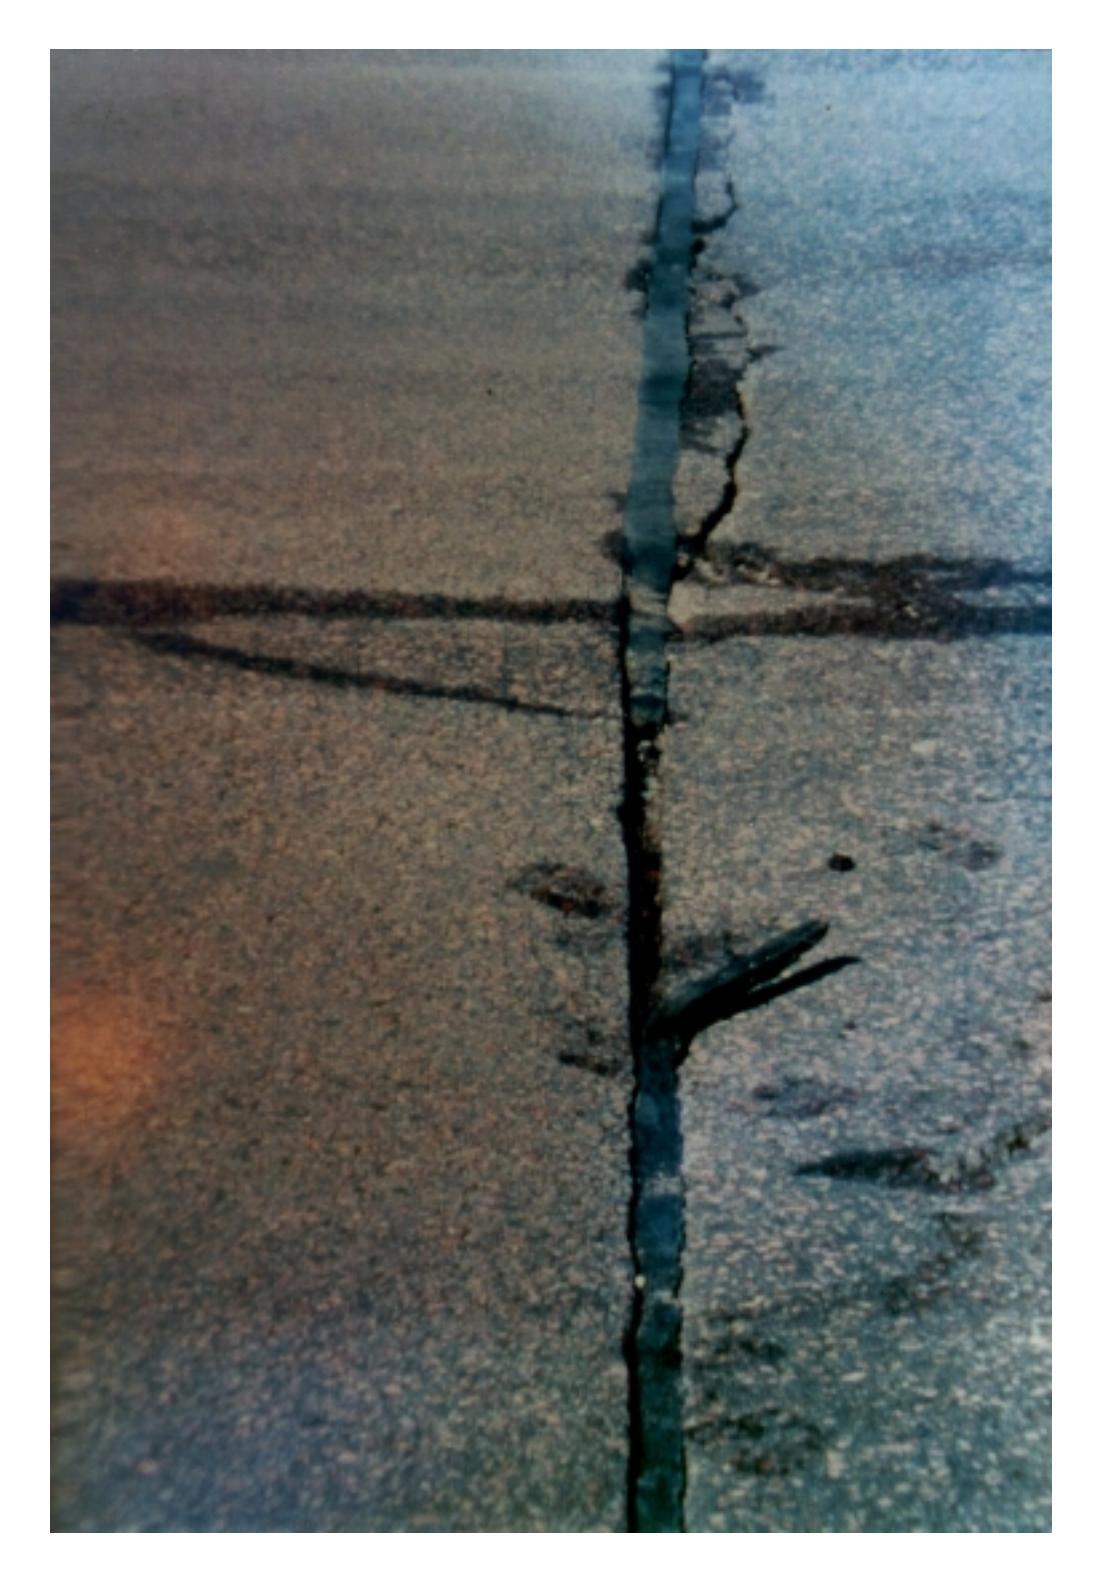
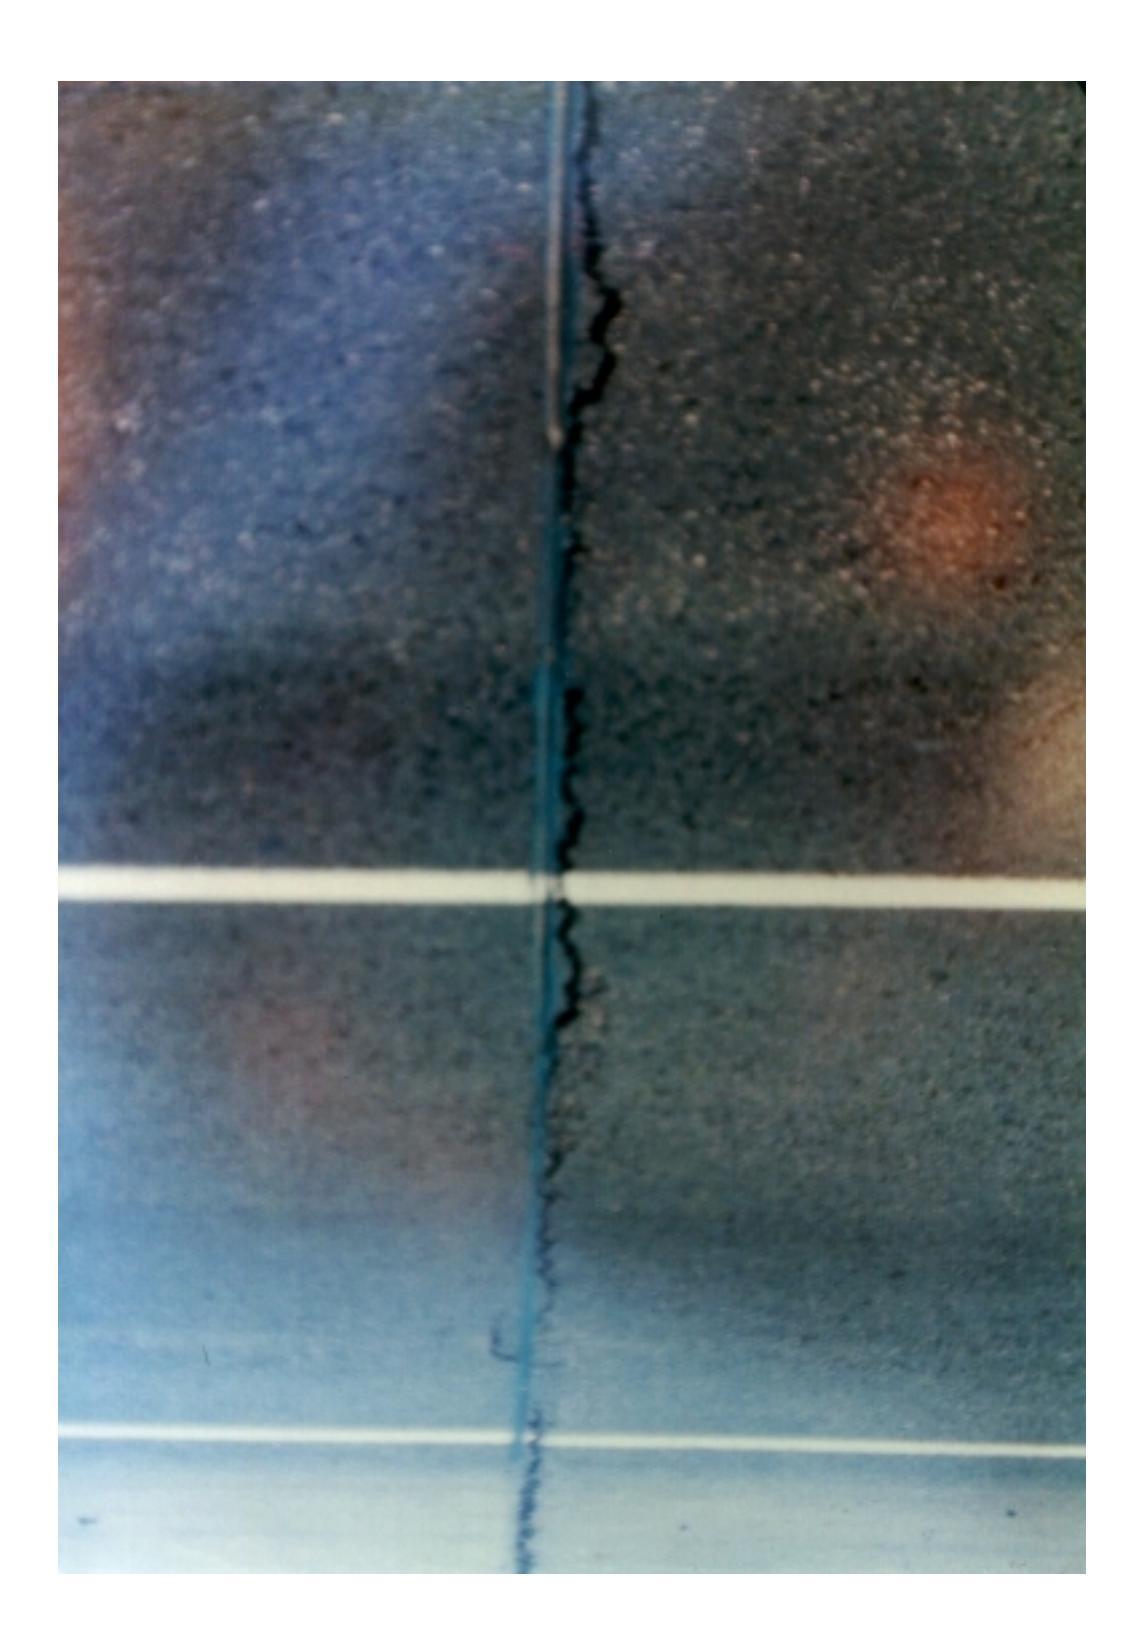
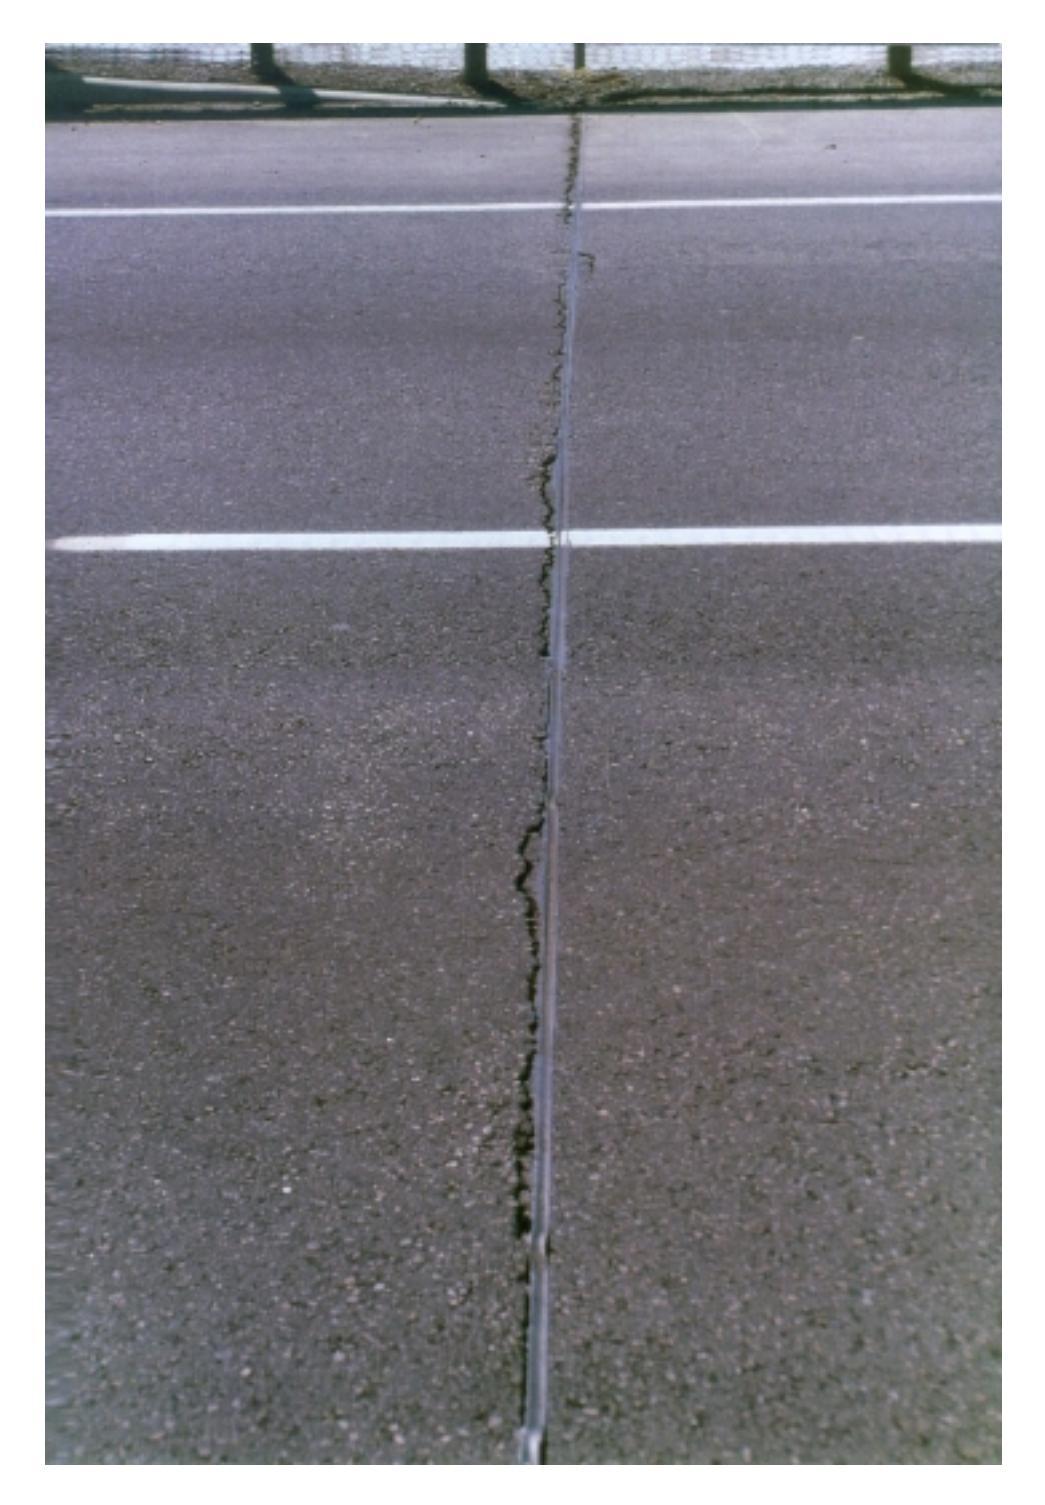
The quality control during the construction of isolation joints and the preparation of the sub-base, greatly influences the durability and effectiveness of the joint. A well made joint should be placed on a well compacted sub-base between straight sawn cut edges as shown in Fig 5. A carelessly made joint and deficient compaction of the sub-base in the vicinity of the joint, as shown in Fig 6, may result in early deterioration of the pavement and may need more frequent maintenance. It is recognised that even a well made joint will, deteriorate in time and would require maintenance (Fig 7,8,9). The Maintenance crews should be fully aware of the need and function of these rather simple looking joints. In some cases the lack of awareness has resulted in partial or complete elimination of the joint during a maintenance operation (Fig 10).

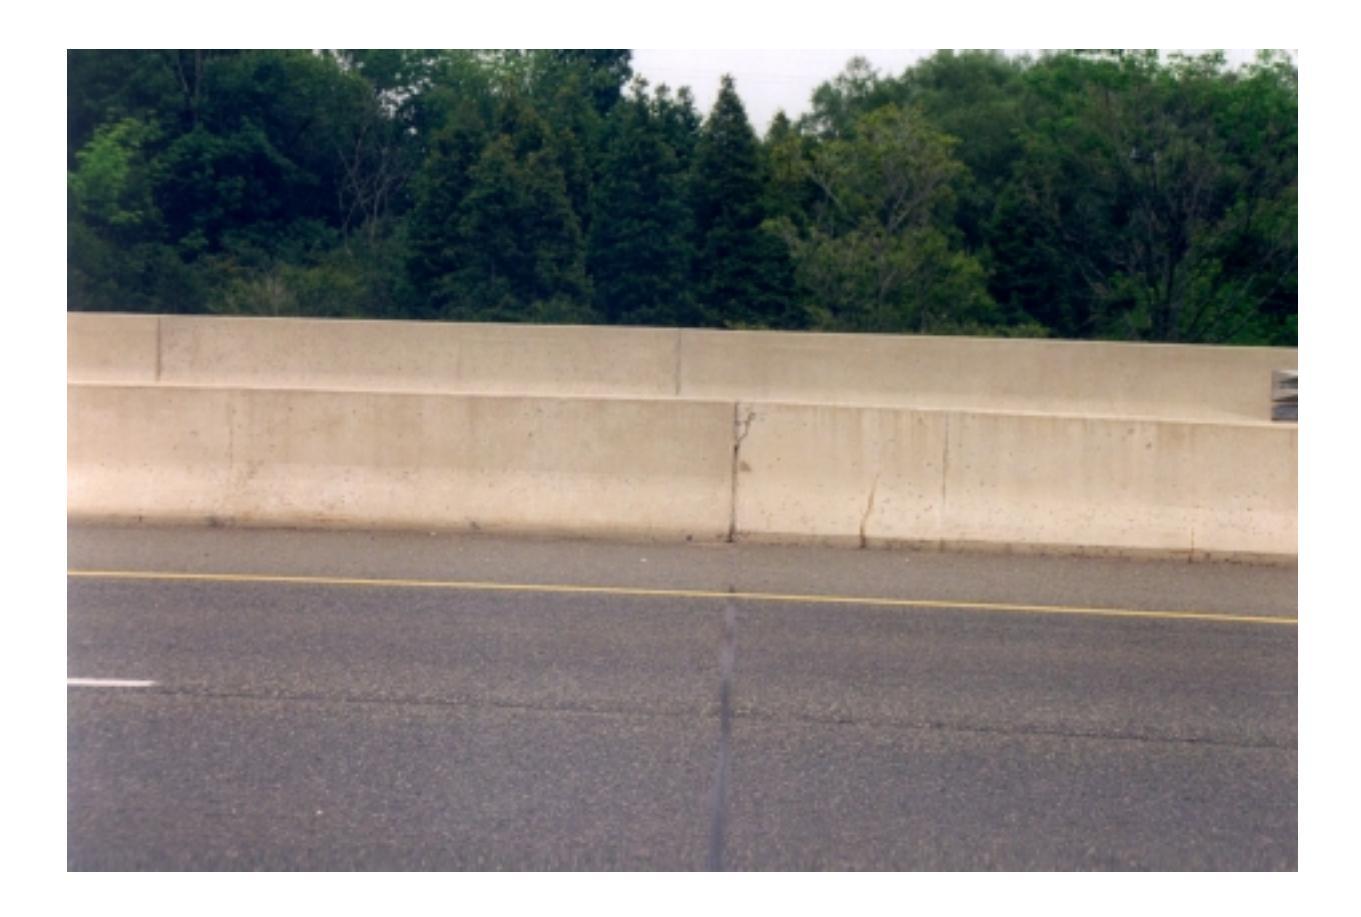
Fig 11

There is evidence of cracking in barrier walls just above the abutments. The most likely cause of this is the tension from negative bending moment at the supports (Fig 11). These cracks are not desirable as they may lead to durability problems due to ingress of salt and water, resulting in rapid deterioration of the barrier walls. It is suggested that the barrier wall should be provided with additional reinforcement at this location and the length of wingwall and height of the abutments should be minimised to reduce the negative bending moment. Alternatively an expansion joint may be provided in the barrier wall at this location.

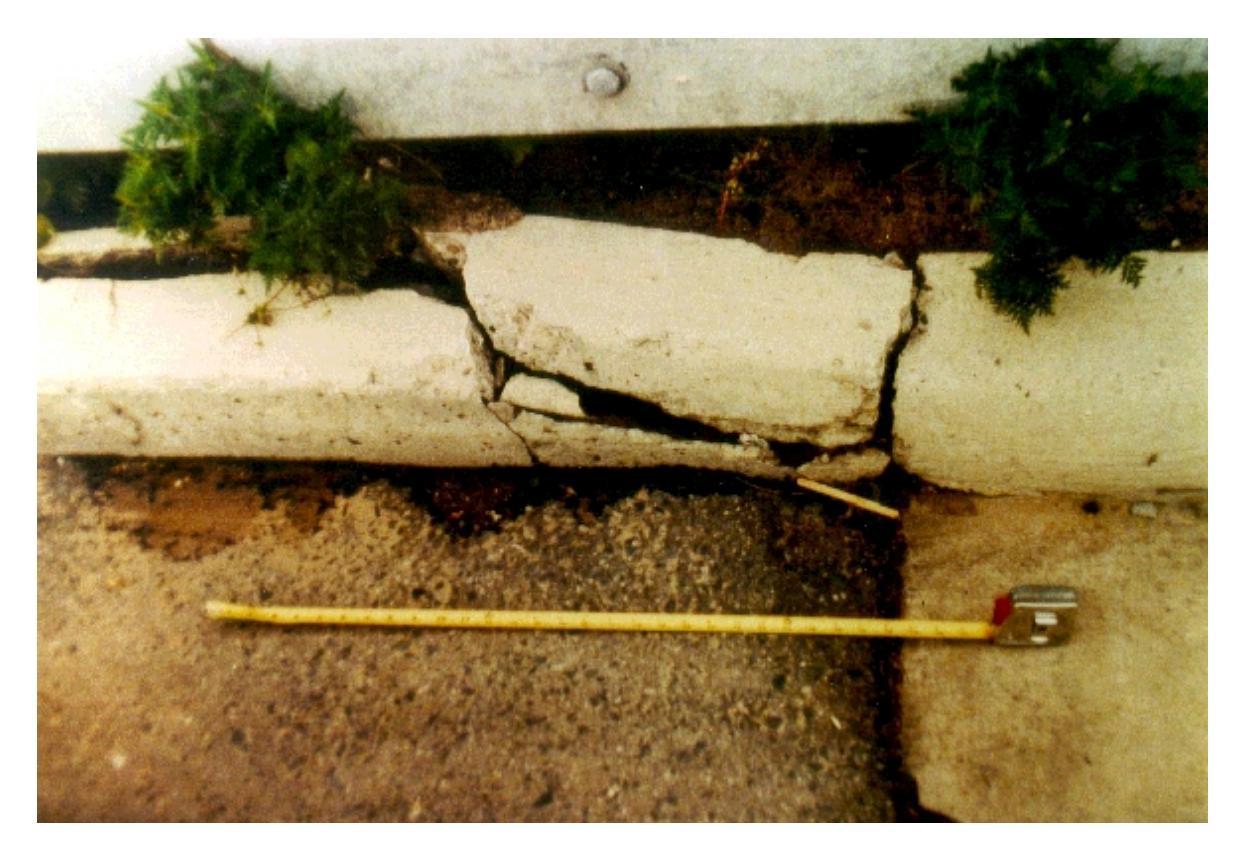
Fig 12

In many cases the edges and corners of the curbs have been damaged at the abutment locations as shown in Fig 12. This damage appears to have resulted from a gap that is too small to accommodate movements, or the complete absence of a joint. This could be avoided by providing an expansion joint in the curbs at this location.

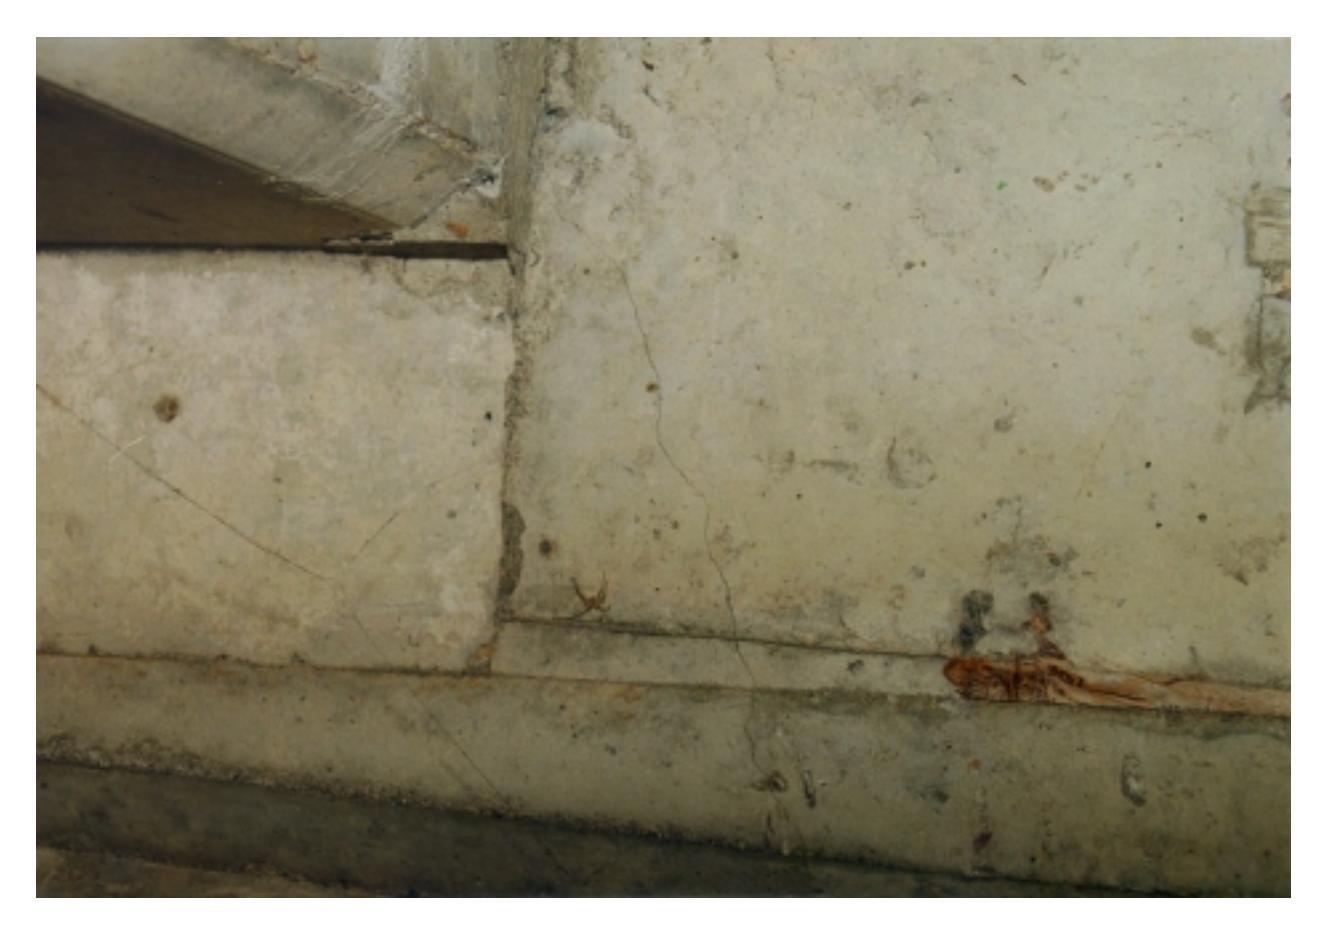
Fig 13

In fully integral bridges the purpose of the bearing seat pedestals is to minimise the eccentricity of loads transferred to the piles and to provide for the anticipated girder end rotations without causing damage or causing built-in stresses. In many bridges, a diagonal hairline crack, starting at the tips of lower flange of the girder, is apparent as shown in Fig 13. These cracks are not significant and not likely to cause a major durability concern. The cracks appear to have been caused by a stress concentration and load transfer to the concrete in front of the pedestals. The thickness and hardness of the bearing pad plays a significant role in load transfer. A thin stiff, bearing should be used to minimise deformation due to load transfer. In the past, MTO has used 15-20 mm thick rubber or elastomeric pads with 50+/-5 Duro-hardness, but this practice is currently being reviewed.

It is suggested that the height of the pedestals and space in front should be sufficient to place adequate reinforcement in this area.

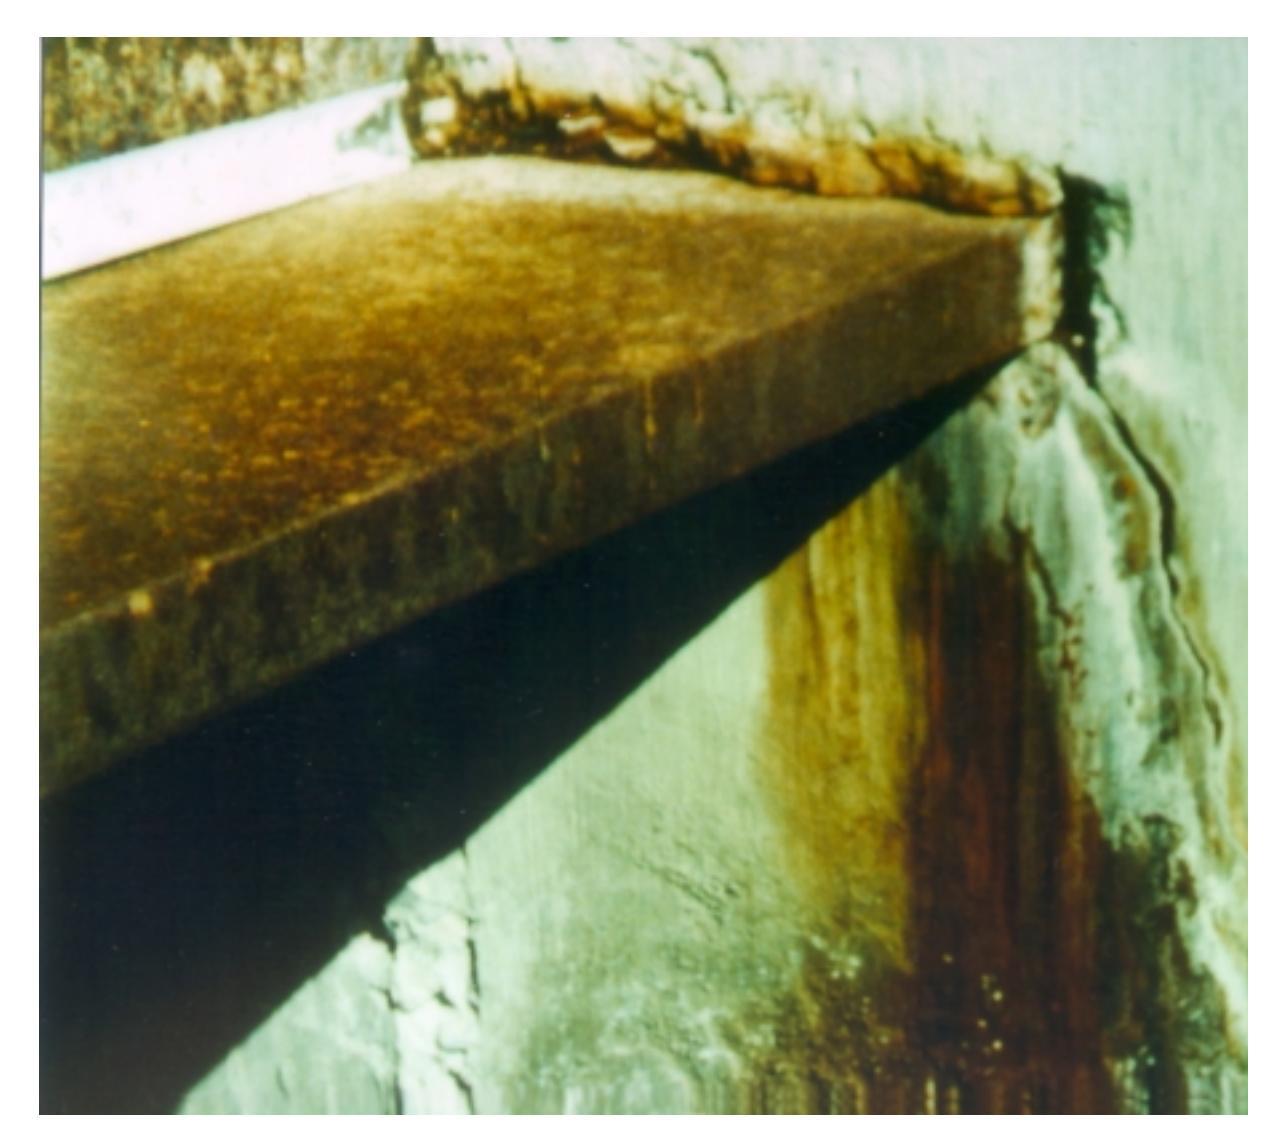
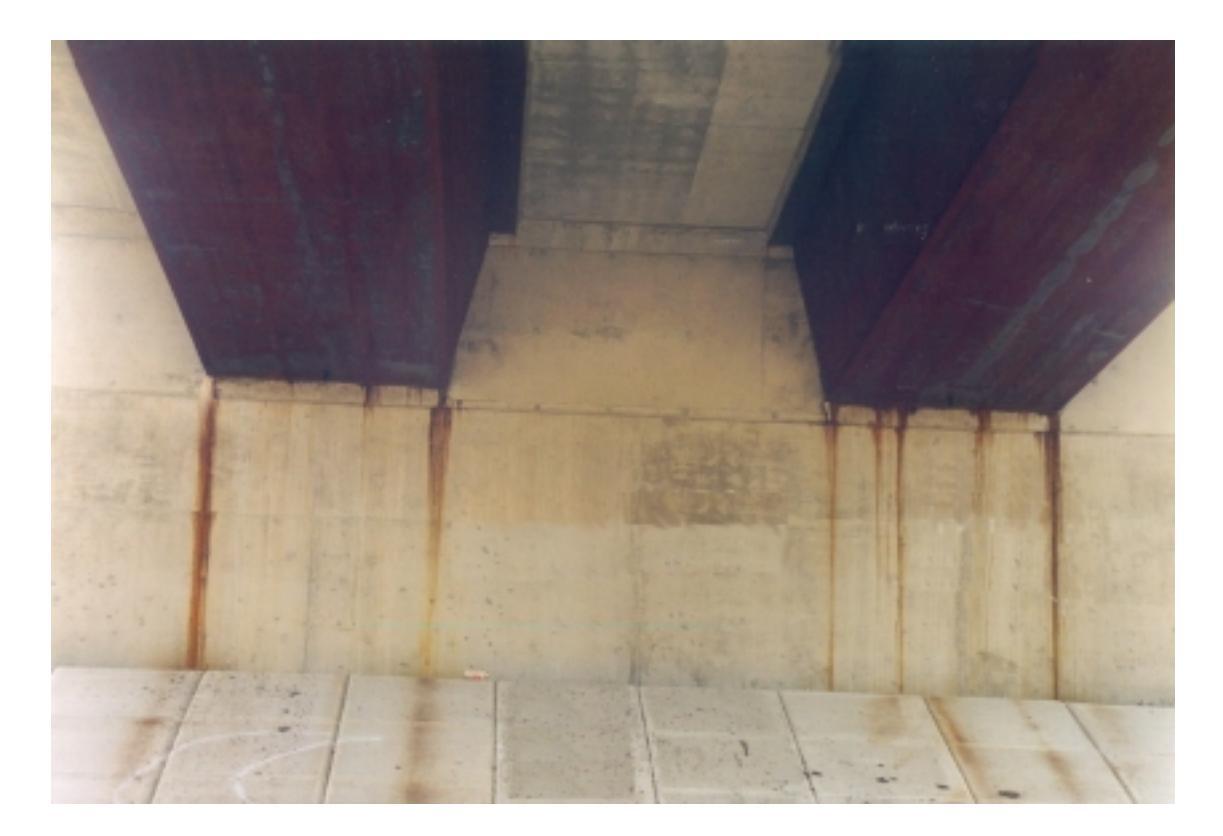
Fig 15

The condensation due to the difference in temperature between the steel girder ends and adjoining concrete or other atmospheric reason causes rust stains at the face of the abutment as shown in Fig 14,15. It is suggested that girder ends within 500mm from the face of the abutment should be coated to avoid this problem.
