TRIP REPORTS ON SITE VISITS TO FRANCE, SWEDEN AND ITALY

Ontario-Quebec High-Speed Rail Project

1: SITE VISIT TO FRANCE

PHOTO REFERENCES FOR SNCF VISIT

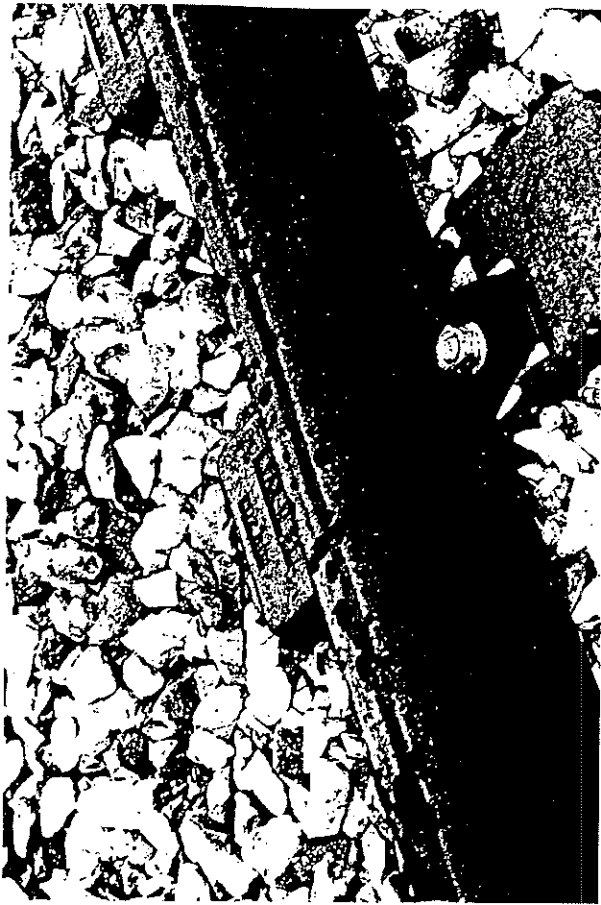
Photos I-4.1 — I-4.4

The ballast (Photo I-4.1) was 50/25 graded crushed 'granite' and what appeared to be metaquartzite. These materials are generally suitable for this type of application, but there appear to be two deficiencies, based on visual inspection:

- the ballast material seems to have a large number of particles with a high shape factor (SF - defined as maximum dimension/minimum dimension), which results in poor interlocking, reduced section stability, and increased tendency to fracture; and
- some of the source material is composed of minerals with large grain sizes.

Ideally, ballast particles should be cuboid (SF between 1 and 2). SF values over 2 are not acceptable for this class of track, and there are numerous examples of such particles in the accompanying photos. Also, ballast materials should be fine-grained and free from planes of weakness (jointing, grain boundaries, gneissic or schistose texture). Coarse-grained materials tend to fracture readily on grain boundaries, and coarse-grained granites (and pegmatites) which contain a substantial proportion of feldspar, are also vulnerable to fracturing on the cleavage planes of these minerals. Once fractured, feldspars will weather to clay minerals, which foul the ballast and interfere with drainage.
