Development of a Safety Improvement Strategy at a Truck Rollover Prone Location

James Donnelly, P.Eng., PTOE
Urban Systems Ltd.

Paper prepared for presentation at the
Intelligent Transportation Systems as a Tool for Improving Road Safety
Session of the 2008 Annual Conference of the Transportation Association of Canada
Toronto, Ontario

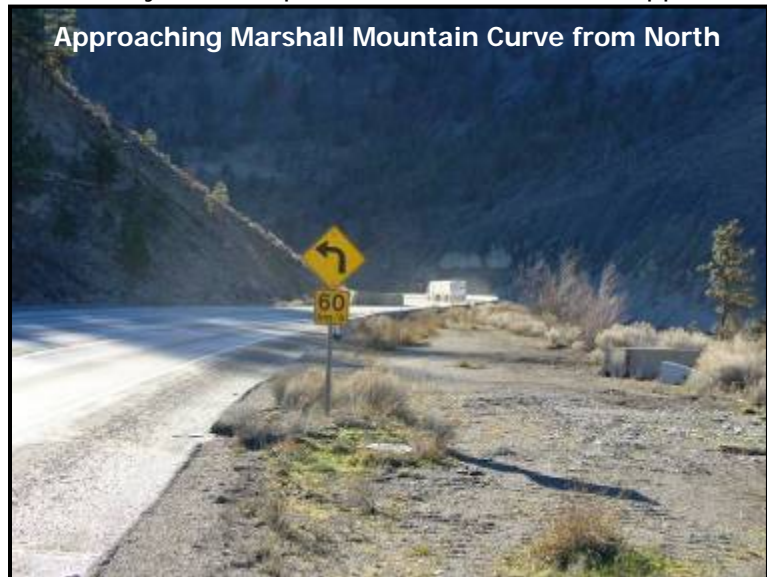
While HAS database collision statistics in this area are inconclusive, the number of documented truck rollover incidents reported by the Ministry of Transportation and the RCMP support the conclusion of work undertaken by ICBC, indicating that this location is a 'Truck Rollover Prone Location'. The curve is located at the bottom of a 7% downgrade and has a 200m radius. Travel lanes through the curve are approximately 3.6m with 2.0m paved shoulders. While the regulatory speed limit of the highway corridor is 90 km/hr, the critical curve has a design speed of 80km/hr and a posted advisory speed of 60 km/hr. The majority of truck rollover incidents occur in the southbound direction, at the end of the 7% downgrade.

The existing advance warning sign placement is illustrated in **Figure 2.1**. A total of six static warning signs are currently placed in advance of the critical curve. The relatively high number of warnings over a short distance (approximately 560m) may be contributing to reduced compliance levels as the existing sign placement does not adequately communicate the specific location and magnitude of the hazard. In particular, the Truck Rollover Warning (W-324) sign is placed in advance of the first curve to the right. This would seem to indicate that the first curve is the critical curve, as opposed to the actual rollover prone location which follows on the curve to the left. The 60 km/h advisory speed warning is also displayed in three separate locations (including a W-23 starburst), and is further reinforced by a 'Slow' (W-21) warning sign. The number of advisory speed warnings over a relatively short distance may be reducing the conspicuity of the critical truck rollover warning message.

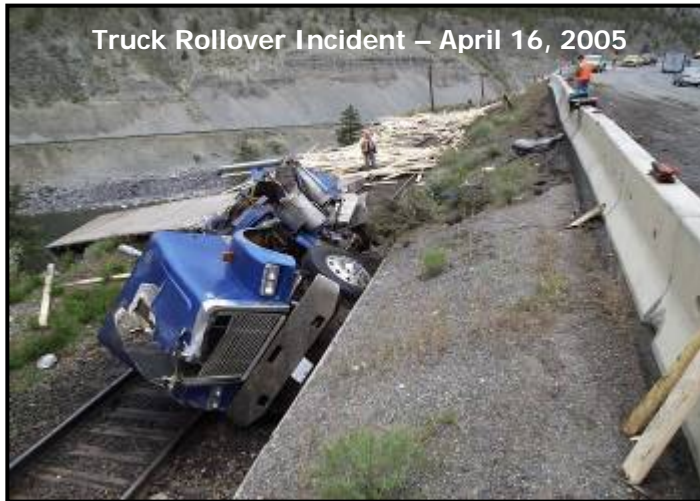
Due to the proximity of the CPR railway at this location, several truck rollover incidents have resulted in either the entire truck or its load affecting traffic activity on railway line. At the

critical section of the curve, the CPR line is approximately 10m (horizontally) from the highway. A standard roadside barrier wall is in place along the entire curve; however this configuration does not offer protection in the event of a direct truck collision. At least one event is known to have resulted in the entire truck breaching the barrier and landing on the railway line itself. In other cases the rolled truck stayed on the highway, while its load spilled over the barrier and onto the railway line.

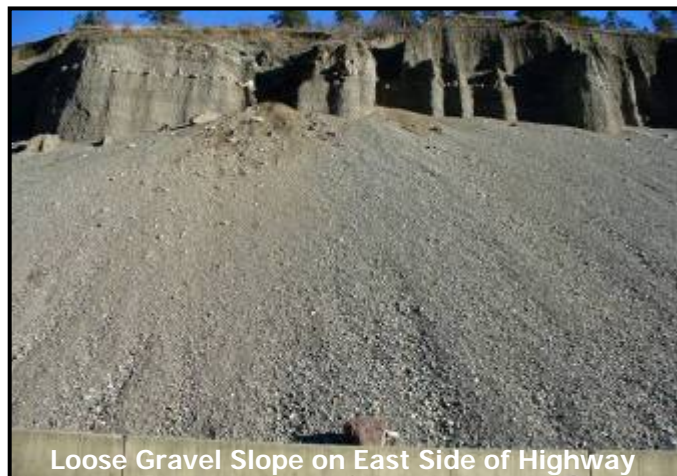
The east side (inside) of the Marshall Mountain curve is dominated by a large steep slope of loose rock material. A rock catch retaining wall protects the highway and the railway from loose debris. This slope is in a constant state of erosion, and requires a significant investment in maintenance to preserve its stability. Even with the wall and associated maintenance it is not uncommon for loose rocks to pass over the wall and land on either the highway or the railway tracks. This results in an additional risk to both highway and railway users.
