Best Practices in  
Traffic Operations and Safety:  
Phase II: Zig-zag Pavement Markings

1. Report No.: FHWA/VTRC 11-R9		2. Government Accession No.:		3. Recipient's Catalog No.:	
4. Title and Subtitle: Best Practices in Traffic Operations and Safety: Phase II: Zig-zag Pavement Markings				5. Report Date: December 2010

**BEST PRACTICES IN TRAFFIC OPERATIONS AND SAFETY:  
PHASE II: ZIG-ZAG PAVEMENT MARKINGS**

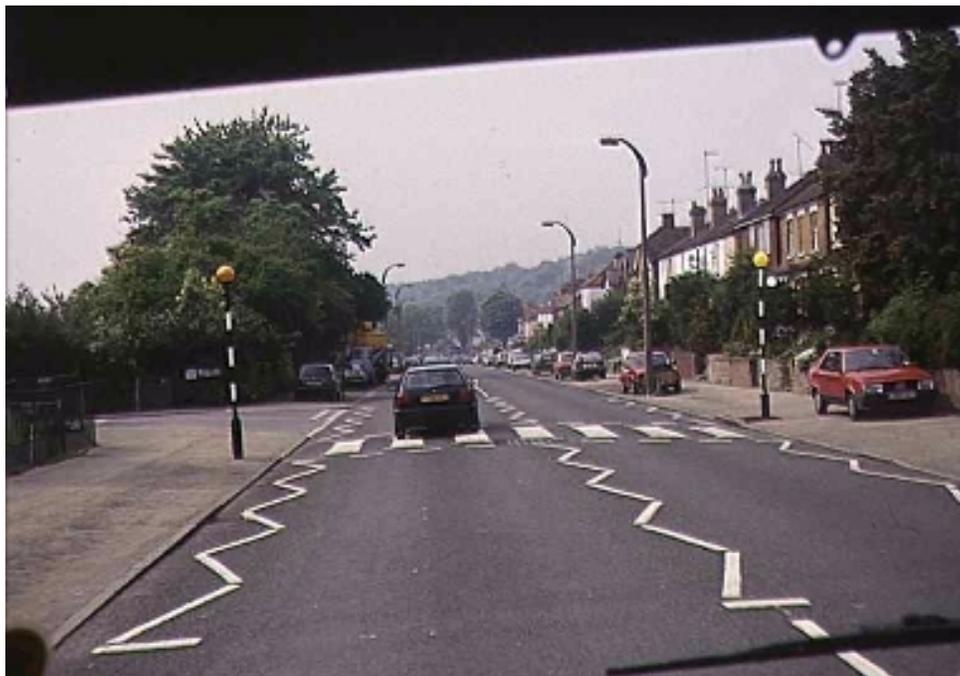
**Figure 1. Zig-zag Pavement Markings in England Observed by U.S. Traffic Engineers.** From Scott Wainwright.

Under the auspices of the FHWA's International Technology Scanning Program, a team of 10 U.S. traffic engineers traveled to Europe in May 1998 to observe innovative traffic control practices and identify those that could be implemented in the United States. In England, team members observed a unique means of informing drivers that they were approaching a pedestrian crossing: zig-zag pavement markings (shown in Figure 1). The purpose of these markings is to provide motorists an additional warning of an upcoming crosswalk. They also indicate no parking areas and overtaking prohibition zones.

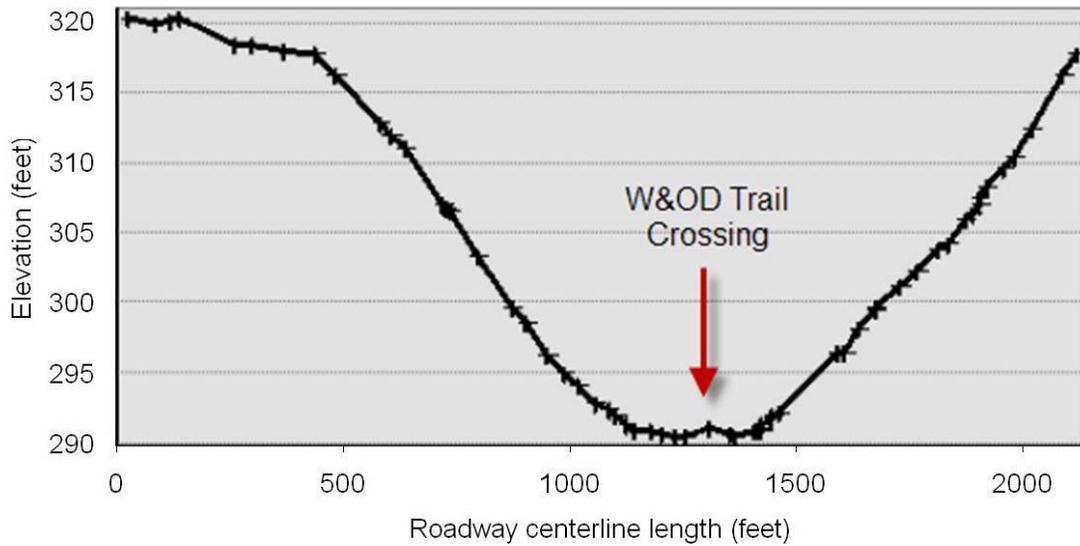
**Figure 2. Road Profile of Belmont Ridge Road in Relation to W&OD Trail Crossing**

The geometry of Belmont Ridge Road consists of downhill grades on both the north and south approaches to the crossing. Figure 2 shows the road profile in relation to the W&OD Trail crossing. The sight distance of the W&OD Trail crosswalk on the northbound and southbound approaches is approximately 660 and 1,750 feet, respectively. As opposed to the southbound approach, which has a relatively straight line of sight to the crossing, the northbound approach has a horizontal curve that decreases the viewing distance of the crossing. In advance of the crosswalk, warning signs of the trail crossing are located 600 and 690 feet from the crosswalk in the northbound and southbound approaches, respectively. In addition, warning signage with arrow placards is located at the crossing facing both approaches (shown in Figure 3).

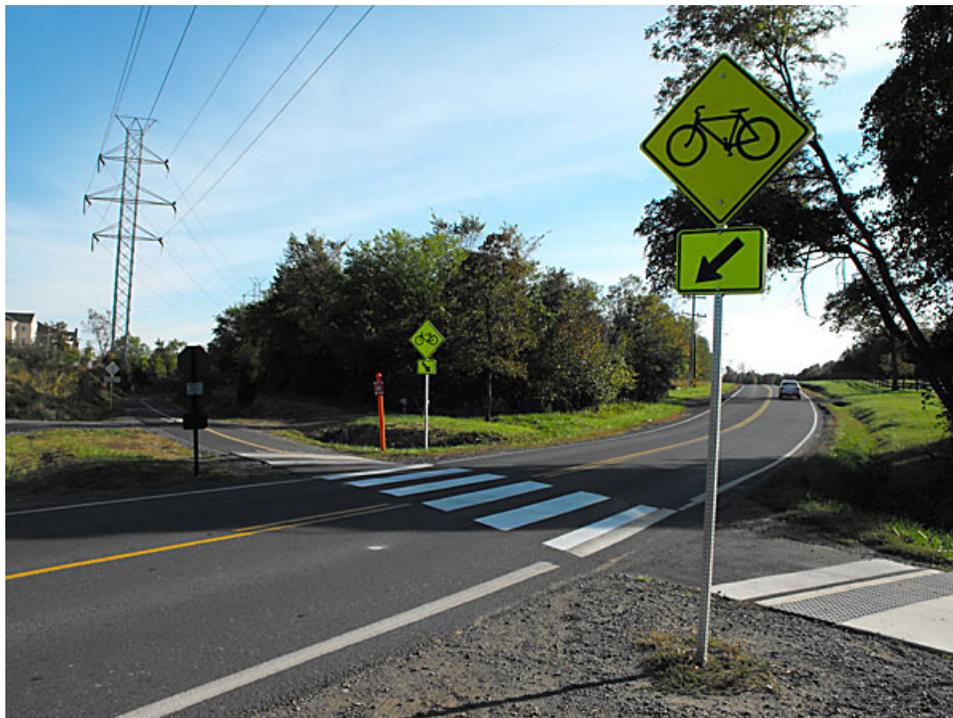
**Figure 3. Trail Warning Signs at Belmont Ridge Road W&OD Crossing**

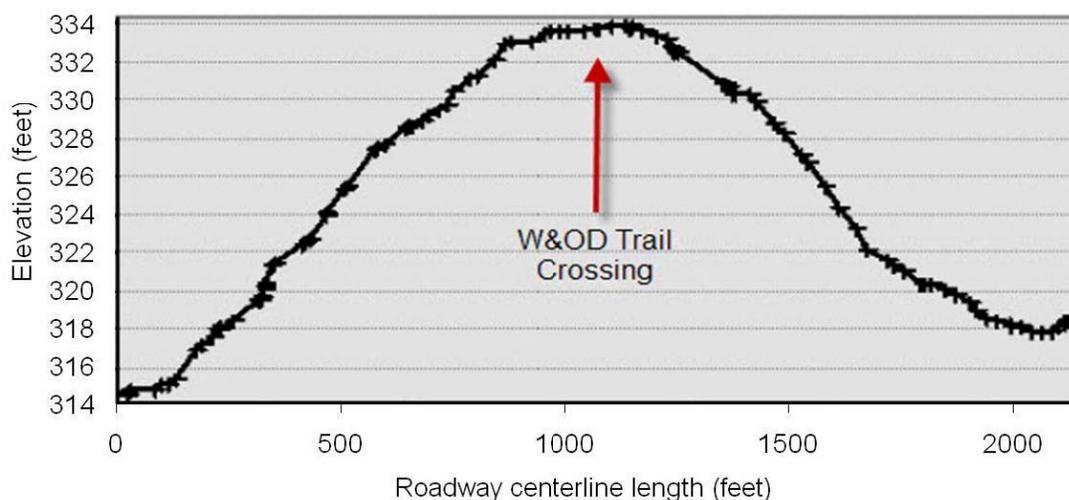
**Figure 4. Road Profile of Sterling Boulevard in Relation to W&OD Trail Crossing**

The W&OD Trail, which runs generally in a west-northwest / east-southeast direction in relation to Sterling Boulevard, has the same pavement markings and signage as it does at Belmont Ridge Road with one slight difference. Instead of a double STOP sign at the trail/road intersection, there is a single STOP sign with a placard stating “REQUIRED BY LAW.” Photographs of the advance warning signs on Sterling Boulevard and the W&OD Trail pavement markings and signage are provided in Appendix C.

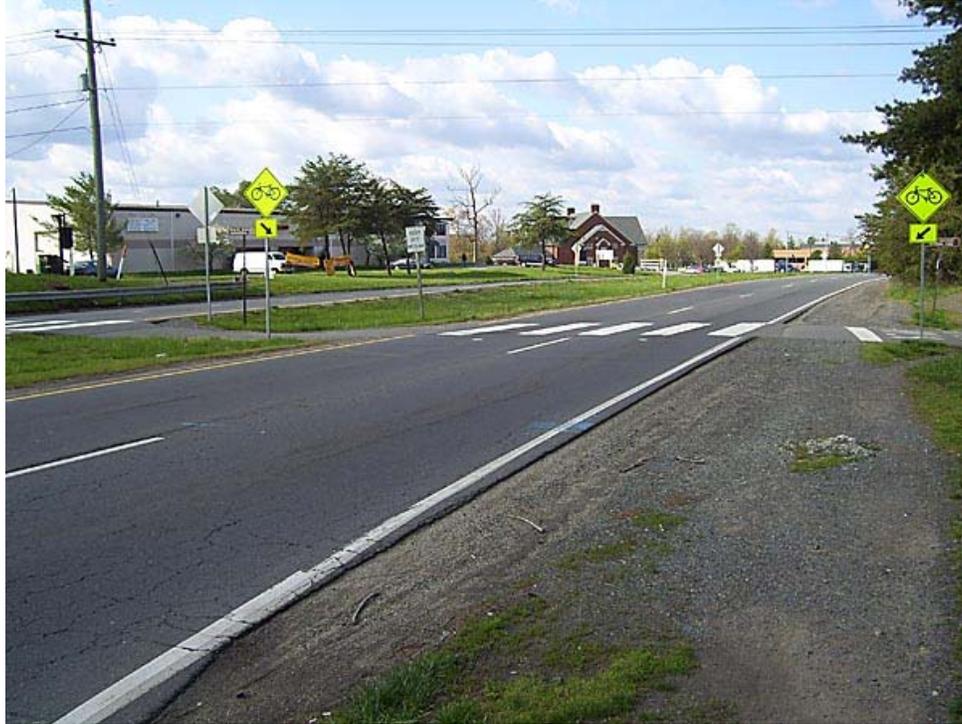
Figure 5. Trail Warning Signs at Sterling Boulevard W&OD Crossing

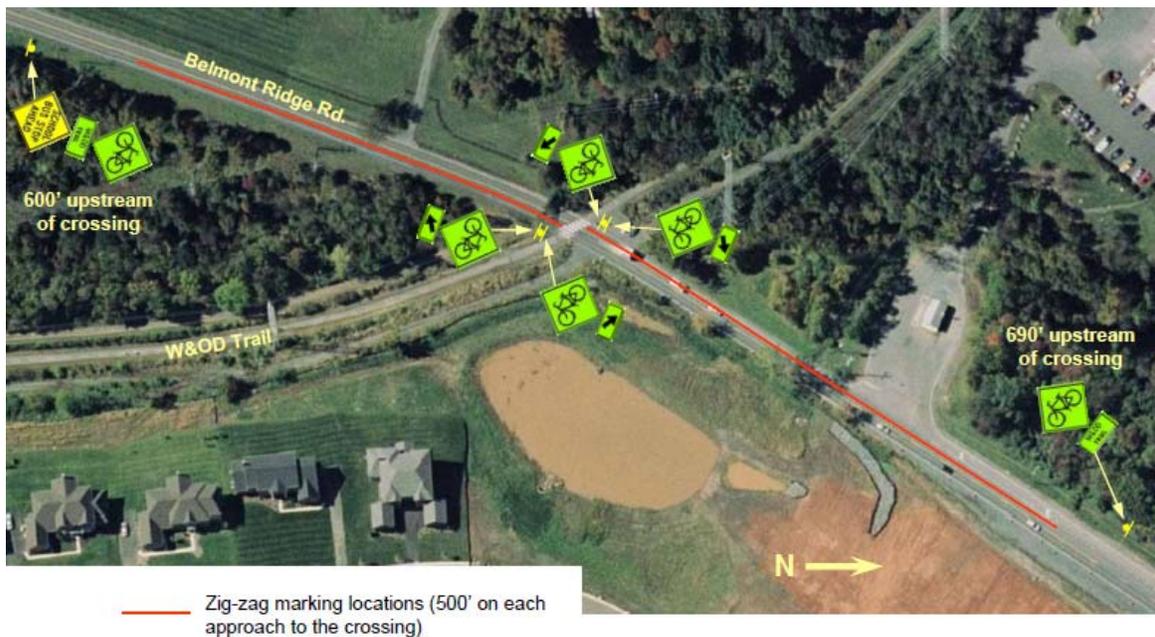
**Figure 6. Aerial View of Belmont Ridge Road Showing W&OD Trail Warning Sign Locations and Longitudinal Zig-zag Dimensions**

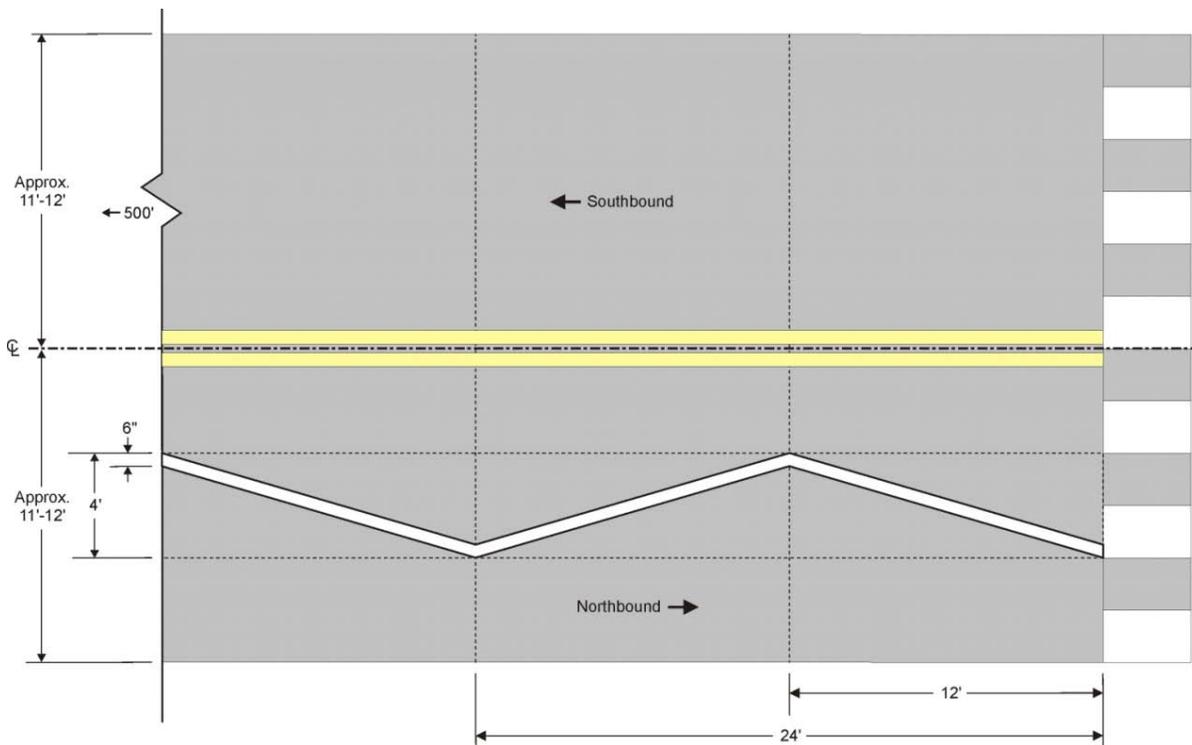
**Figure 7. Schematic of Zig-zag Design Chosen for Belmont Ridge Road**

As with most secondary roads in Virginia, the edgeline and centerline markings on Belmont Ridge Road are 4 inches in width. To increase the visibility of the zig-zag markings (and possibly the “awareness” of motorists), the striping width was chosen to be 6 inches. The dimension of the lateral span of the markings was chosen to be 4 feet. This decision was made so that the span of vehicle wheel track widths would clear the zig-zag markings, thus preventing accelerated wear of the zig-zag points (where lines intersect).

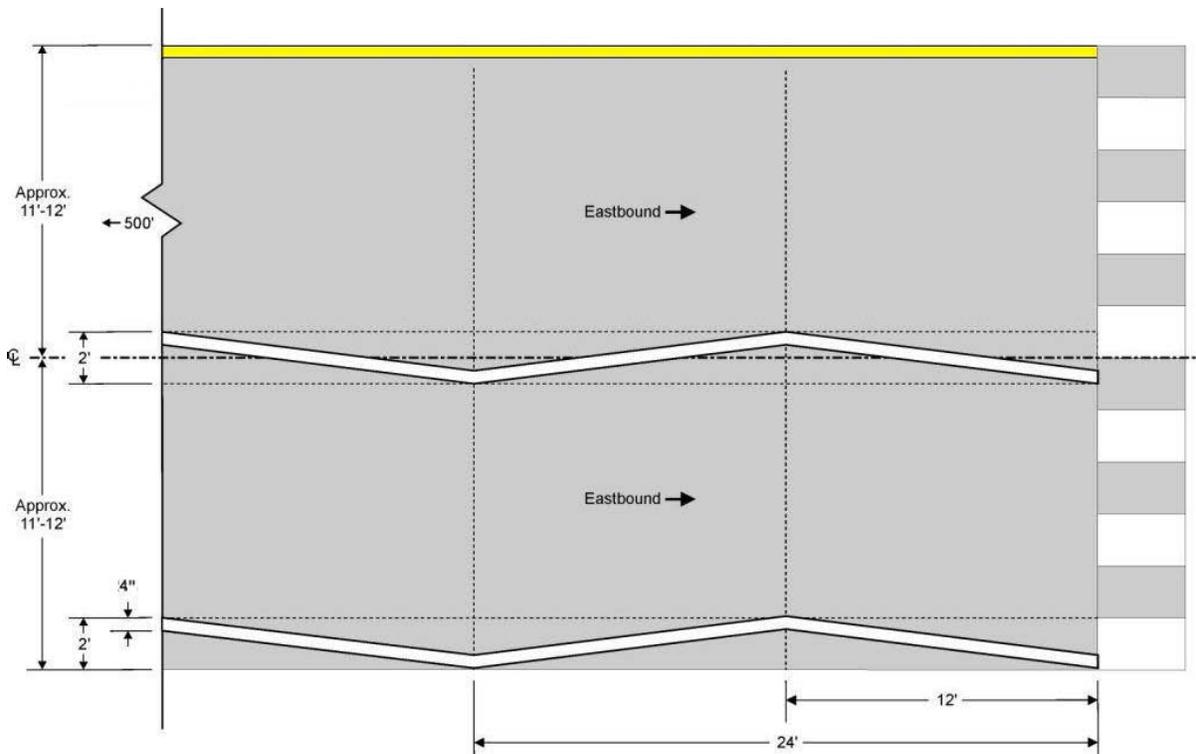
**Figure 8. Schematic of Zig-zag Design Chosen for Eastbound Approach of Sterling Boulevard**

Figure 8 is a schematic of the final zig-zag design chosen for the eastbound approach to the W&OD Trail. It should be noted that the initial intention was to create a yellow zig-zag line along the left edgeline; however, the type of pavement marking material required for this application was unavailable. Maintaining a yellow edgeline was important, and therefore zig-zag markings were not installed along the left edge of the roadway. In the westbound direction, curb and gutter tapers reduce the lane widths on the approach to the crosswalk. Thus, to maintain an appropriate width throughout the travel lanes, no zig-zag markings were installed along either the

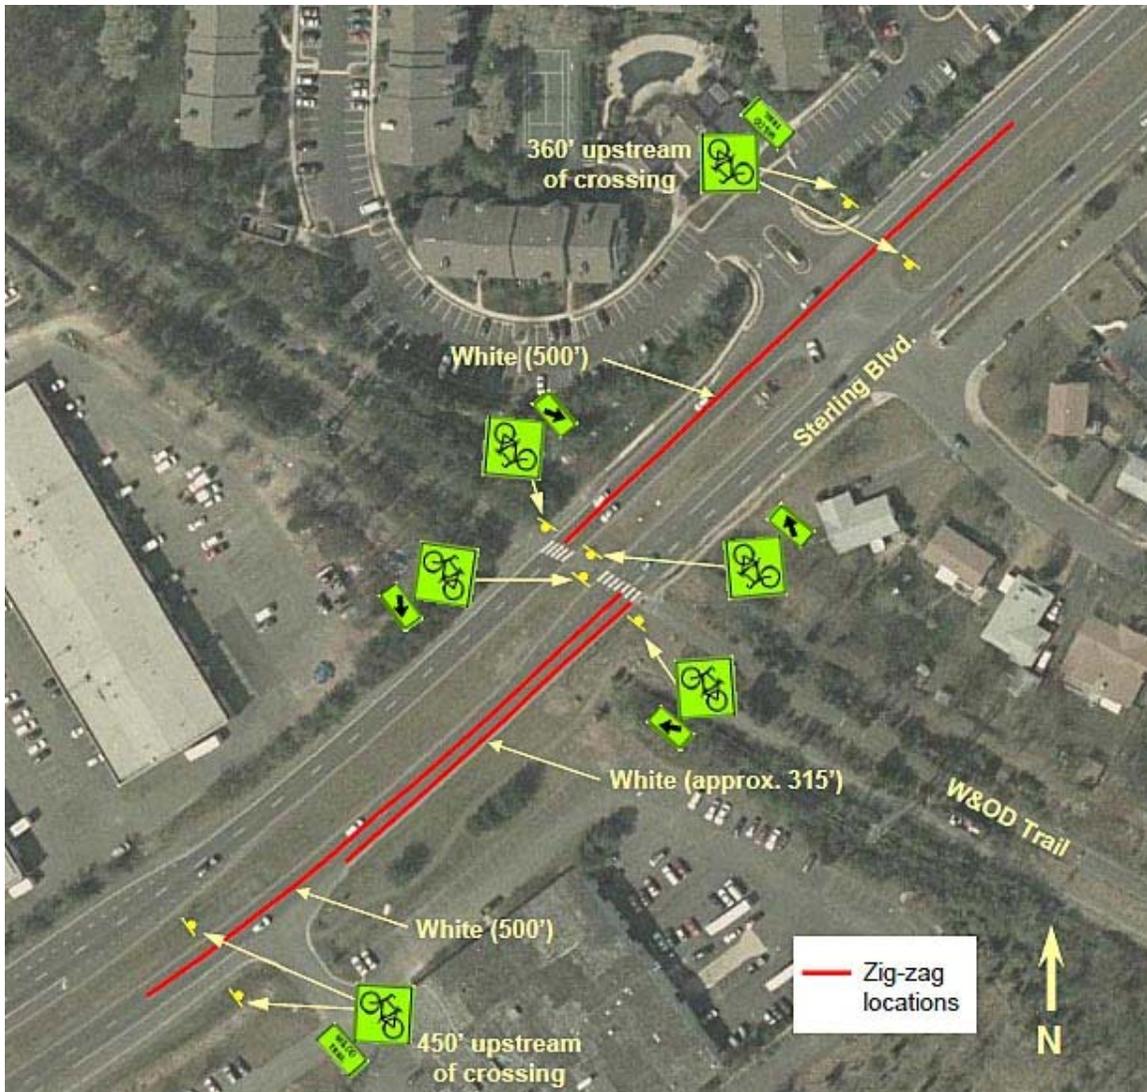
**Figure 9. Aerial View of Sterling Boulevard Showing Locations of W&OD Trail Warning Signs and Longitudinal Zig-zag Dimensions**

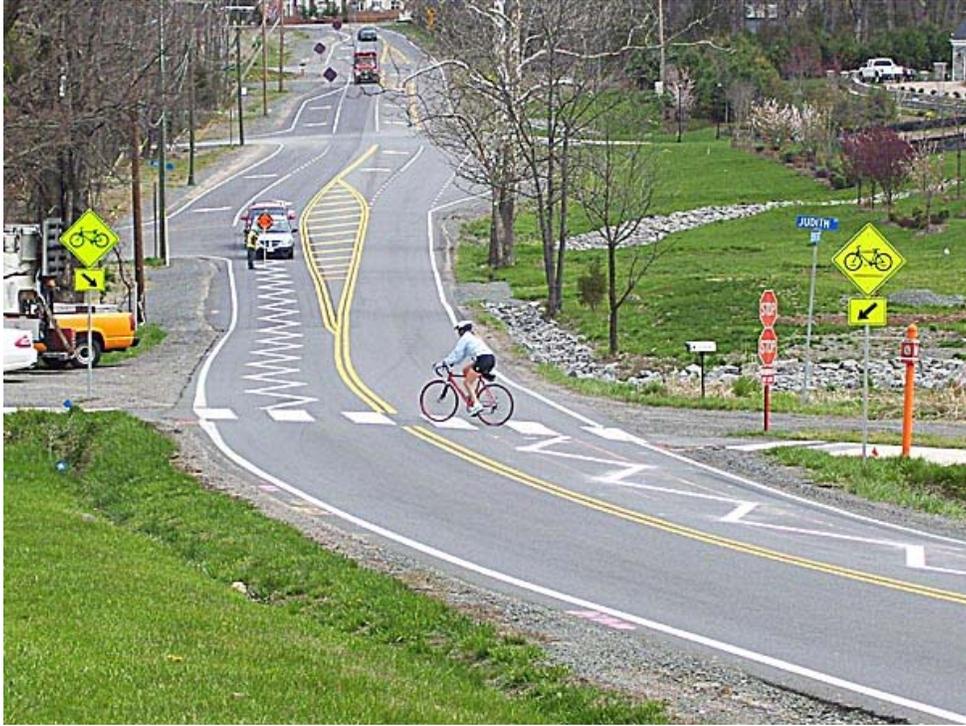
**Figure 10. Zig-zag Markings at Belmont Ridge Road**

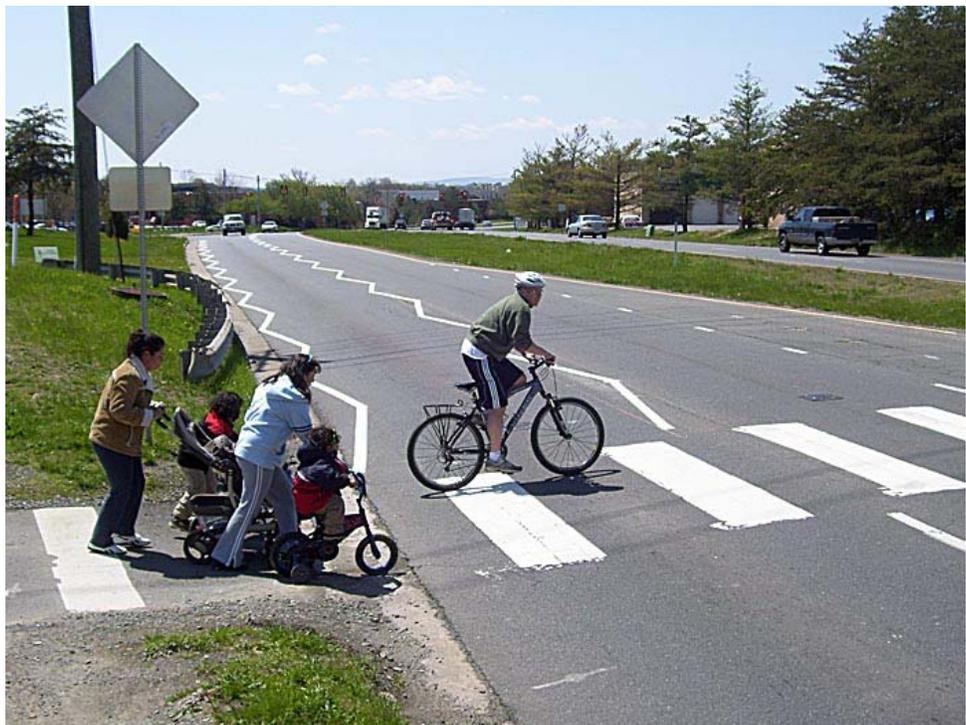
**Figure 11. Zig-zag Markings on Eastbound Approach at Sterling Boulevard**

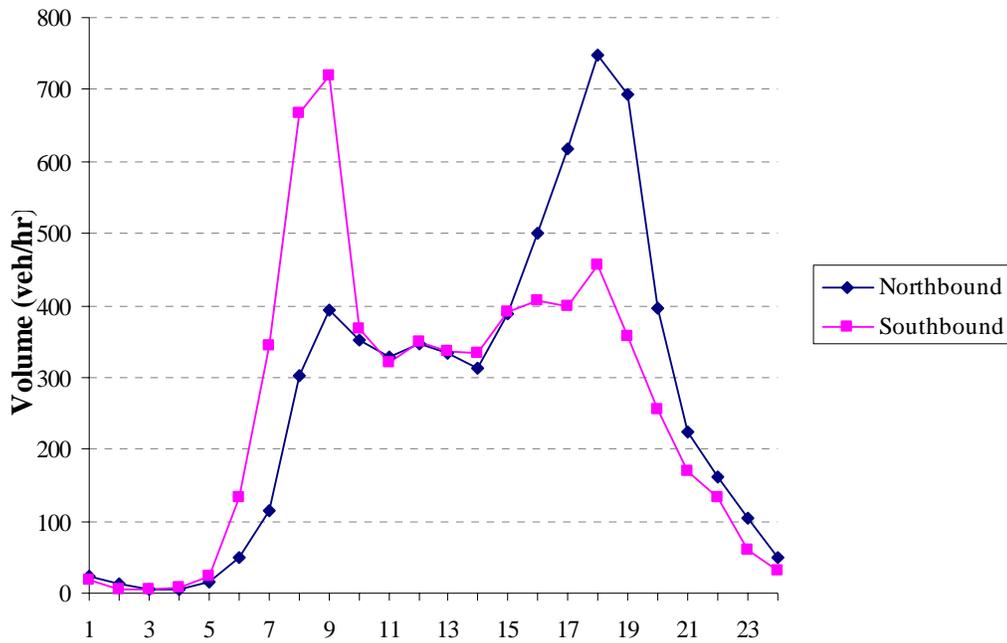
Figure 12. Average "Before" Traffic Volumes on Belmont Ridge Road

The data "expansion" procedure was performed for each data collection day and study period (before, 1 week after, 6 months after, and 1 year after). Using the volume profiles as described in the "Methods" section (see Figures 12 and 13), the data were further reduced into categories of high volume, medium volume, and low volume. This was carried out to evaluate differences in mean vehicle speeds during varying traffic conditions (based on time of day). Analysis of variance was then performed on mean speeds from the data obtained at each ATR location, for each volume condition (high, medium, and low), and for each data collection period. Mean speed profiles for the high, medium, and low volume conditions exhibited similar trends at Belmont Ridge Road and Sterling Boulevard. Therefore, the results provided in this report include only data from the medium volume condition. The high and low volume conditions are shown in Appendices E and G.

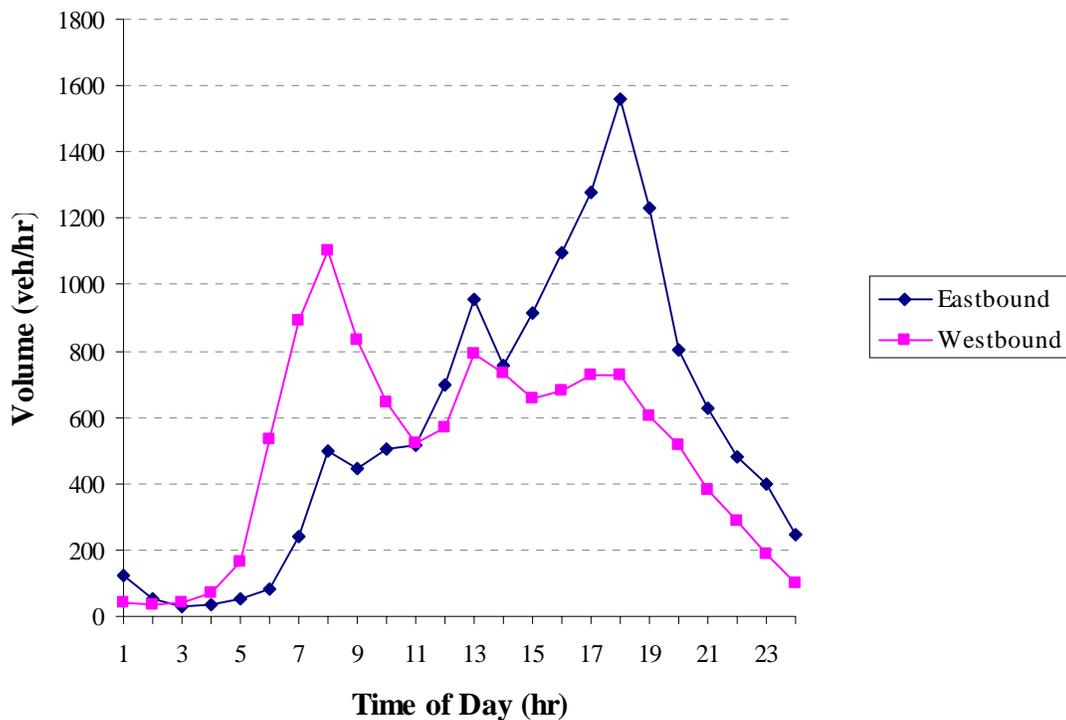
Figure 13. Average “Before” Traffic Volumes on Sterling Boulevard

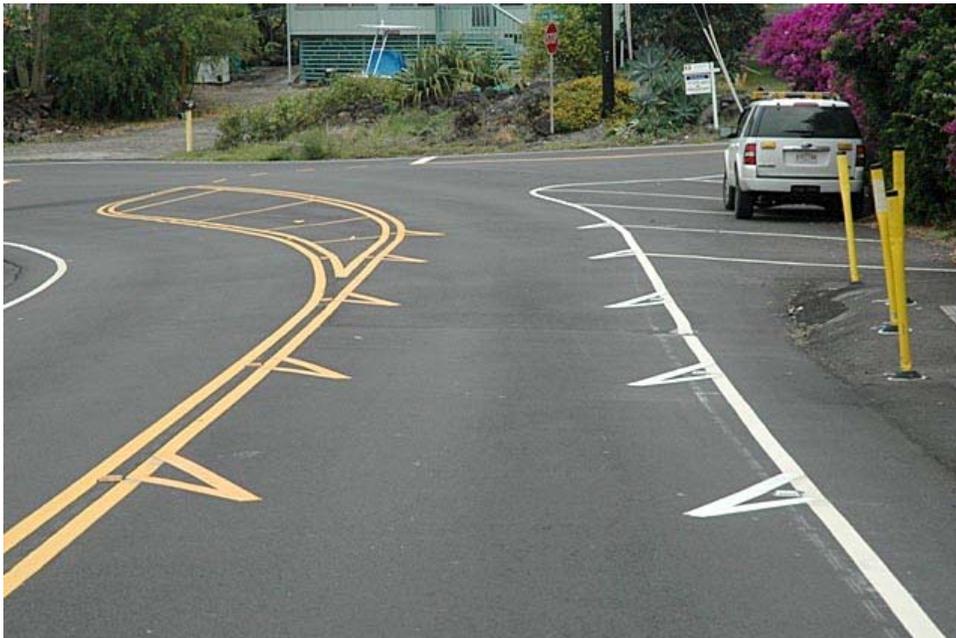
**Figure 14. Shark's Teeth Pavement Markings Installed in Hawaii.** From Ron Thiel. Reprinted with permission.

Within the last decade, some localities and DOTs in the United States and abroad have used perceptual countermeasures in the form of innovative pavement markings in an attempt to influence driver behavior for the purposes of creating safer driving environments. For example, transverse lines that run across roadways (either evenly spaced or staggered) have been used for speed reduction on high-speed facilities in the United Kingdom<sup>22</sup> and have been studied in the United States.<sup>10</sup> Peripheral transverse lines (or hatch lines) installed along edgelines have been used in the United States<sup>23</sup> and Australia<sup>24</sup> as traffic calming measures at curves on low-speed facilities, rural roads, and approaches to intersections. This traffic calming measure is also included in VDOT's current *Traffic Calming Guide for Local Residential Streets*.<sup>25</sup> A variation of peripheral transverse lines is used in Hawaii where markings referred to as "shark's teeth" have been installed to reduce speeds on curves (see Figure 14).<sup>26</sup> Converging chevron markings

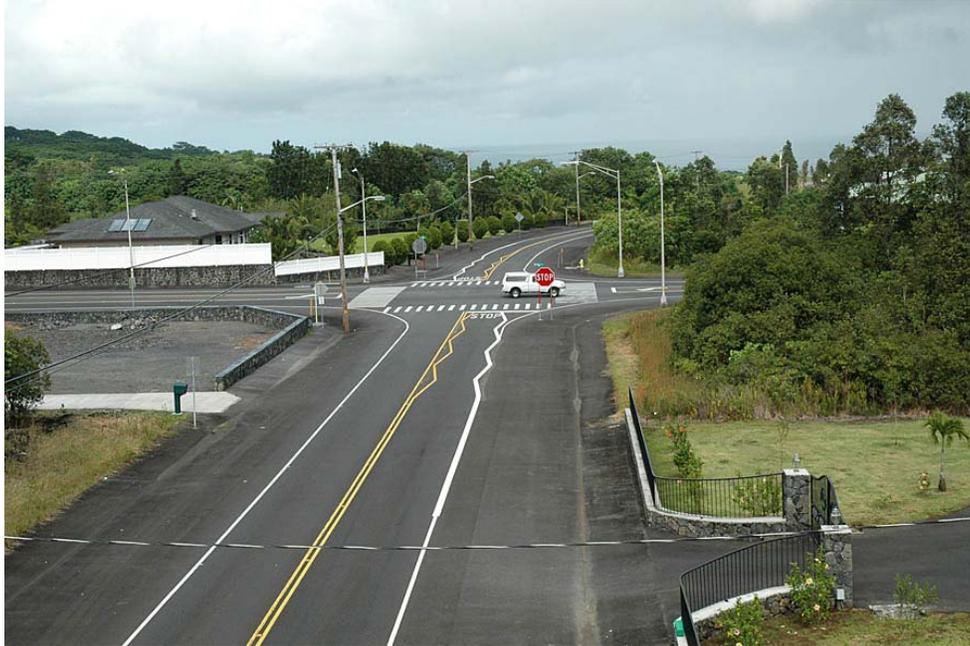
**Figure 15. Zig-zag Pavement Markings at Intersection of Wilder and Puainako in Hawaii.** From Ron Thiel. Reprinted with permission.

In North America, two locations were found to have installed variations of zig-zag markings as a means to increase motorist awareness near crosswalks and STOP-controlled intersections. To encourage motorists to slow down near a school, the Traffic Division of Public Works in Hawaii installed the markings to capture the attention of motorists and reduce speeds as motorists approached the crosswalks at Kalaniana'ole School in PaPa'ikou. Zig-zag markings have also been applied at the residential intersections of Kekuanaoa and Kalanikoa; Kukuau and Mohouli; and Wilder and Puainako. Figure 15 shows the markings at Wilder and Puainako. Informal studies performed at these intersections showed that instances of crashes decreased after the markings were installed.<sup>26</sup>

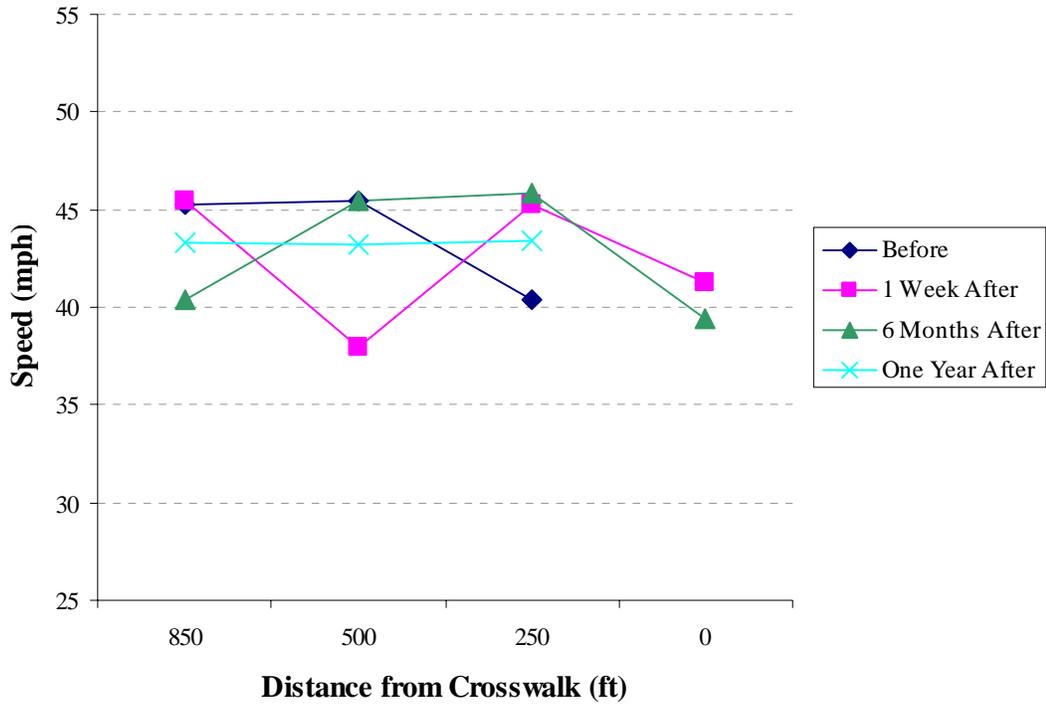
Figure 16 shows the mean speed profiles for the medium volume condition on the northbound approach of Belmont Ridge Road (the high and low volume conditions are shown in Appendix E). Each data point correlates with its respective ATR location upstream of the crosswalk (i.e., 850, 500, 250, and 0 feet), and each curve represents the time period when the data were collected (i.e., before, 1 week after, 6 months after, and 1 year after). Data points are not shown at the crosswalk (0 feet) during the before period and the 1-year after period because of poor data quality obtained from the ATRs. These missing data points compromised the ability to analyze fully the nature of northbound speeds at the crosswalk over the duration of the project. Further compromising the analysis on this approach was the apparent random scatter of the data points. Some of this “randomness” may be attributed to site geometry for which vehicle speeds on a horizontal and vertical curvature exhibit less uniformity. Notwithstanding the random scatter, a few key trends noted in this graphic are:

- At 850 feet from the crosswalk, mean speeds in the before and 1-week after period are essentially identical (45.3 and 45.5 mph, respectively). However, upon vehicles entering the zig-zag zone at 500 feet, mean speeds in the 1-week after period dropped by a statistically significant amount compared to the before speeds ( $\Delta = 7.5$  mph).

**Figure 16. Mean Speed Profiles from ATR Data on Northbound Approach of Belmont Ridge Road**

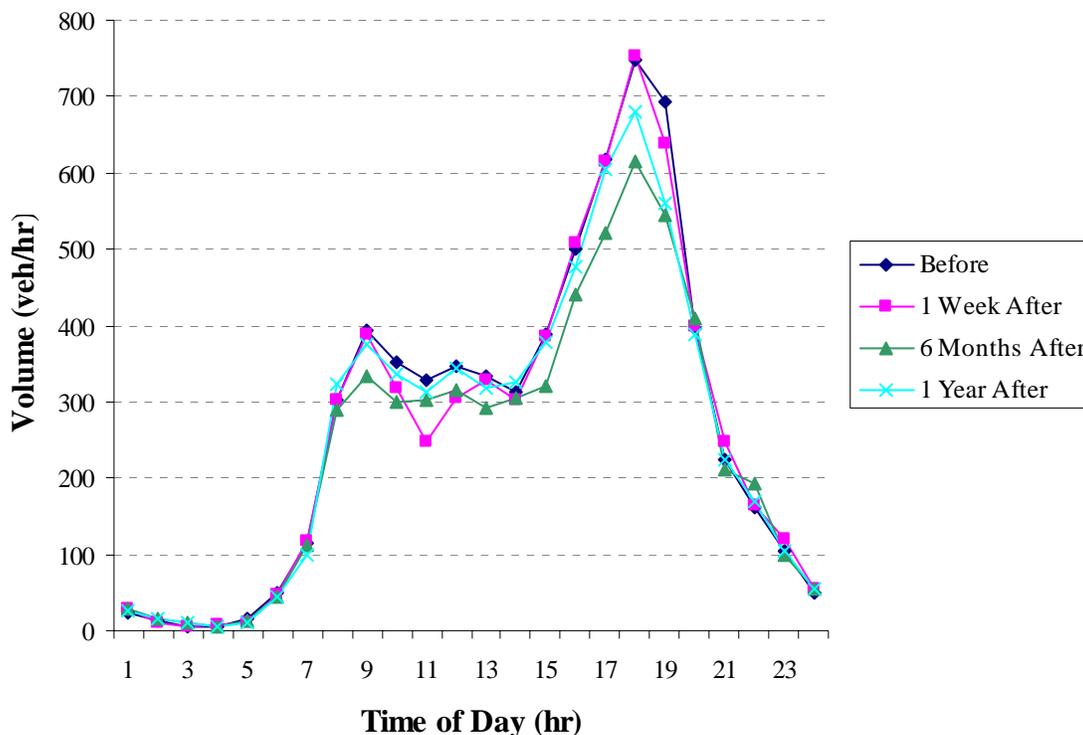
Figure 17. Average Before and After Northbound Traffic Volume Profiles on Belmont Ridge Road

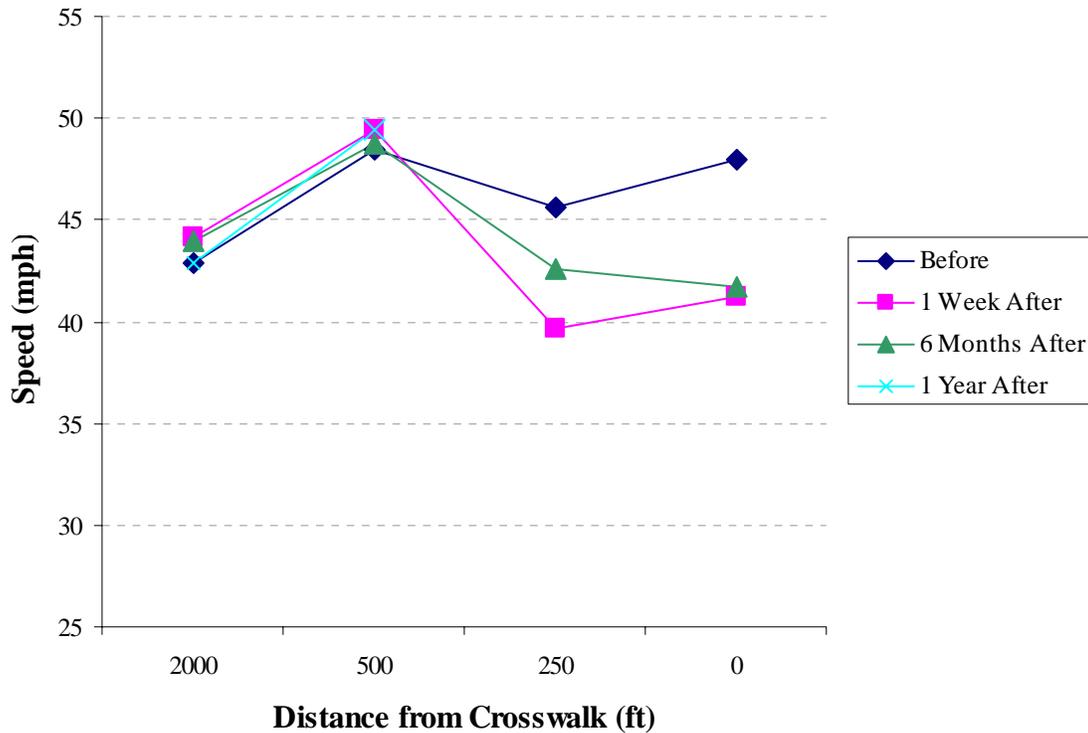
Mean speed profiles for the medium volume condition on the southbound approach of Belmont Ridge Road are shown in Figure 18 (the high and low volume conditions are shown in Appendix E). Because of poor ATR data quality, data points at 250 feet and 0 feet from the crosswalk are missing for the 1-year after period. The profiles indicate an increase in mean speeds for all before and after data points from 2,000 feet to 500 feet from the crosswalk. This is an intuitive result because of the sharp downhill grade between these points. Upon vehicles entering the zig-zag zone at 500 feet from the crosswalk, there is little difference between mean vehicle speeds during each period. Past this 500-foot distance, key trends include:

- At 250 feet, mean speeds decreased for each period with the greatest decrease occurring during the 1-week after period. This indicates the zig-zag markings had a positive effect in terms of speed reduction.

**Figure 18. Mean Speed Profiles from ATR Data on Southbound Approach of Belmont Ridge Road**

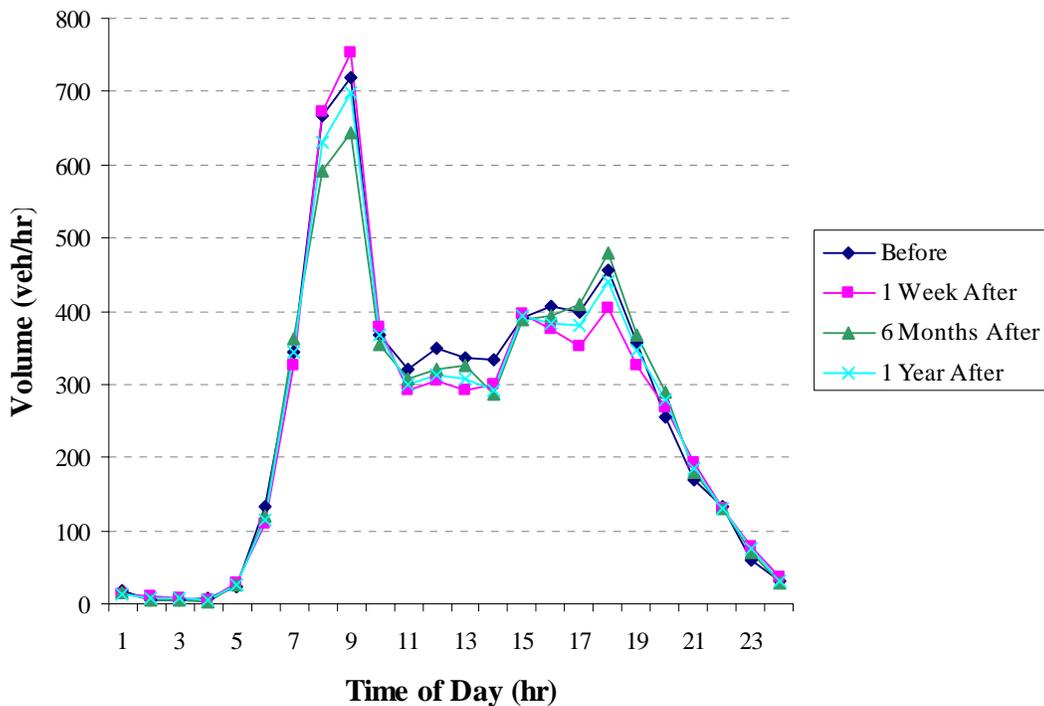
**Figure 19. Average Before and After Southbound Traffic Volume Profiles on Belmont Ridge Road**

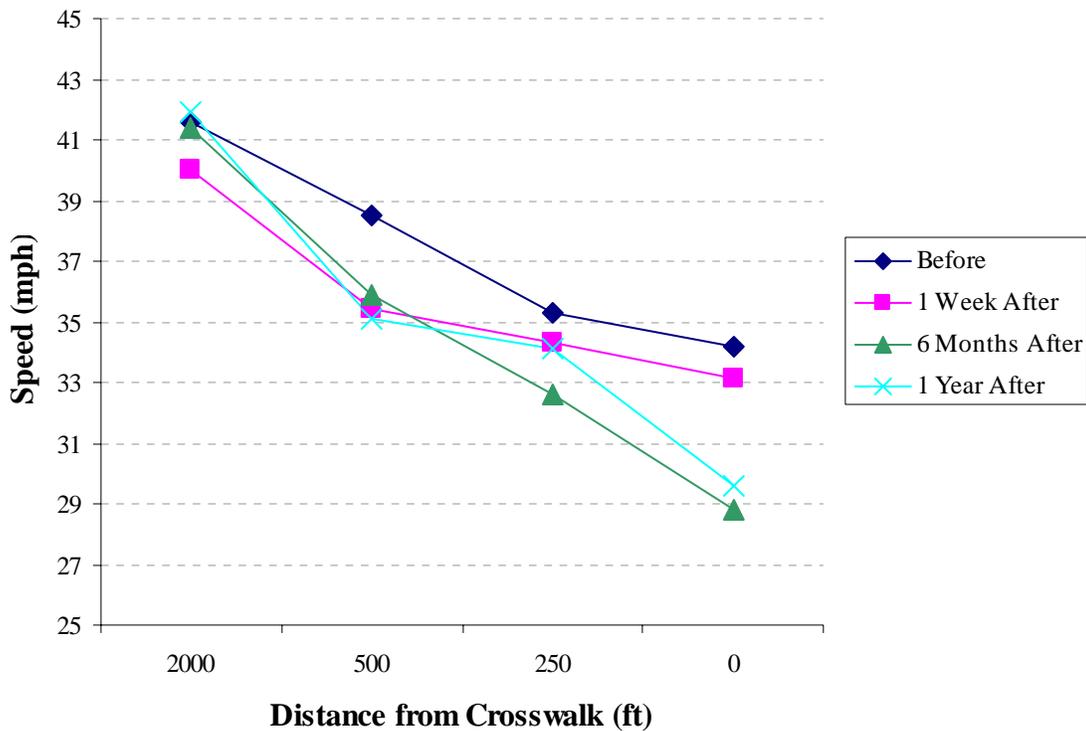
Figure 20 shows the mean speed profiles for the medium volume condition on the eastbound right lane approach of Sterling Boulevard (the high and low volume conditions are shown in Appendix G). Relevant trends are noted as follows:

- At the crosswalk (0 feet), all after mean speeds remained below the before mean speed. Of note, during the 6-month after and 1-year after periods, lower mean speeds from that of the 1-week after period were sustained, suggesting a sustained positive effect of the zig-zag markings and possibly a contradiction of the notion of a novelty effect (e.g., after time, mean speeds rebound to speeds in the before period).

**Figure 20. Mean Speed Profiles From ATR Data on Eastbound Right Lane Approach of Sterling Boulevard**

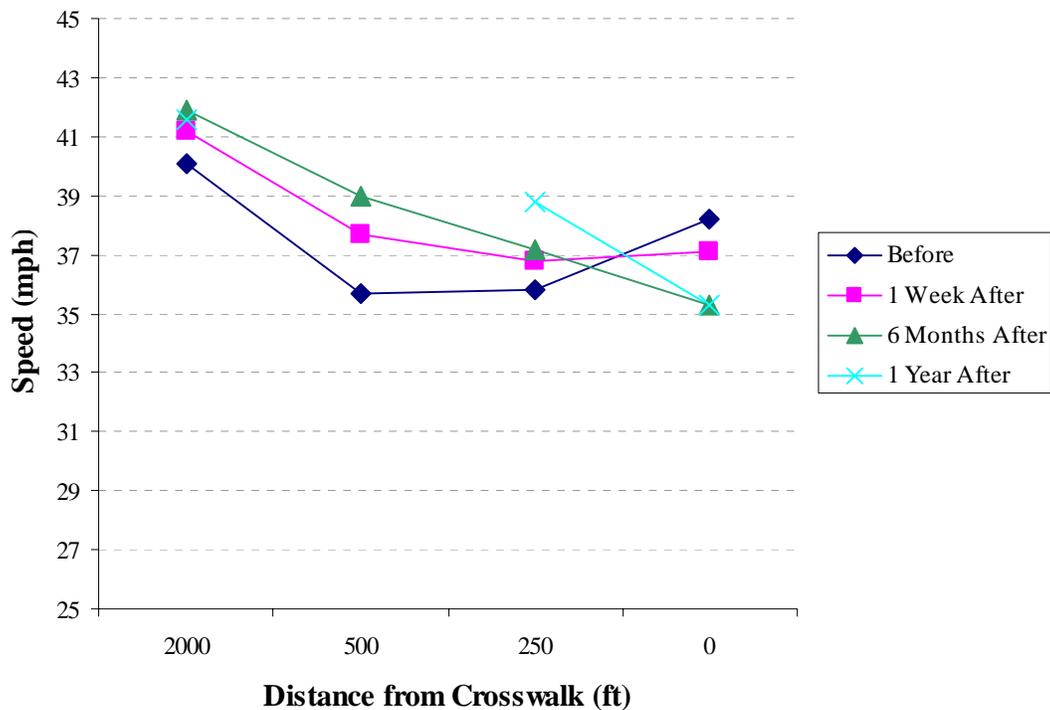
Speed profiles for the eastbound left lane of Sterling Boulevard are shown in Figure 21. Data points at 2,000 and 500 feet are missing for the 1-year after period because of poor ATR data quality. Noteworthy trends include:

**Figure 21. Mean Speed Profiles From ATR Data on Eastbound Left Lane Approach of Sterling Boulevard**

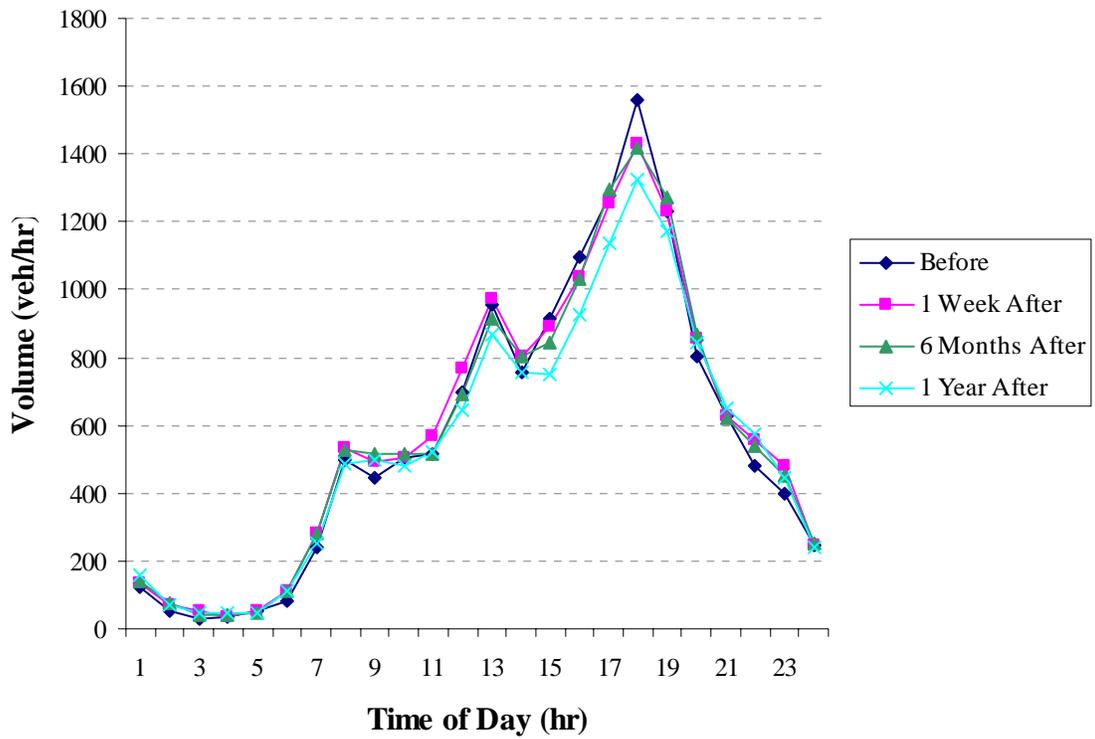
Figure 22. Average Before and After Eastbound Traffic Volume Profiles on Sterling Boulevard

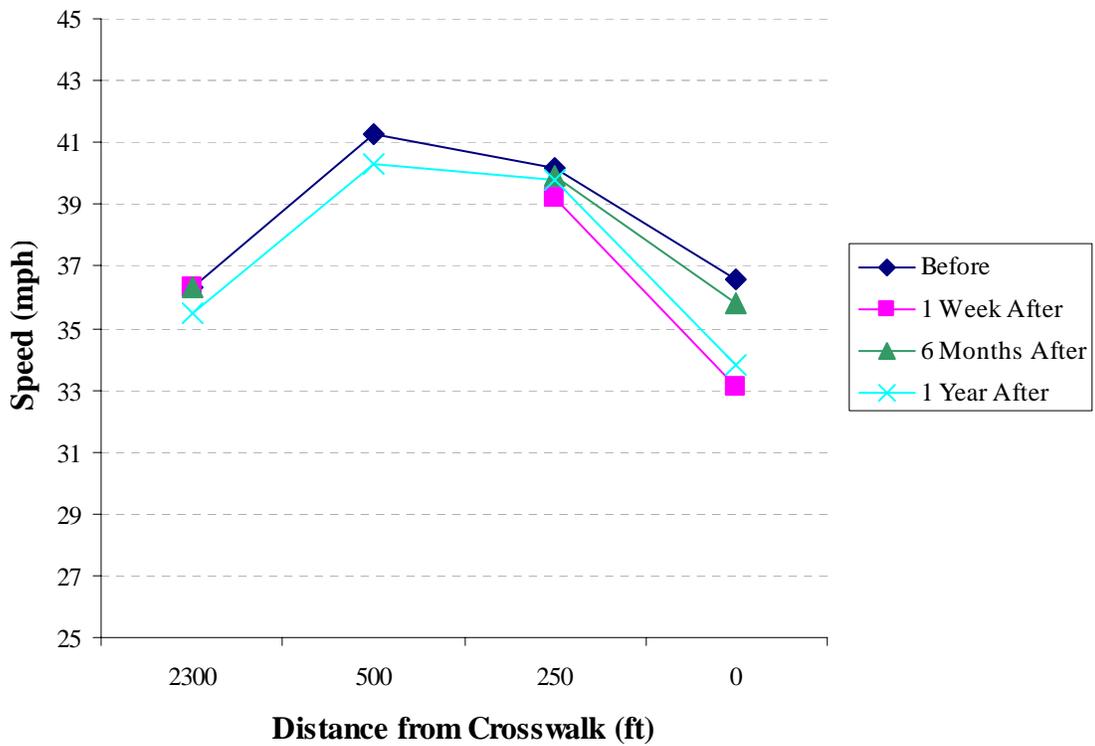
Figure 23 shows the mean speed profiles for the right lane on the westbound approach at Sterling Boulevard. Data points at 2,300 feet for the before period and 500 feet for the 1-week after and 6-month after periods are missing because of poor ATR data quality. In a phenomenon

Figure 23. Mean Speed Profiles From ATR Data on Westbound Right Lane Approach of Sterling Boulevard

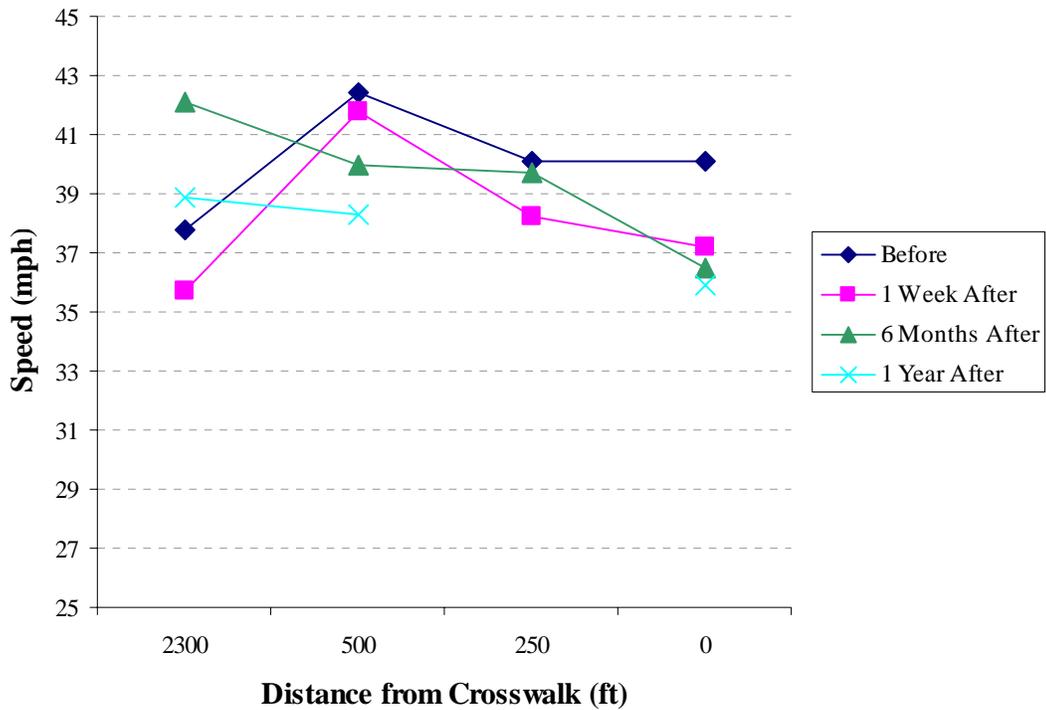
Figure 24 shows the mean speed profiles for Sterling Boulevard’s westbound left lane. The data point at 250 feet is missing for the 1-year after period because of poor ATR data quality. The data show a wide distribution of speeds at 2,300 feet from the crosswalk. From 2,300 to 500 feet, there is an increase in speeds in the before and 1-week after periods and a decline in mean speeds in the 6-month and 1-year after periods. Other noteworthy trends include:

**Figure 24. Mean Speed Profiles From ATR Data on Westbound Left Lane Approach of Sterling Boulevard**

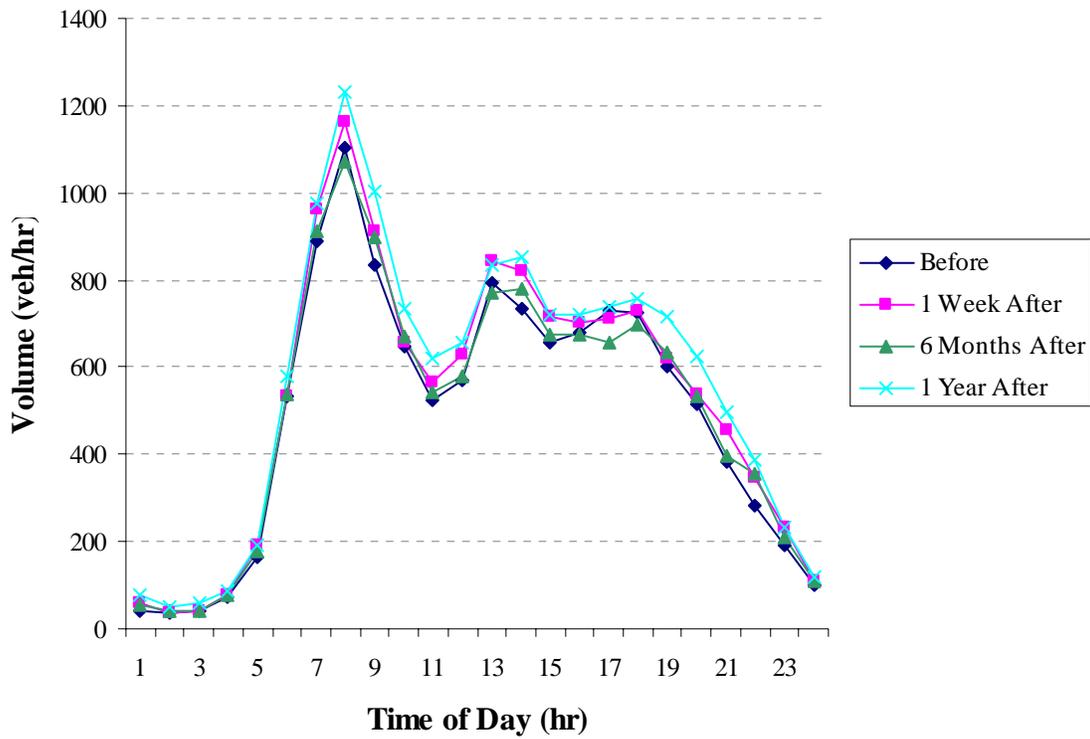
Figure 25. Average Before and After Westbound Traffic Volume Profiles on Sterling Boulevard
