Best Practices in  
Traffic Operations and Safety:  
Phase II: Zig-zag Pavement Markings

1. Report No.: FHWA/VTRC 11-R9		2. Government Accession No.:		3. Recipient's Catalog No.:	
4. Title and Subtitle: Best Practices in Traffic Operations and Safety: Phase II: Zig-zag Pavement Markings				5. Report Date: December 2010

**BEST PRACTICES IN TRAFFIC OPERATIONS AND SAFETY:  
PHASE II: ZIG-ZAG PAVEMENT MARKINGS**

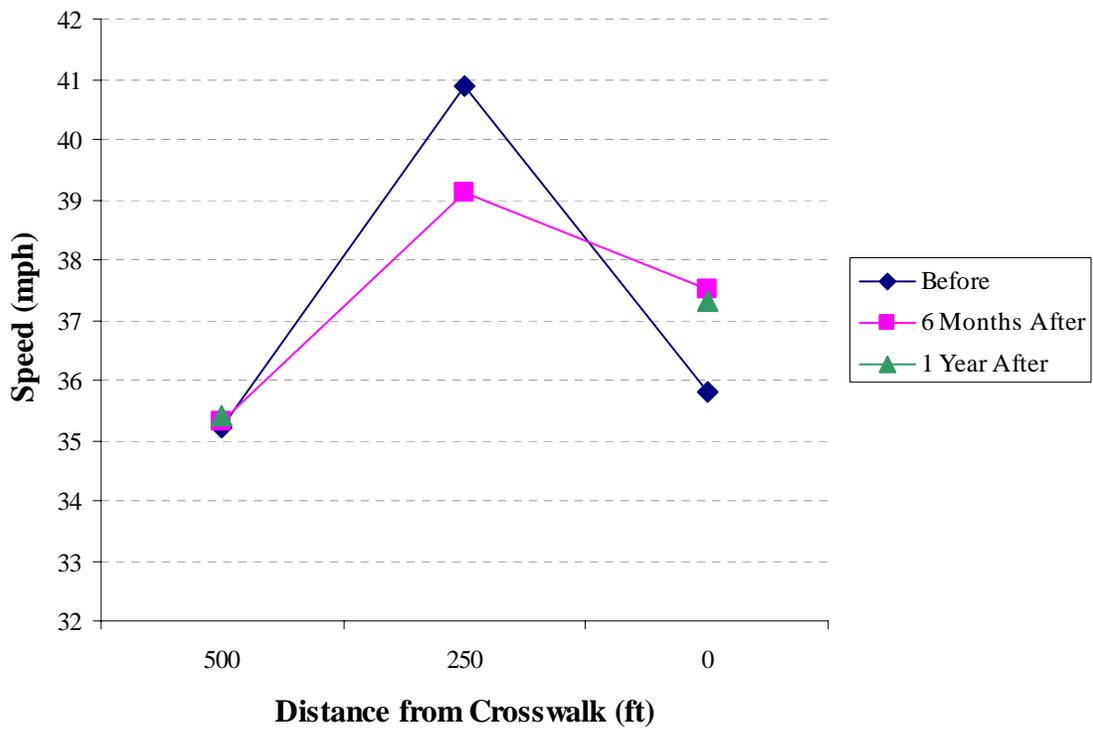
Figure 26. Mean Speed Profiles From ATR Data on Eastbound Approach of Hirst Road

One-year after data are missing at 250 feet because of poor ATR data quality.  
 Noteworthy trends include:

As discussed previously, the primary reason for collecting control site data was to identify any possible changes in the transportation system that would affect vehicle speeds such as construction detours or other events that would increase or decrease system-wide travel patterns. Unfortunately, mean speed profiles could not be created for Sunrise Valley Drive because of too many missing data points because of poor ATR data quality. However, enough good data were available to create speed profiles at Hirst Road, which are shown in Figure 26.

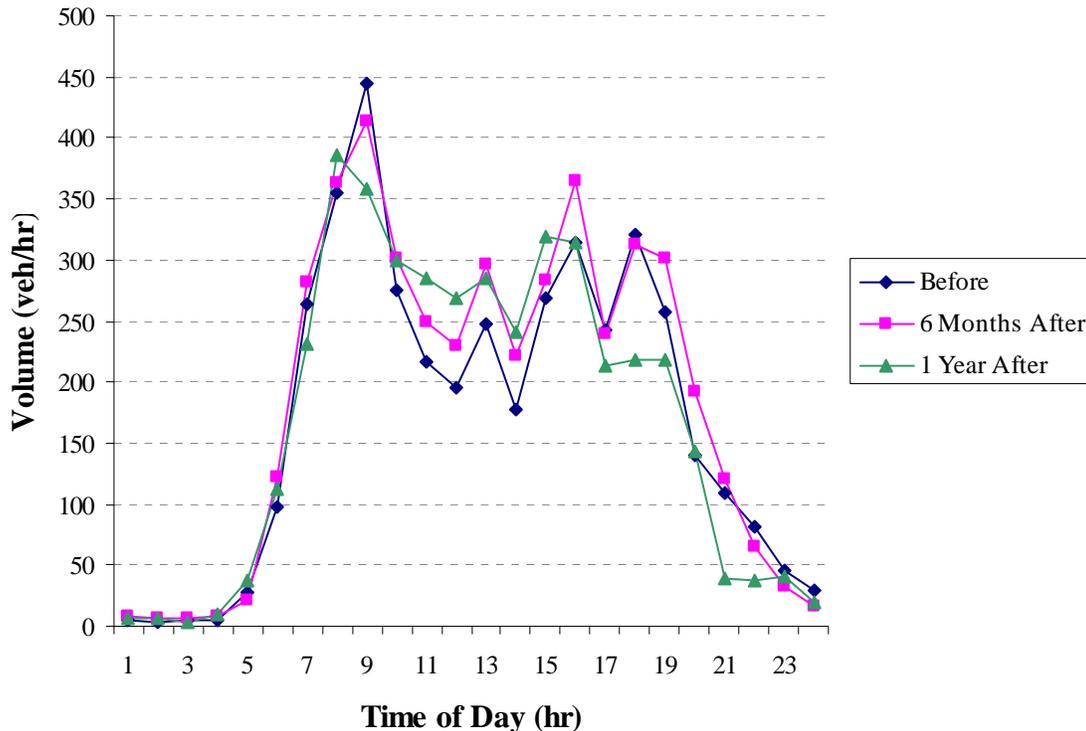
Figure 27. Average Before and After Eastbound Traffic Volume Profiles on Hirst Road

ADT profiles were created for the test sites to identify localized changes in travel patterns that may have impacted speeds. The same procedure was conducted for the control sites. The profiles for Hirst Road and Sunrise Valley Drive are shown in Figures 27 and 28, respectively. The volume scale on the Y-axis is much smaller for Hirst Road, and, therefore, the profiles appear more irregular. However, the peak and off-peak trends are generally consistent. Although mean speed profiles were not constructed for Sunrise Valley Drive because of missing data points, average traffic profiles were constructed to confirm further the consistency of system-wide travel patterns over the duration of the study.

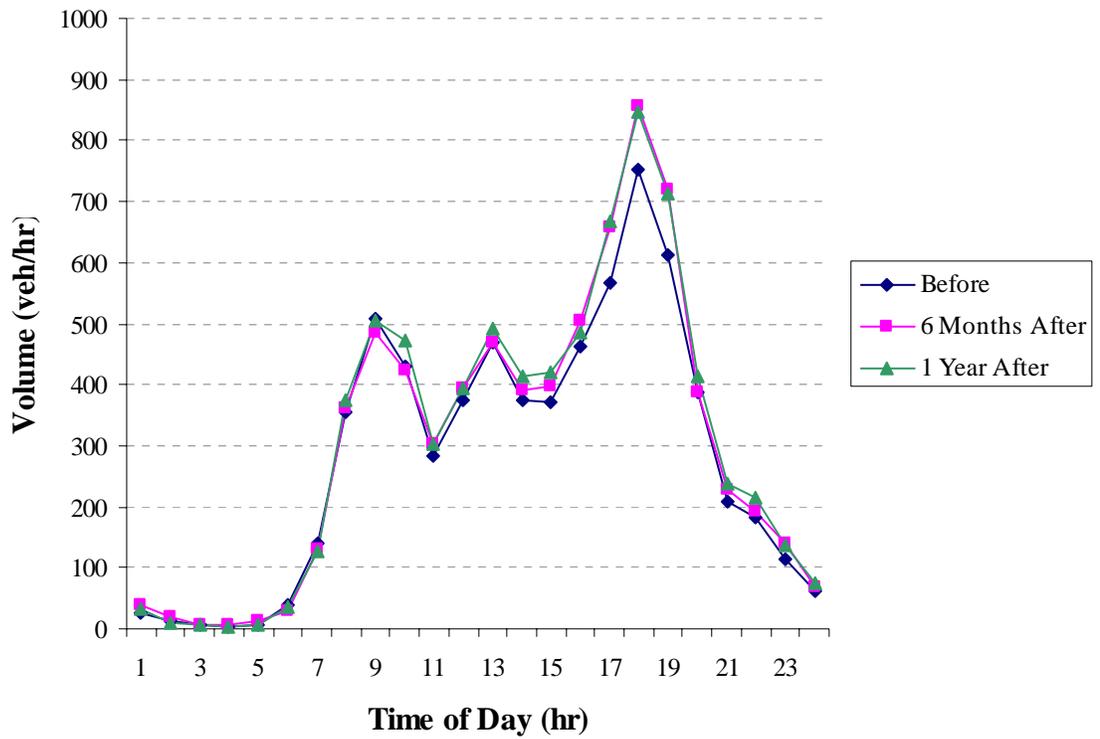
Figure 28. Average Before and After Eastbound Traffic Volume Profiles on Sunrise Valley Drive

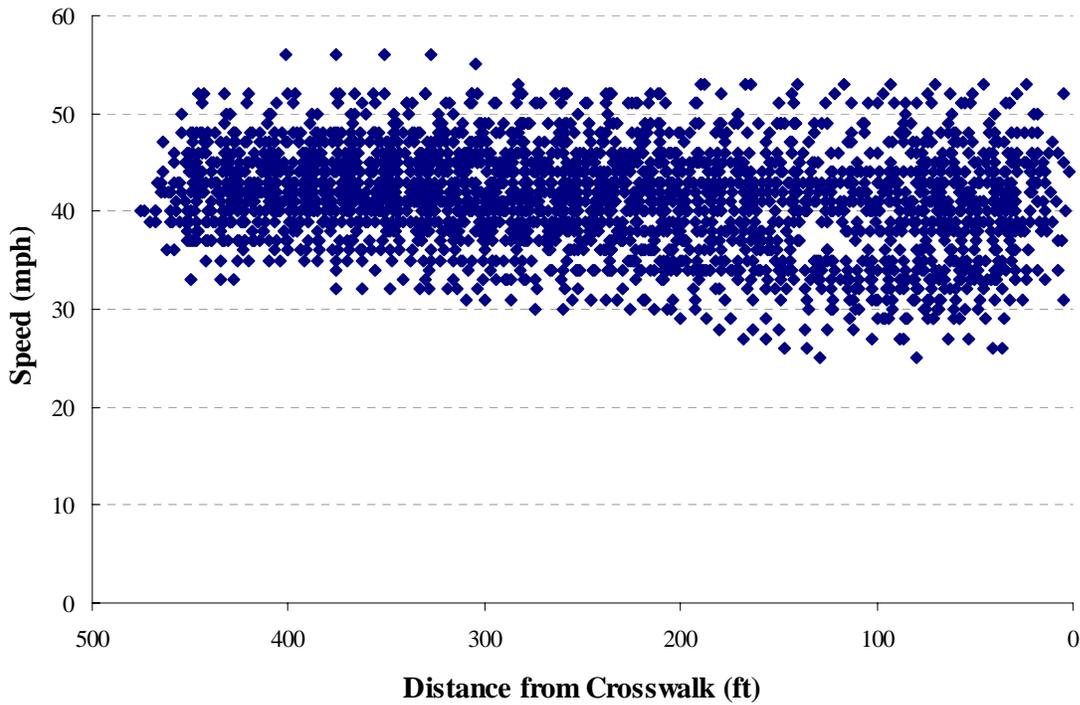
Figure 29. Individual Speed vs. Range Data Points

As previously discussed, individual vehicle speeds were obtained by an observer using a LIDAR gun as vehicles progressed toward the crosswalks at Belmont Ridge Road and Sterling Boulevard. Speed data were recorded as a text file and exported to an Excel spreadsheet. Figure 29 shows an example of individual data points (speed and range) for all vehicles tracked during the 1-week after case on the northbound approach at Belmont Ridge Road. The next step was to extract individual vehicles from the output file. Table 10 shows an example of a reconfigured output file for three vehicles.

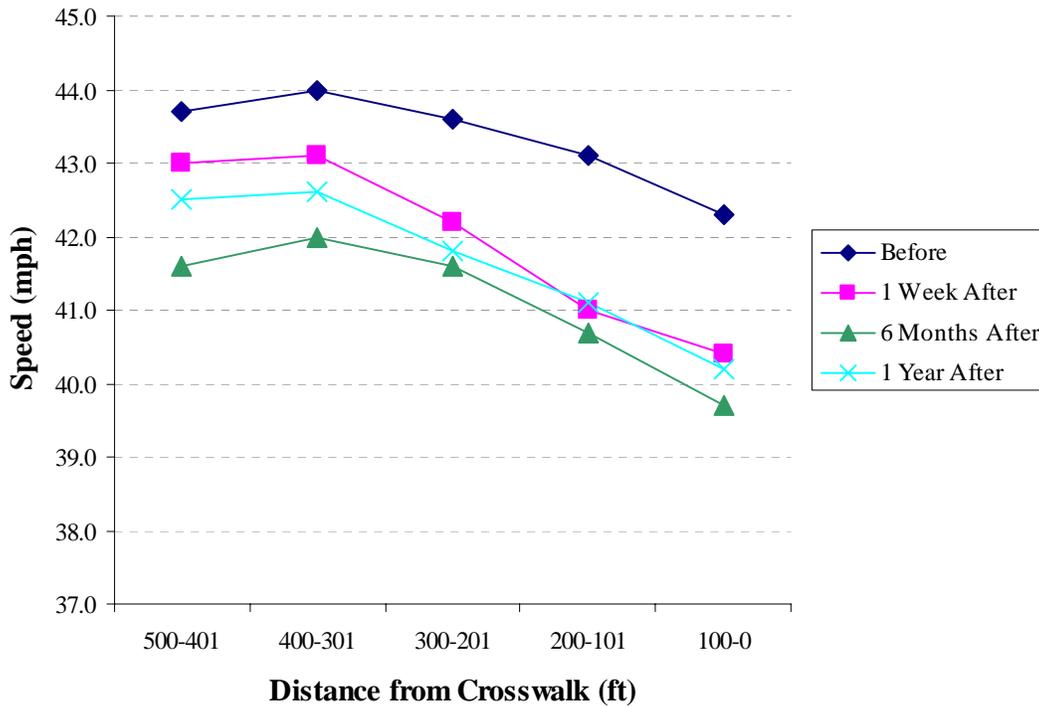
- Mean speeds in the before period at each distance were higher than those for each after period and statistically significantly different from the 6-month and 1-year after period at each distance. This indicates that the zig-zag pavement markings had a positive effect on reducing speeds when a trail user was at the crosswalk.

**Figure 30. Mean Speed Profiles From LIDAR Data on Northbound Approach of Belmont Ridge Road**

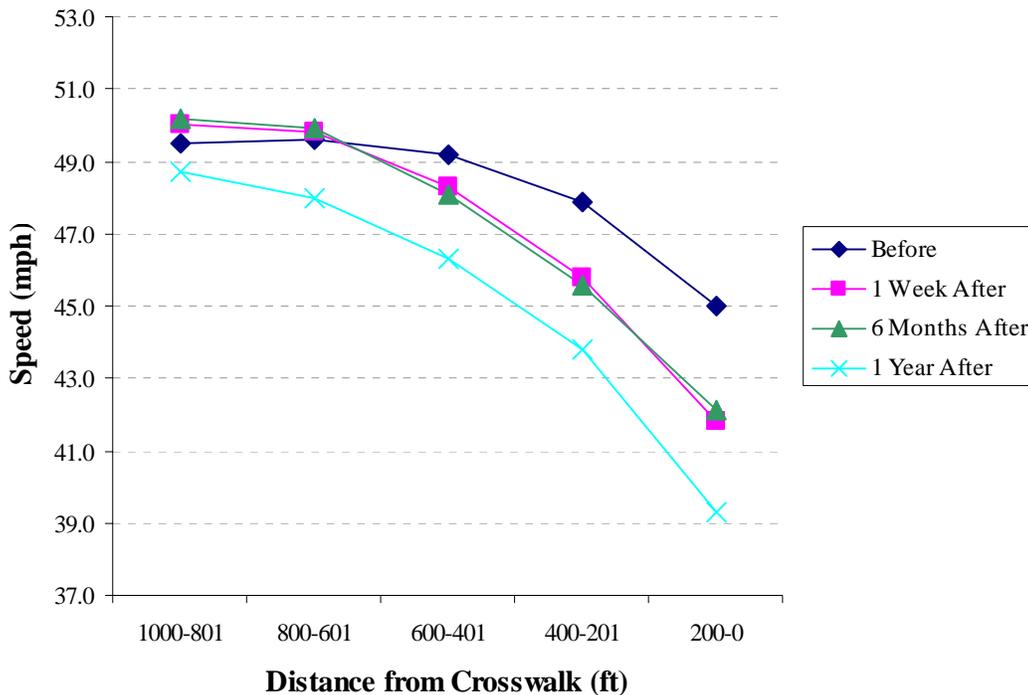
**Figure 31. Mean Speed Profiles From LIDAR Data on Southbound Approach of Belmont Ridge Road**

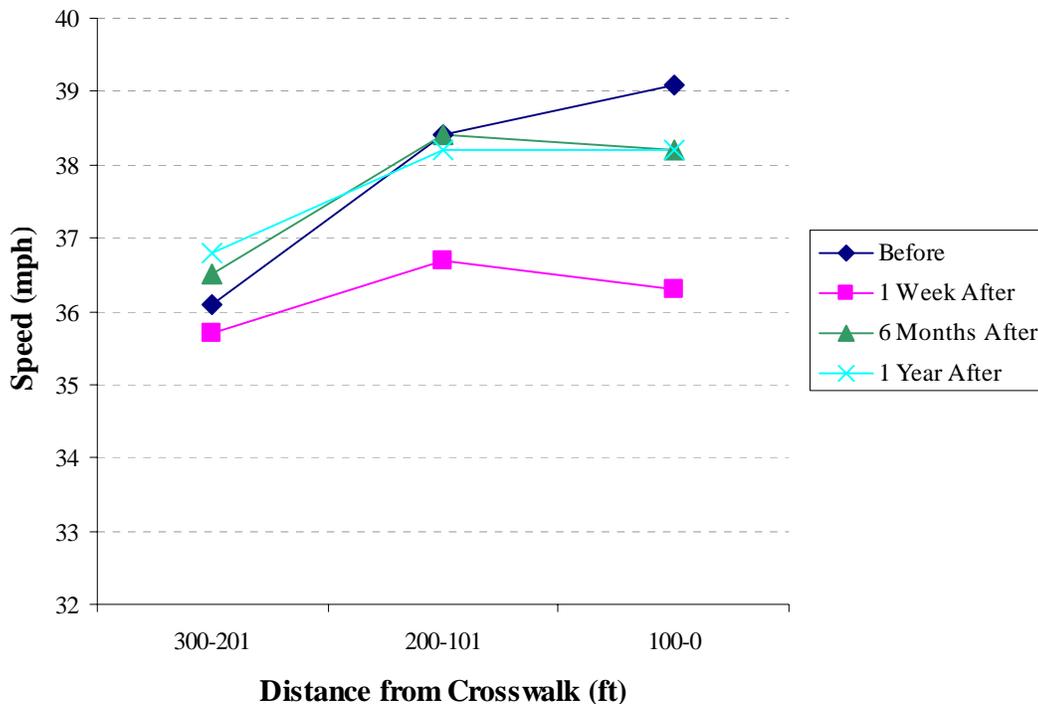
Figure 32 shows the mean speed for each distance bin in the right lane of the eastbound approach at Sterling Boulevard. As previously discussed, data were captured after vehicles had traversed halfway into the zig-zag zone. Noteworthy trends include:

**Figure 32. Mean Speed Profiles From LIDAR Data on Eastbound Approach of Sterling Boulevard**

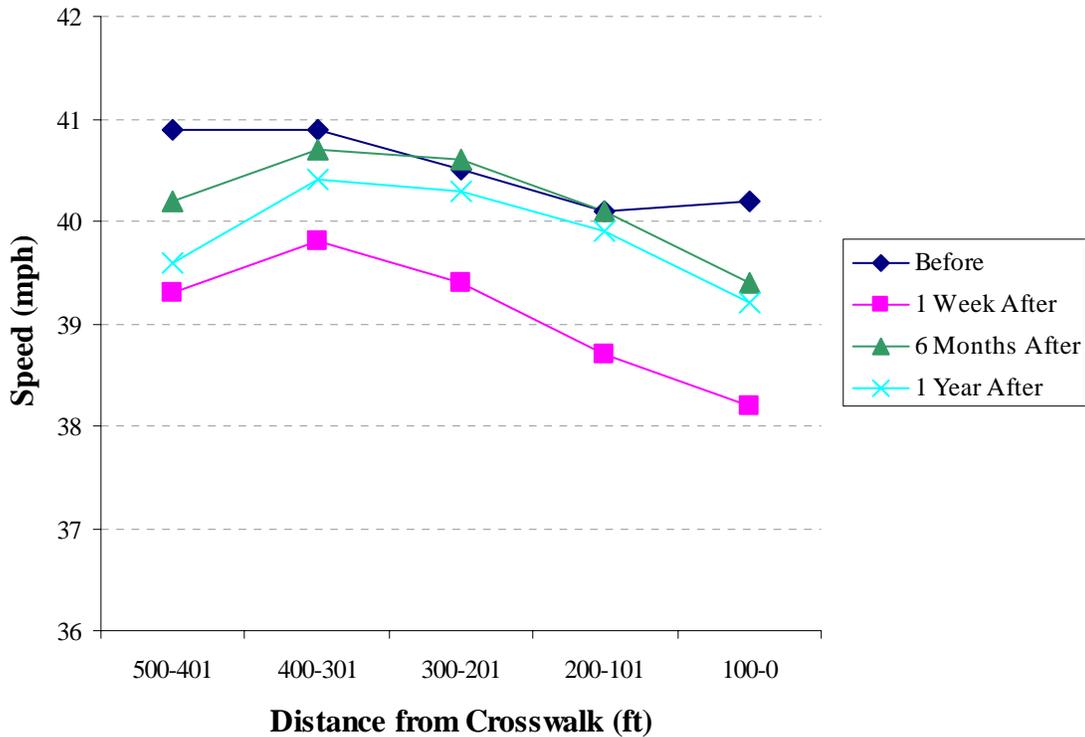
- From 100 feet to the crosswalk, mean speeds were lower in the 1-week and 1-year after periods than in the before period by a statistically significant amount. Mean vehicle speeds remained relatively constant from 200 feet to the crosswalk in the before period, whereas speeds continued to decline in all after periods. This signifies that in close proximity to the crosswalk, the zig-zag pavement markings had a positive effect on speed reduction.

**Figure 33. Mean Speed Profiles From LIDAR Data on Westbound Approach of Sterling Boulevard**

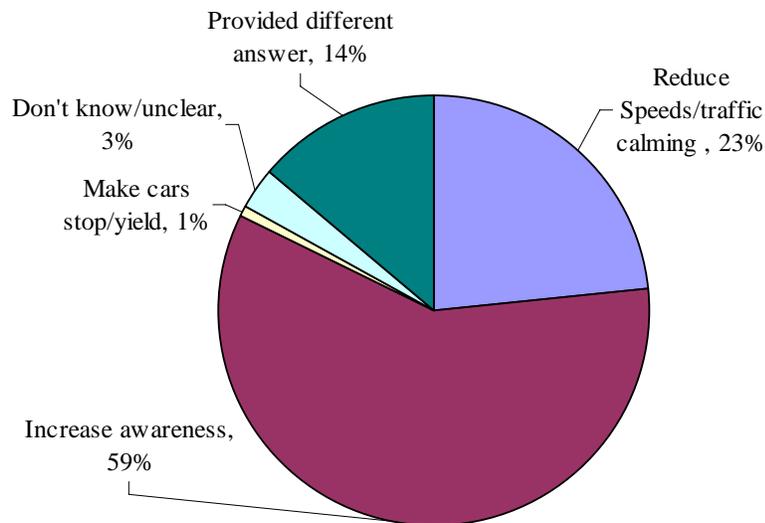
Figure 34 shows the percentages of the types of answers given. Fifty-nine percent of the respondents indicated the correct answer of “increase awareness” of the W&OD Trail. Twenty-three percent gave answers associated with speed reduction. Although speed reduction may be an indicator of increased awareness, the zig-zag markings were not installed specifically to reduce speeds. These results indicate that conveyance of purpose of the markings through public information campaigns could have been improved.

Figure 34. Survey Responses on Why VDOT Installed Zig-zag Markings

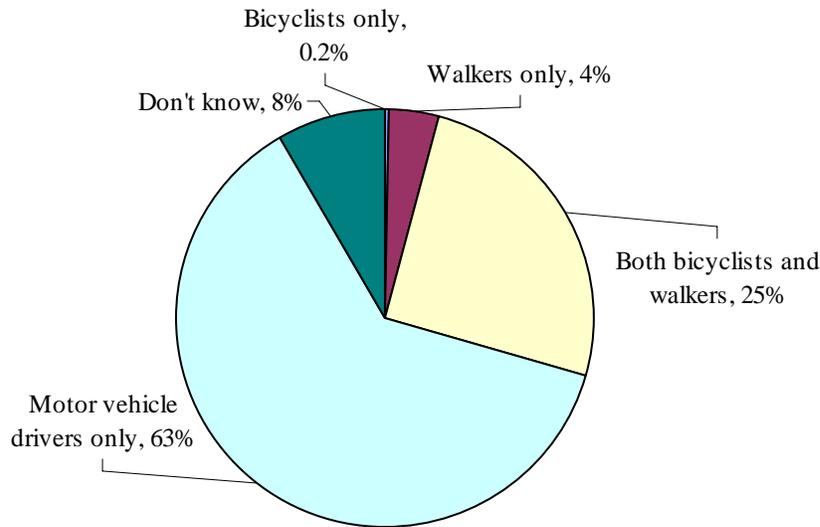
Potential for confusion with respect to right-of-way was observed in the field both before and after the zig-zag marking installation. Corroborating these field observations were the opinions on this question where roughly one-third of the responses are in conflict (see Figure 35). Laws regarding right-of-way are written in the *Code of Virginia*. However, some view these laws as unclear, particularly at W&OD Trail crossings where STOP signs are directed toward trail users. This issue is discussed in more detail later.

**Figure 35. Survey Responses on Who Has Right-of-Way**

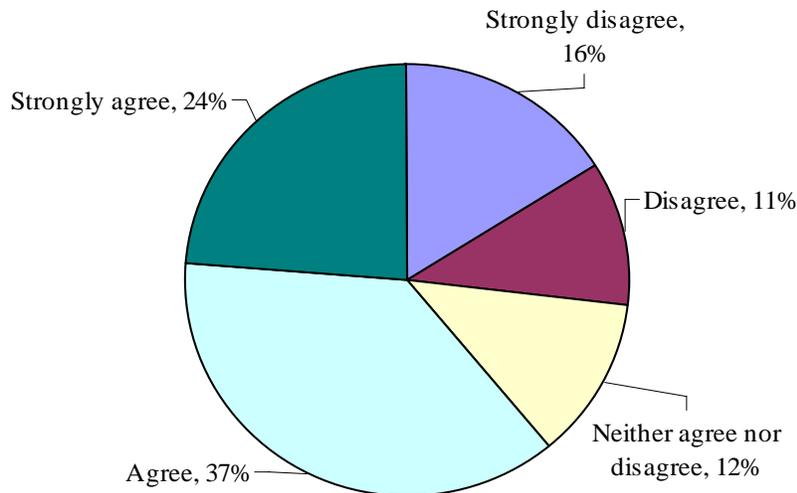
Because of the different zig-zag marking designs on Belmont Ridge Road and Sterling Boulevard, the survey results were filtered to target only motor vehicle drivers at each location (i.e., those that had driven over the markings but had not used the trail). Although a direct comparison cannot be made between the Belmont Ridge Road and Sterling Boulevard markings because of the different marking designs and roadway geometries, the survey responses revealed that a higher percentage of motorists on Belmont Ridge Road thought they had a greater awareness (65% agreed or strongly agreed) compared to those on Sterling Boulevard (39% agreed or strongly agreed).

**Figure 36. Survey Responses on Increased Driving Awareness or Attention**

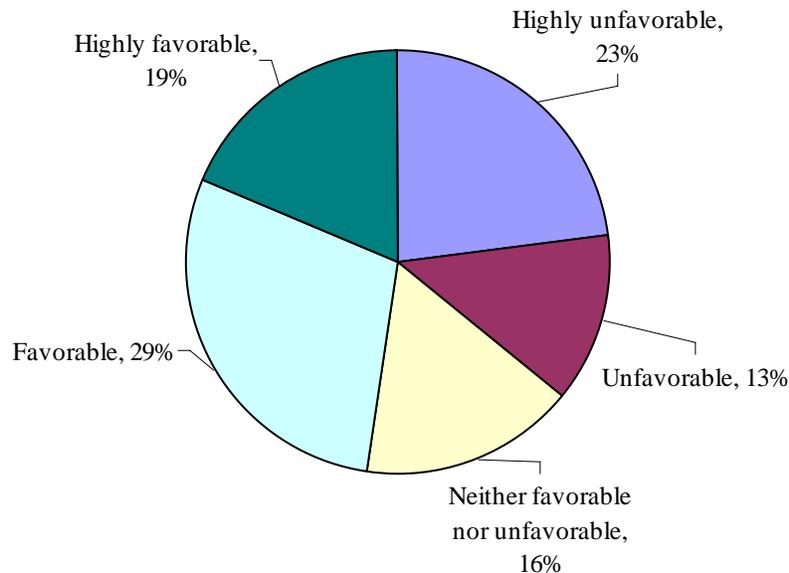
Figure 37 shows all responses to this question, including those of trail users. Almost one-half of the respondents (48%) indicated a favorable to highly favorable opinion of the markings, whereas 36 percent indicated an unfavorable to highly unfavorable opinion of the markings.

**Figure 37. Survey Responses on Overall Opinion of Markings**

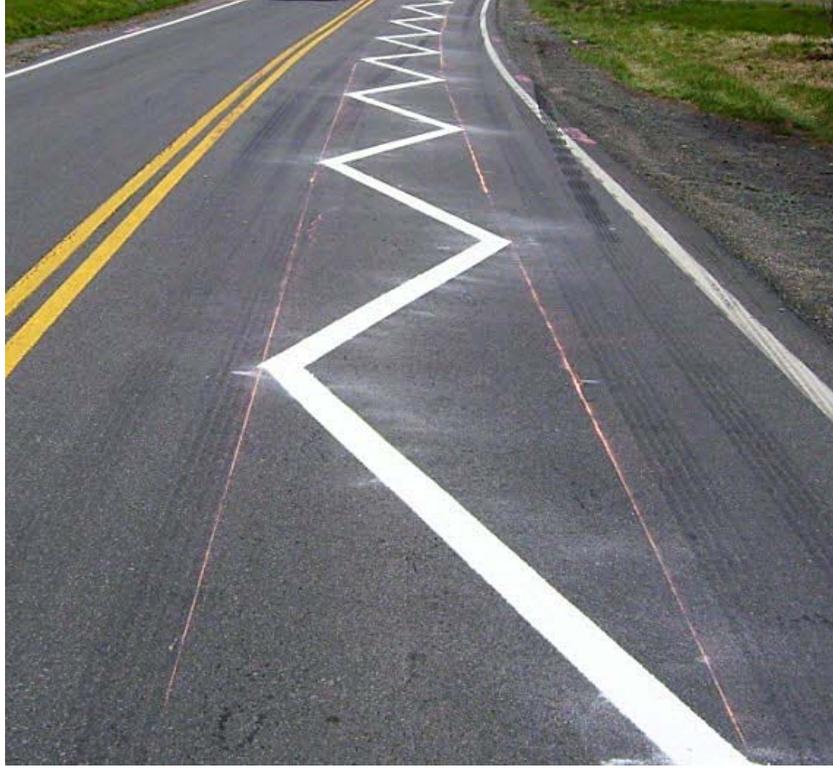
**Figure 38. First Photograph Shown to Subjects of Markings on Belmont Ridge Road**

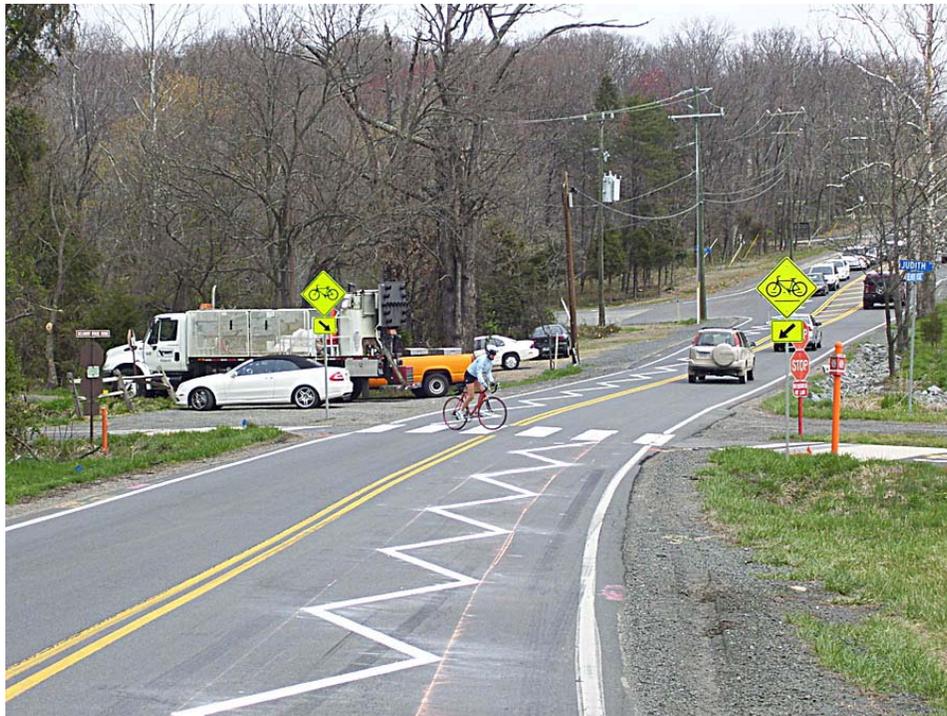
**Figure 39. Second Picture Shown to Subjects of Markings on Belmont Ridge Road**

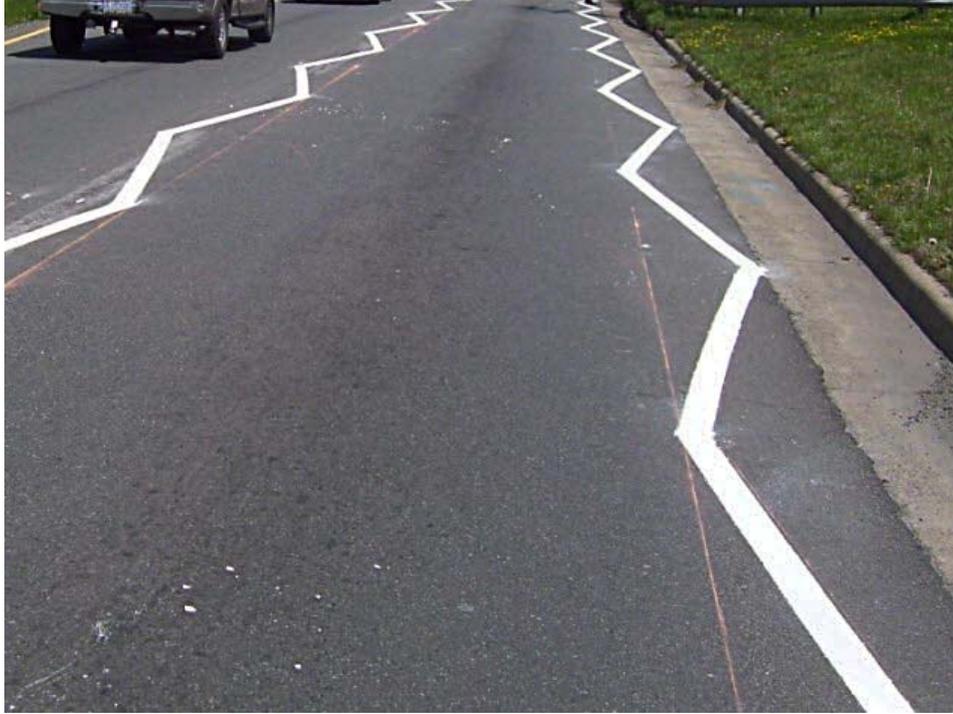
**Figure 40. First Photograph Shown to Subjects of Markings on Sterling Boulevard**

The same procedure for obtaining opinions on the purpose of the Belmont Ridge Road markings was performed using photographs of the Sterling Boulevard markings (i.e., subjects were asked opinions on the purpose of the markings shown without context and with context). Figure 40 is the photograph of the zig-zag markings at Sterling Boulevard presented first. The subjects were asked: (1) Have you ever seen this type of marking on a road, and (2) Do you feel you know the purpose of the pavement marking? For question 1, 75 (100%) of the respondents

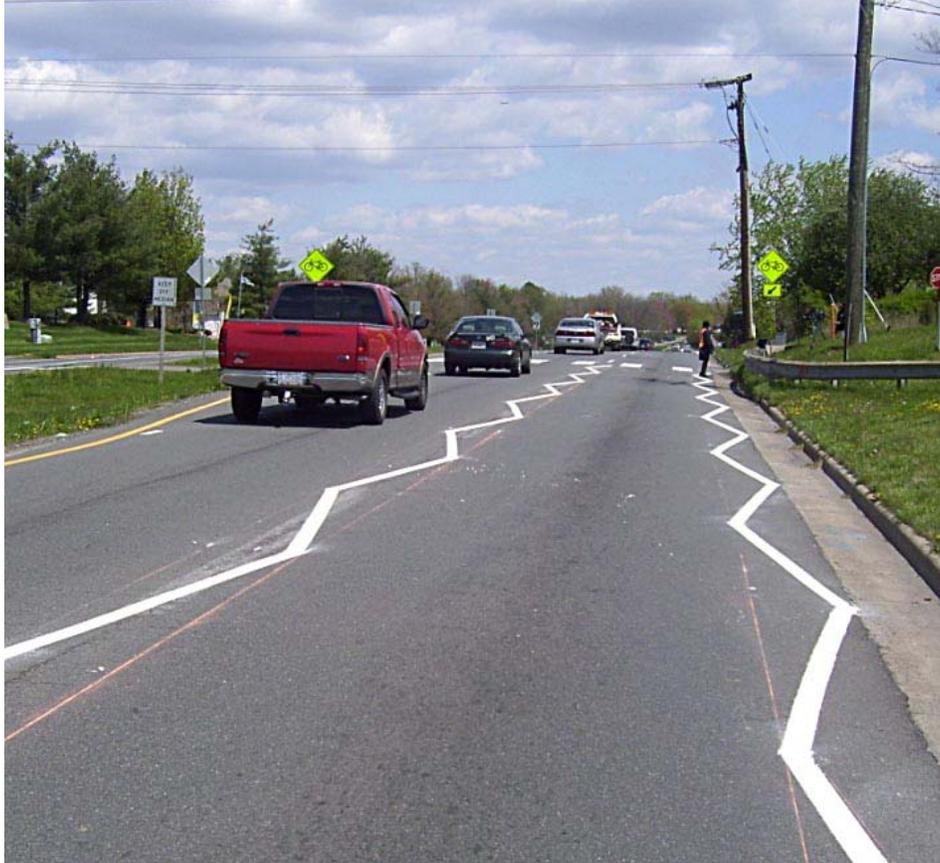
**Figure 41. Second Photograph Shown to Subjects of Markings on Sterling Boulevard**

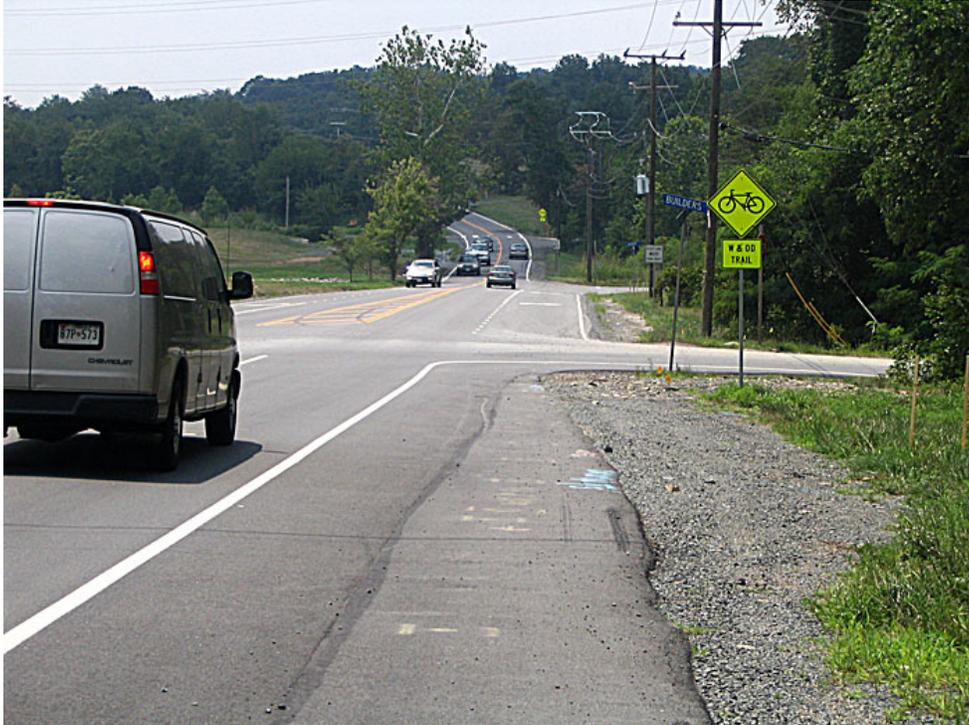
Figure B-1. Southbound Advance Warning Sign

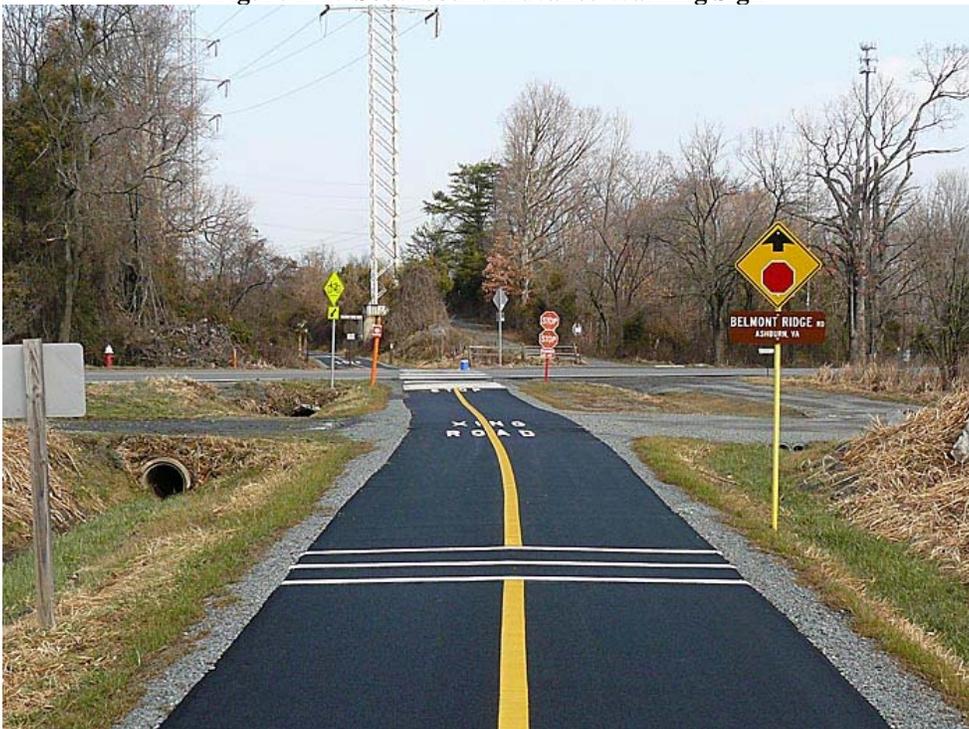
Figure B-2. W&OD Trail Signage and Pavement Markings

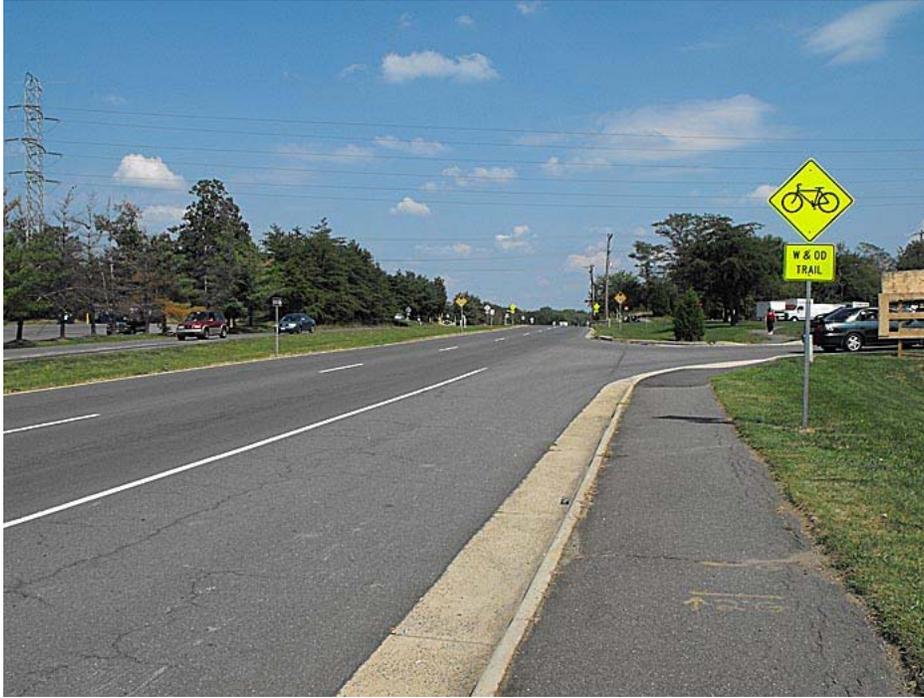
Figure C-1. Eastbound Advance Warning Sign

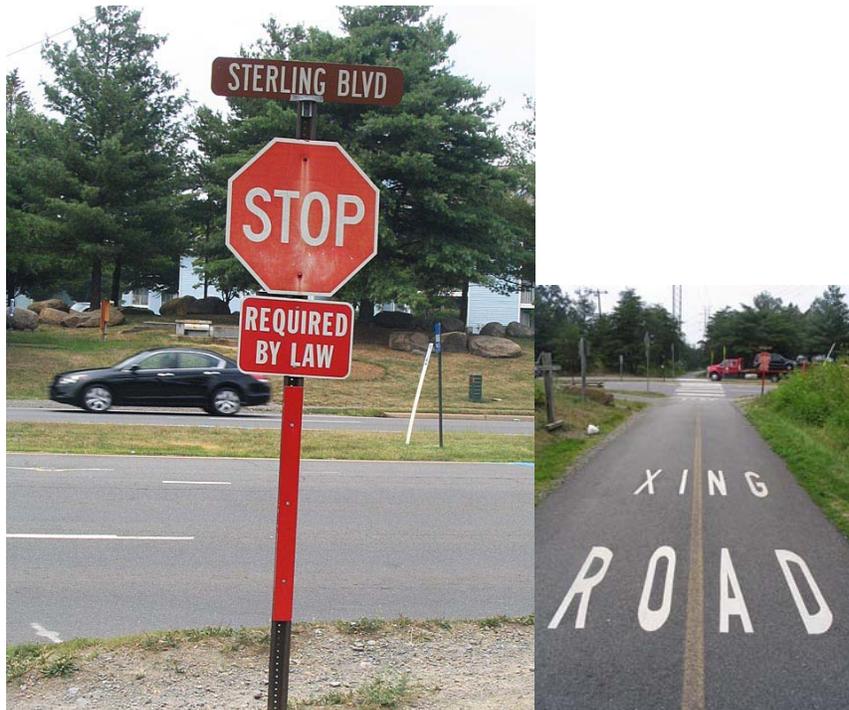
Figure C-2. W&OD Trail Signage and Pavement Markings

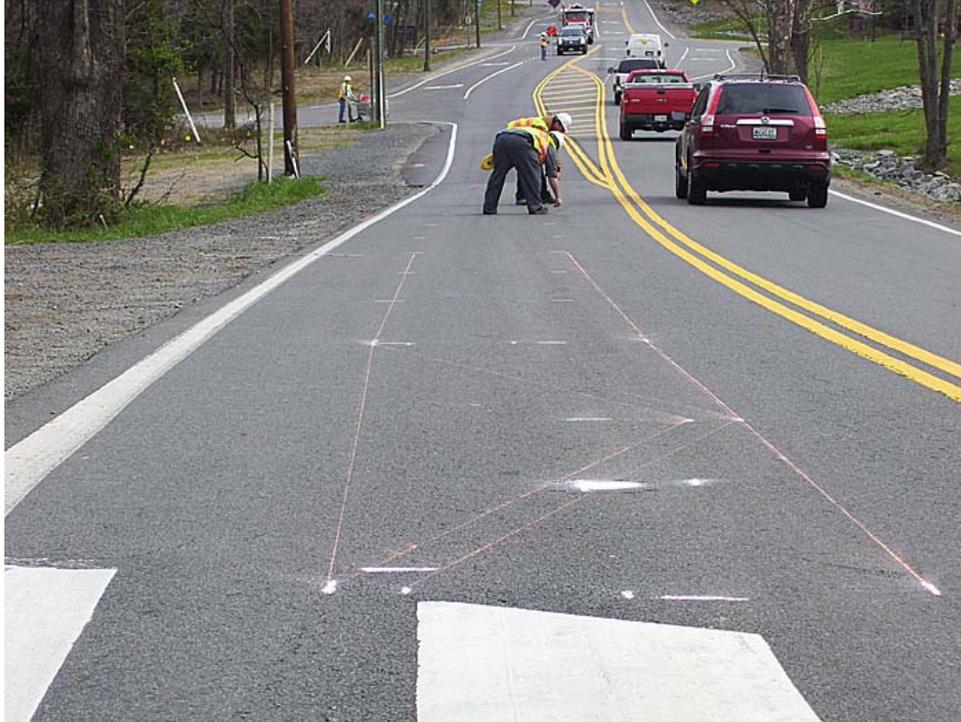
Figure D-1. Marking Layout on Northbound Approach of Belmont Ridge Road

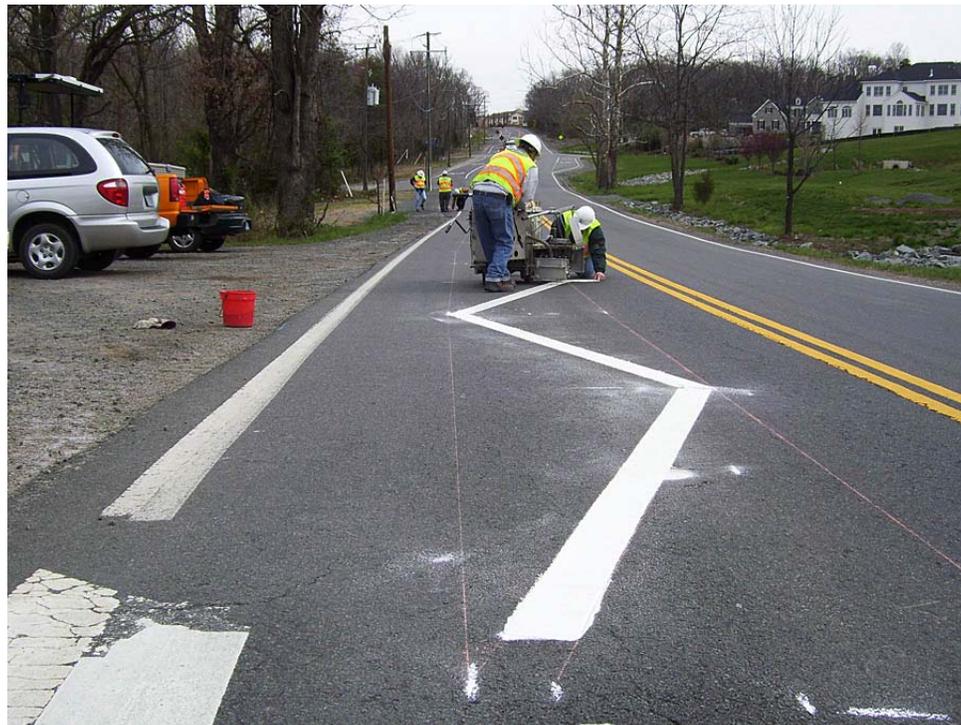
Figure D-2. Marking Painting on Northbound Approach of Belmont Ridge Road

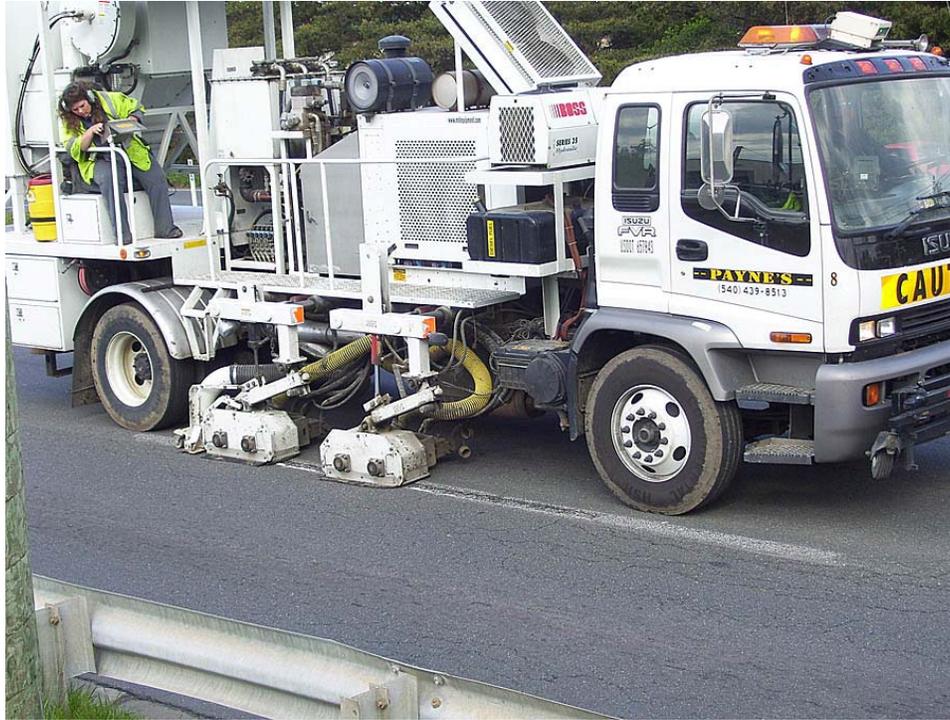
**Figure D-3. Eradication of Skip-Lines on Sterling Boulevard**

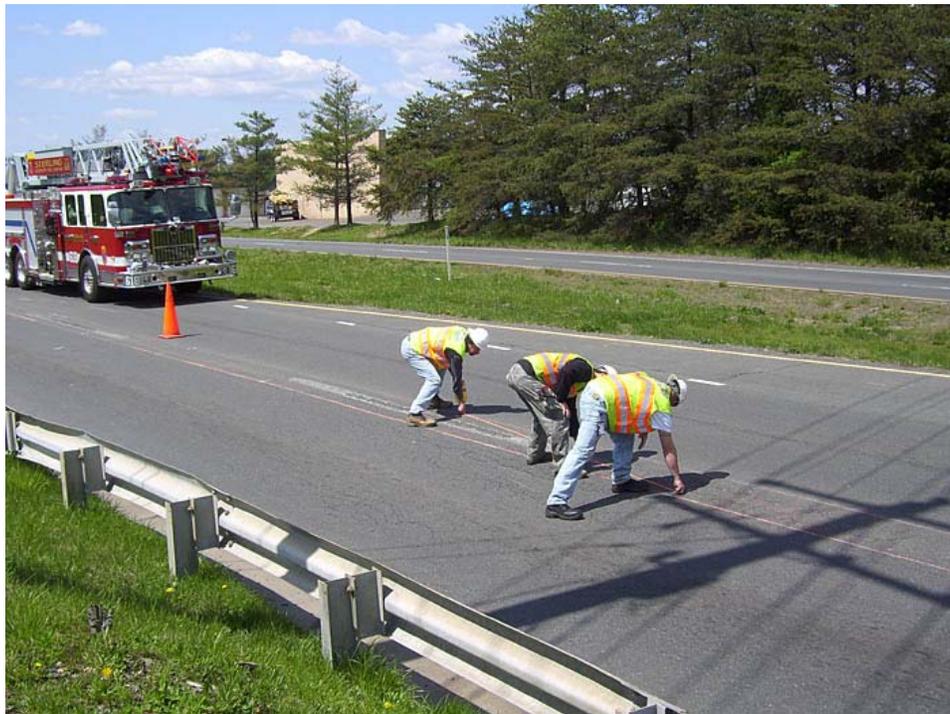
**Figure D-4. Marking Layout on Eastbound Approach of Sterling Boulevard**

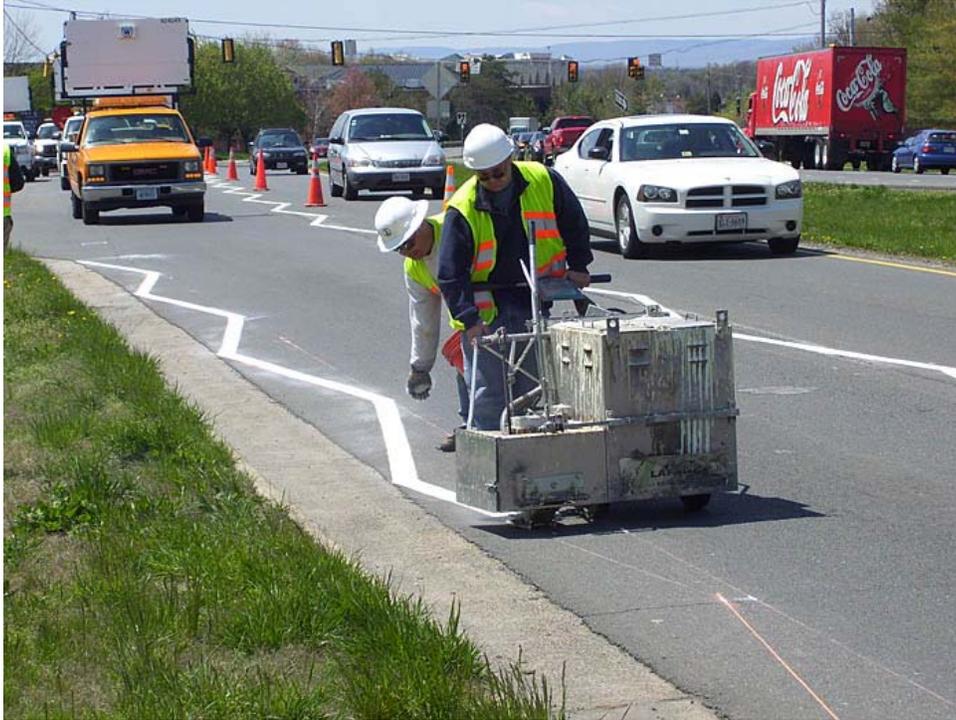
**Figure D-5. Marking Painting on Eastbound Approach of Sterling Boulevard**

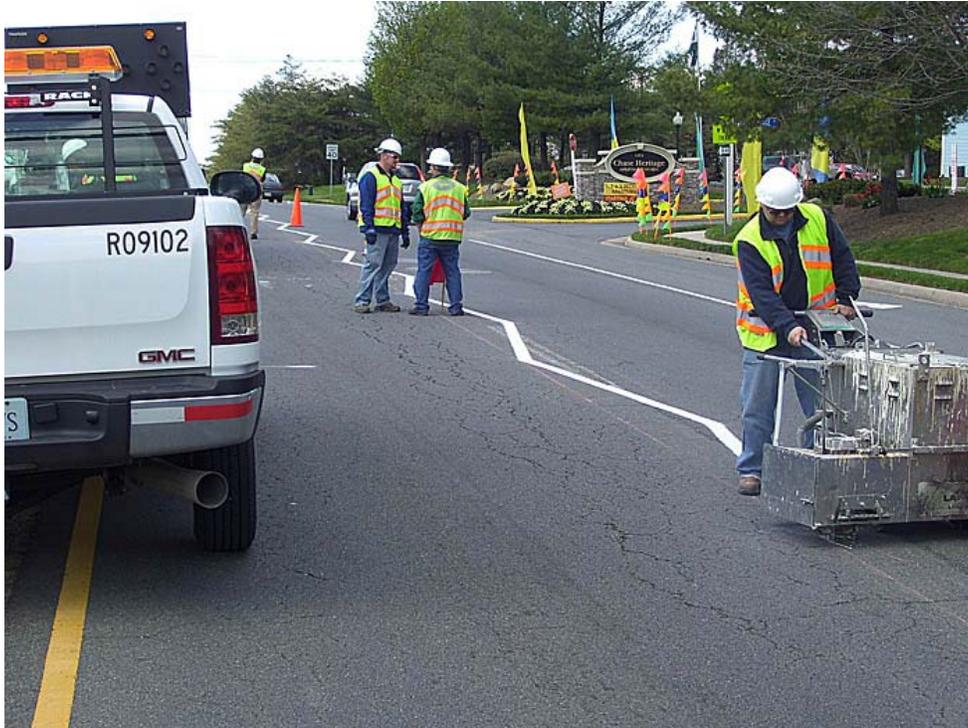
**Figure D-6. Marking Painting on Westbound Approach of Sterling Boulevard**

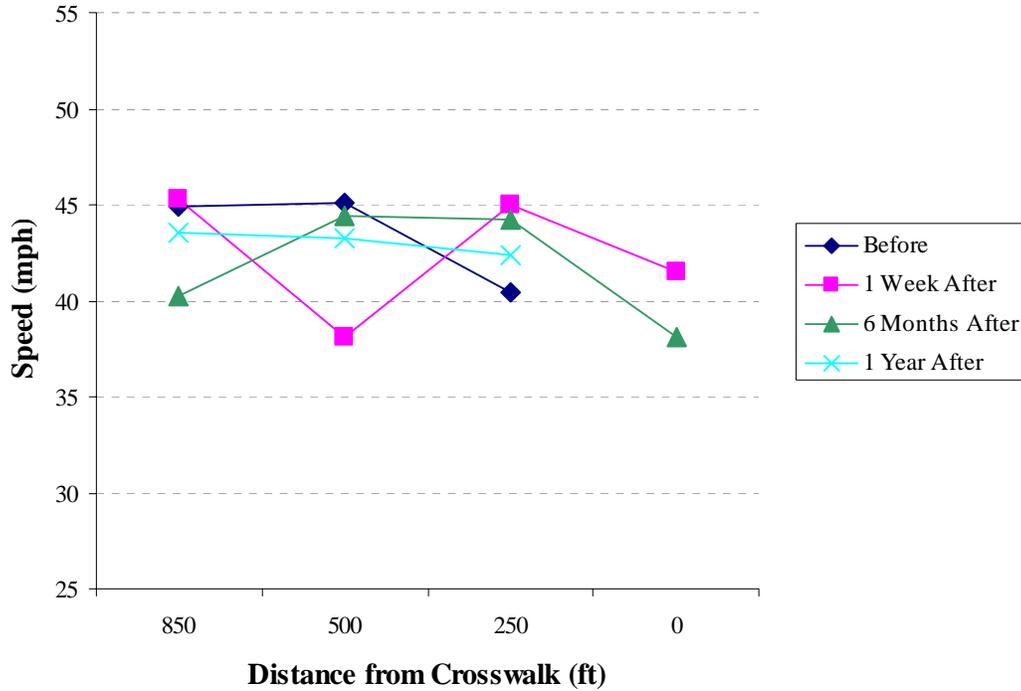
**Figure E-1. Northbound High Volume Speed Profiles**

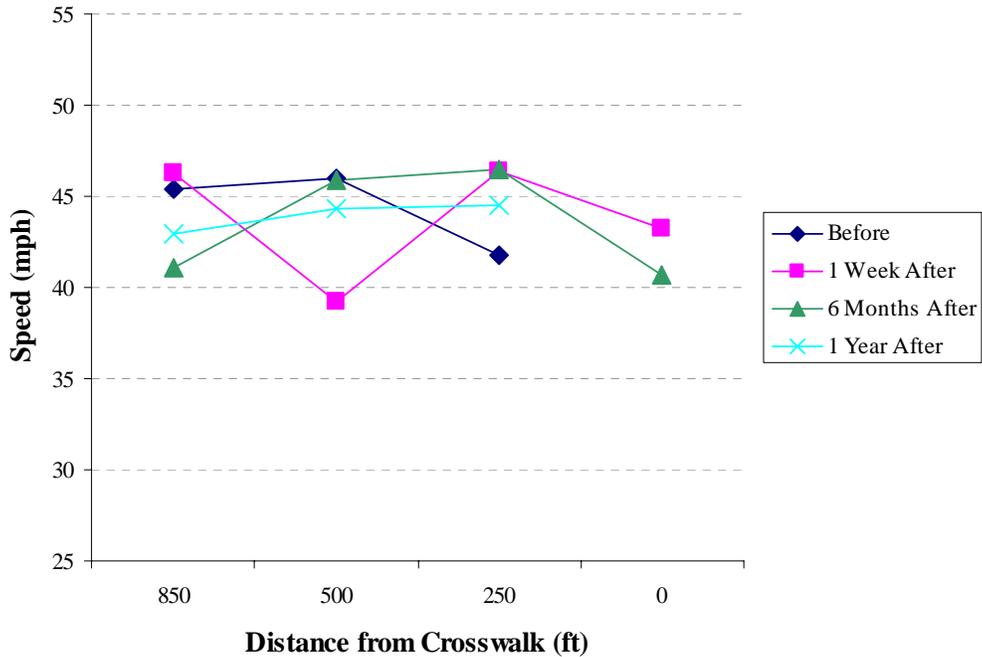
**Figure E-2. Northbound Low Volume Speed Profiles**

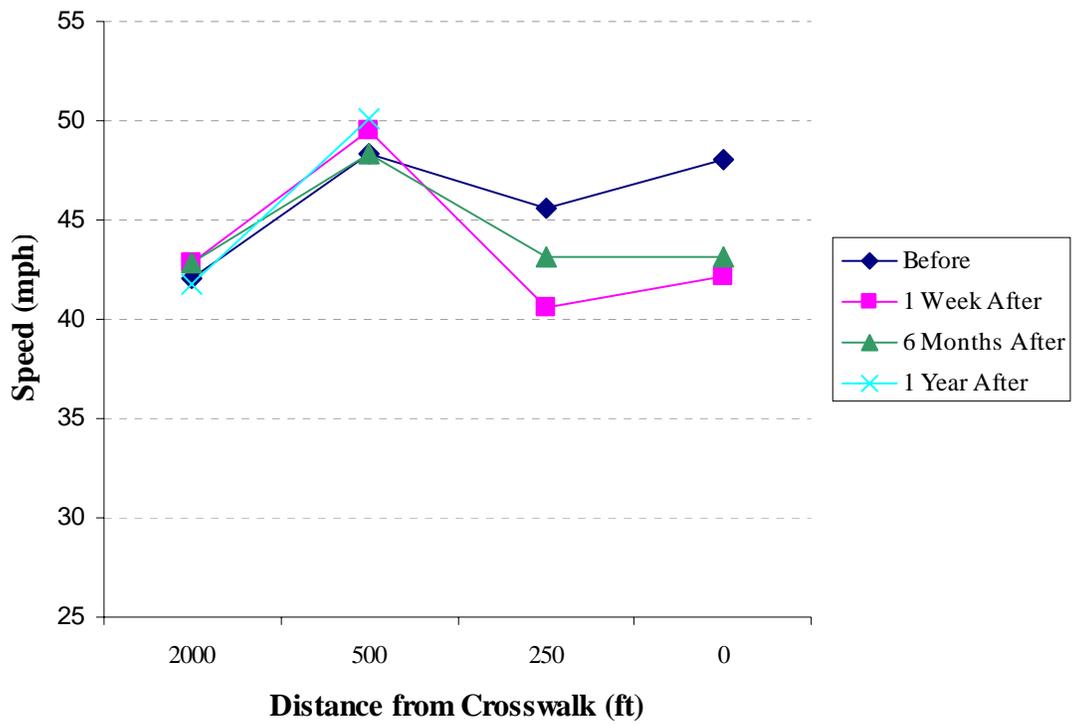
Figure E-3. Southbound High Volume Speed Profiles

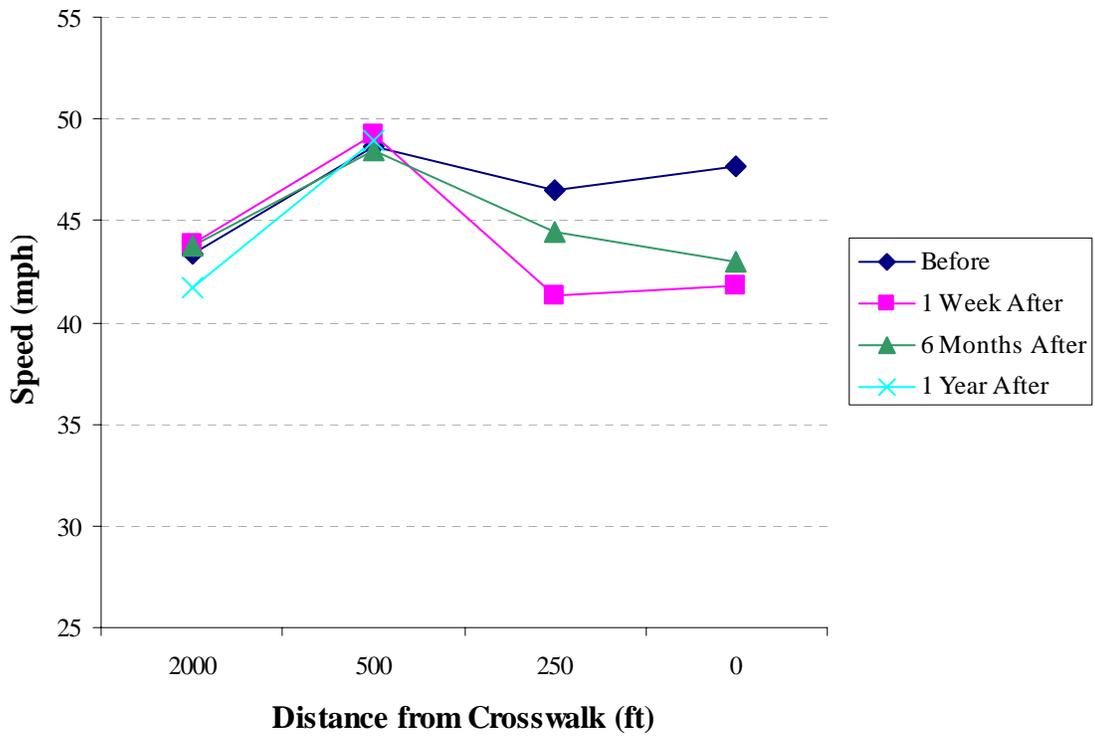
Figure E-4. Southbound Low Volume Speed Profiles
