Best Practices in  
Traffic Operations and Safety:  
Phase II: Zig-zag Pavement Markings

1. Report No.: FHWA/VTRC 11-R9		2. Government Accession No.:		3. Recipient's Catalog No.:	
4. Title and Subtitle: Best Practices in Traffic Operations and Safety: Phase II: Zig-zag Pavement Markings				5. Report Date: December 2010

**BEST PRACTICES IN TRAFFIC OPERATIONS AND SAFETY:  
PHASE II: ZIG-ZAG PAVEMENT MARKINGS**

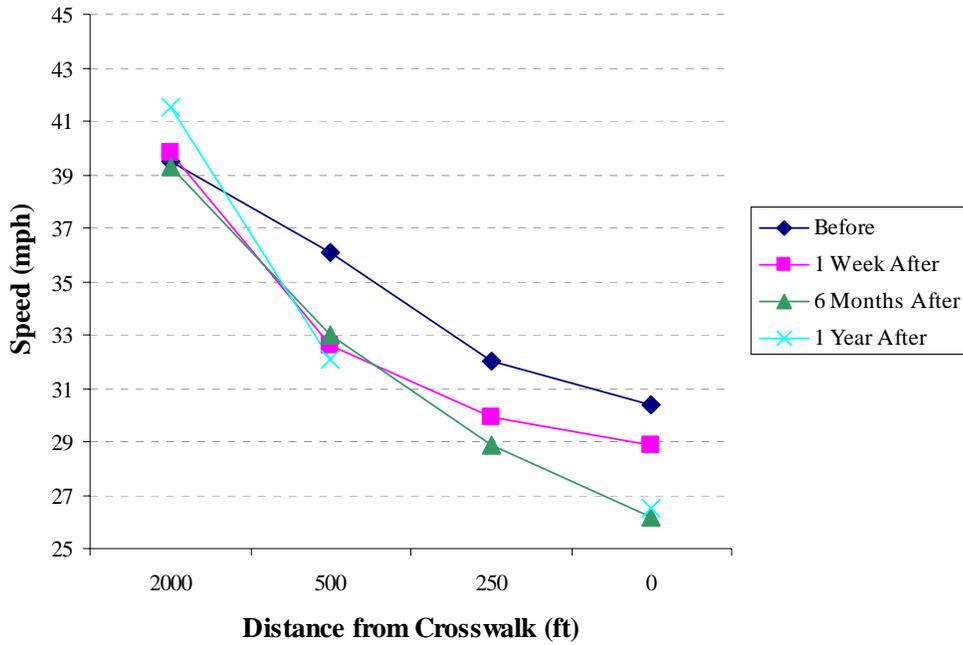
Figure G-1. Eastbound Right Lane High Volume

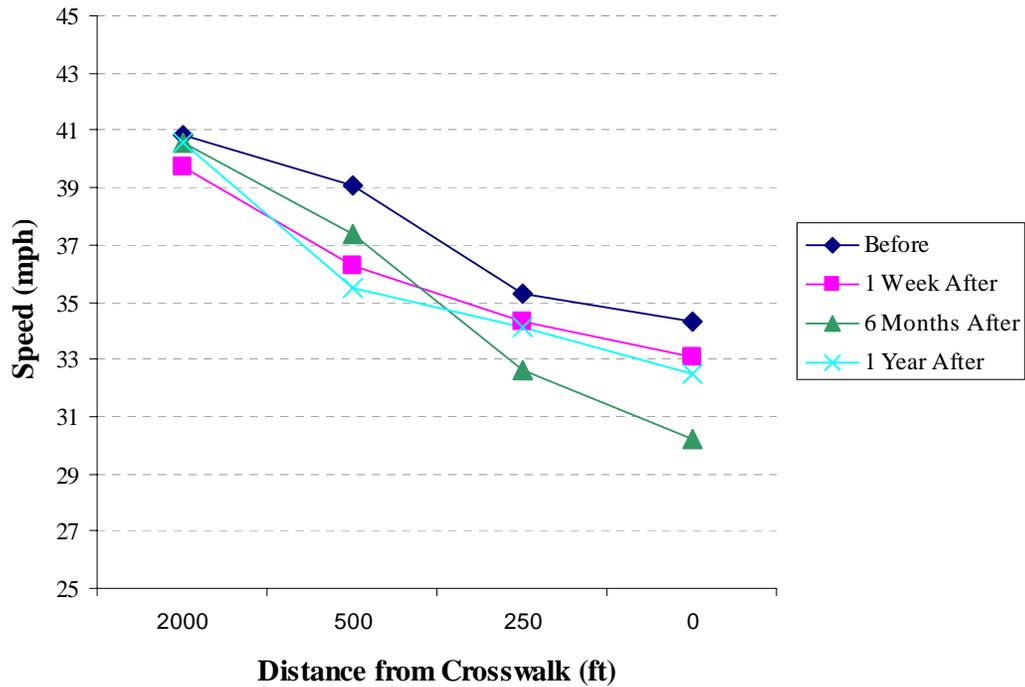
Figure G-2. Eastbound Right Lane Low Volume

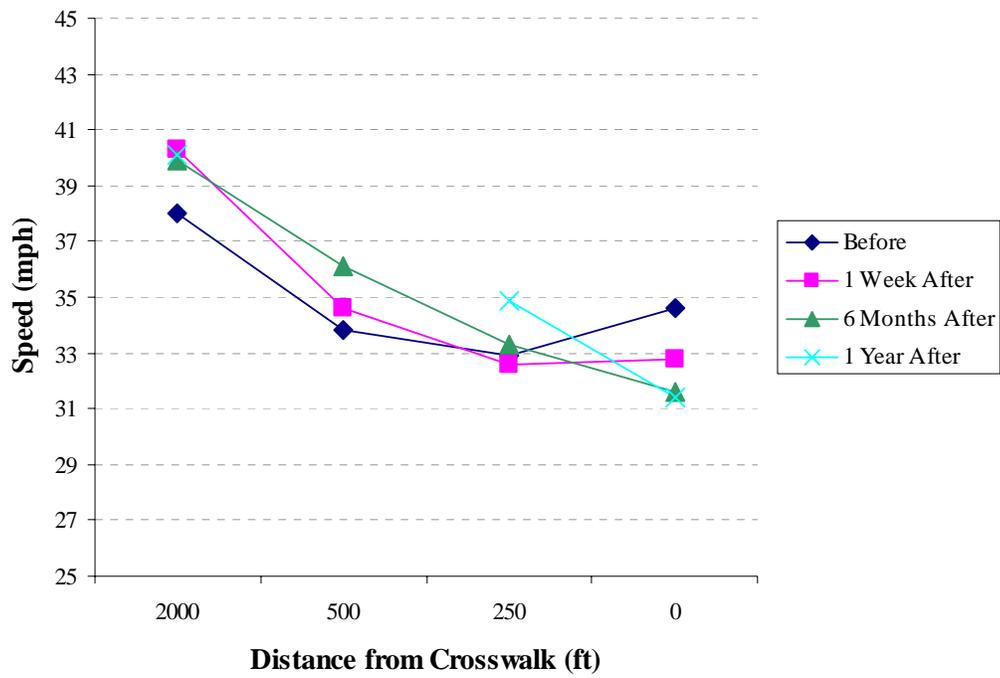
Figure G-3. Eastbound Left Lane High Volume

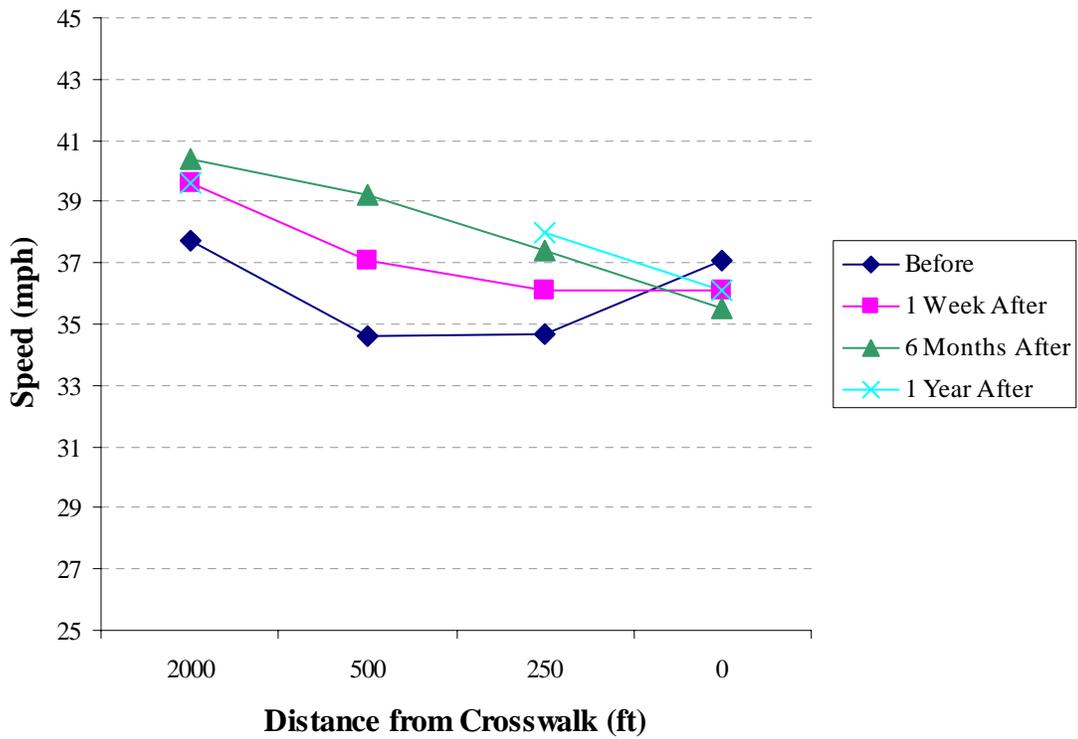
Figure G-4. Eastbound Left Lane Low Volume

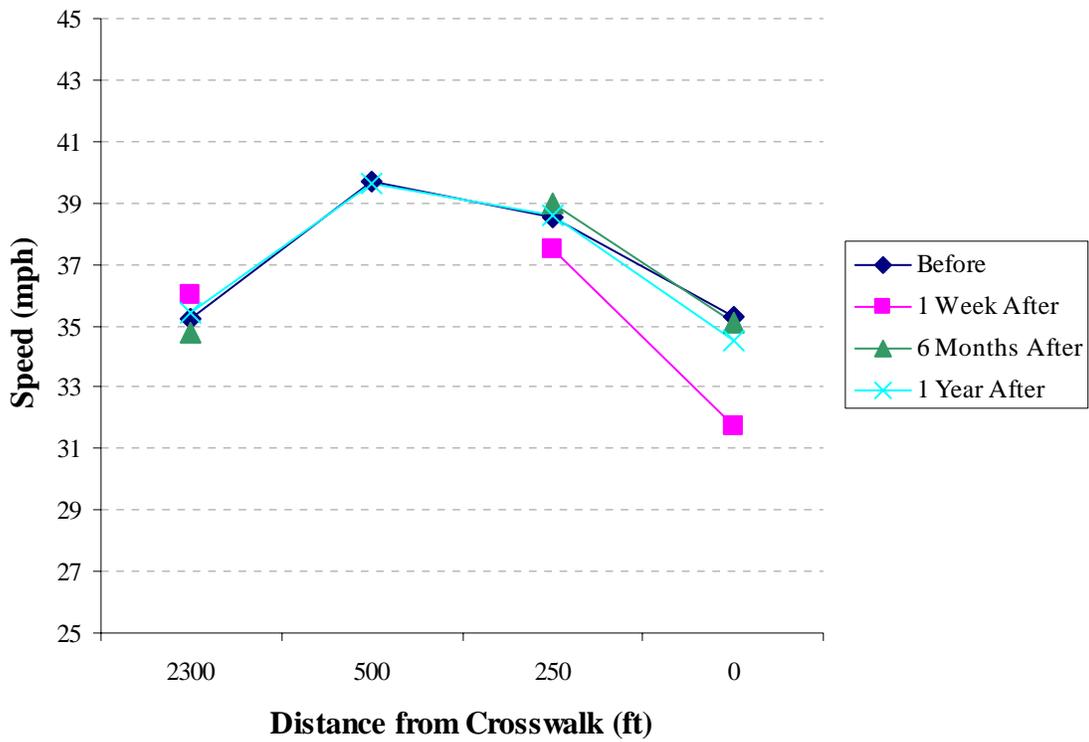
Figure G-5. Westbound Right Lane High Volume

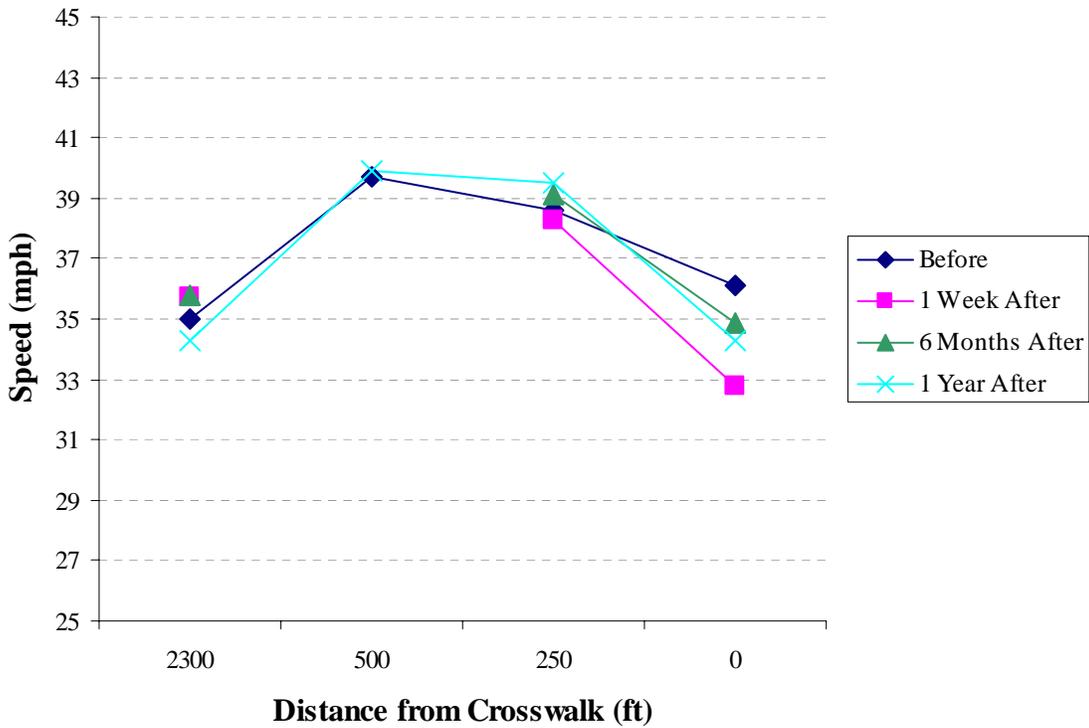
Figure G-6. Westbound Right Lane Low Volume

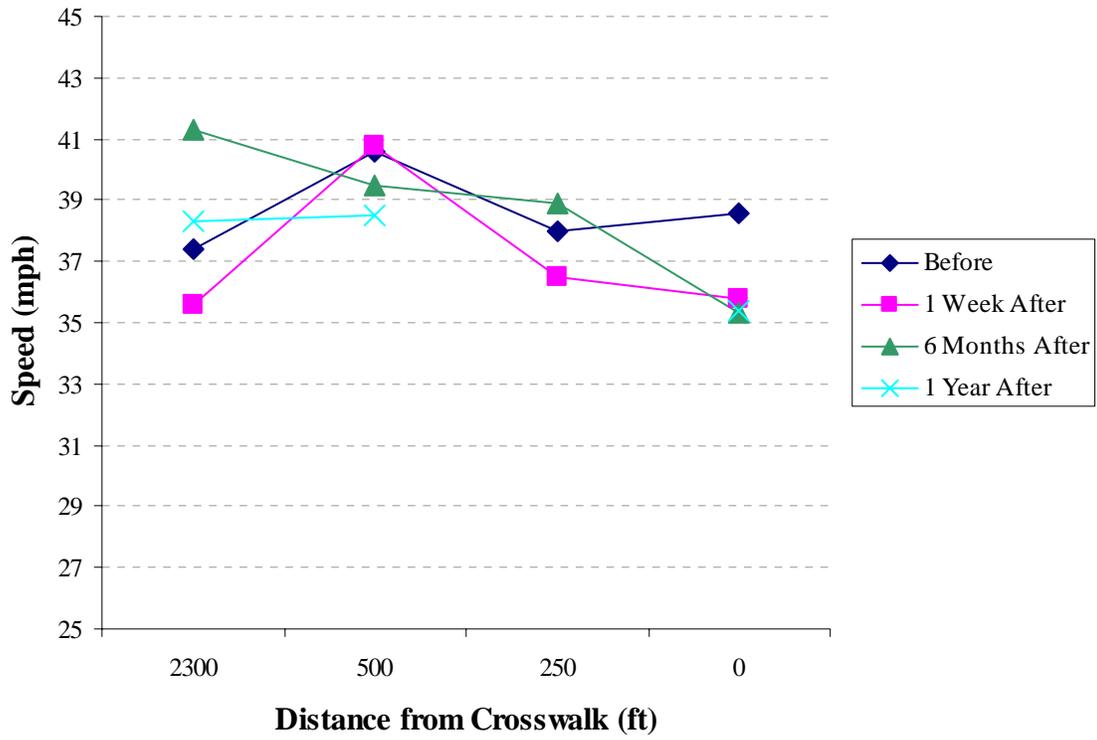
Figure G-7. Westbound Left Lane High Volume

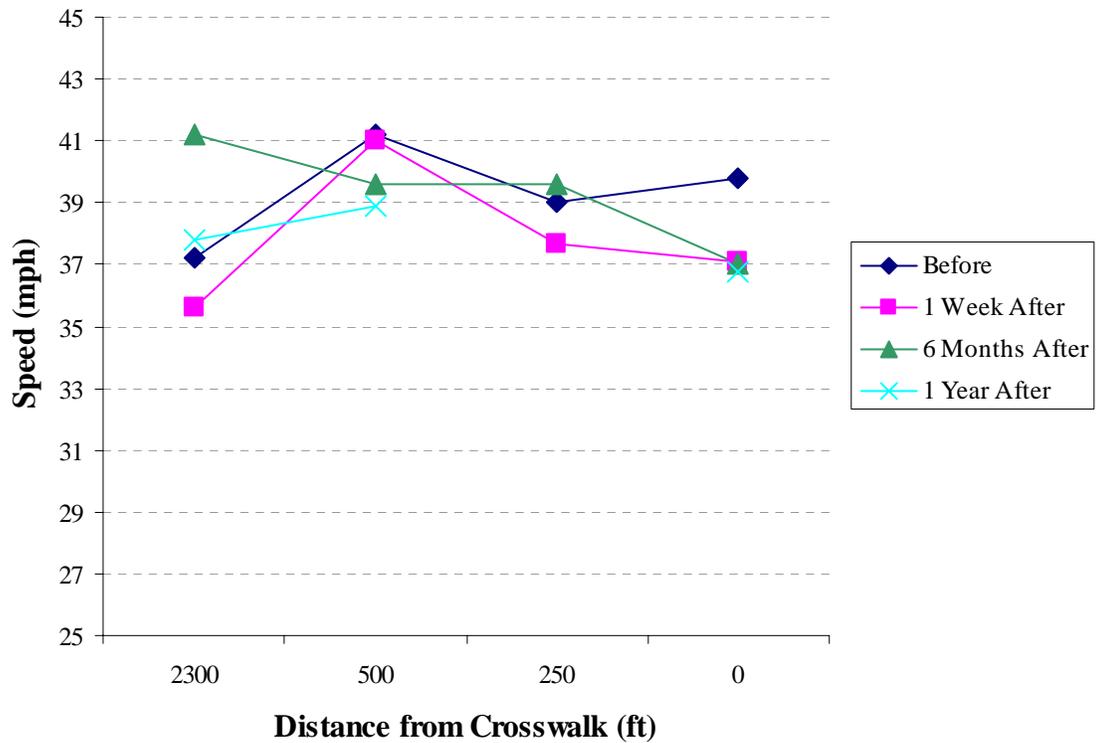
Figure G-8. Westbound Left Lane Low Volume
