Report SO 93-08

IMPULSE RADAR STRATEGIES

FOR BRIDGE DECK ASSESSMENT

March 1993

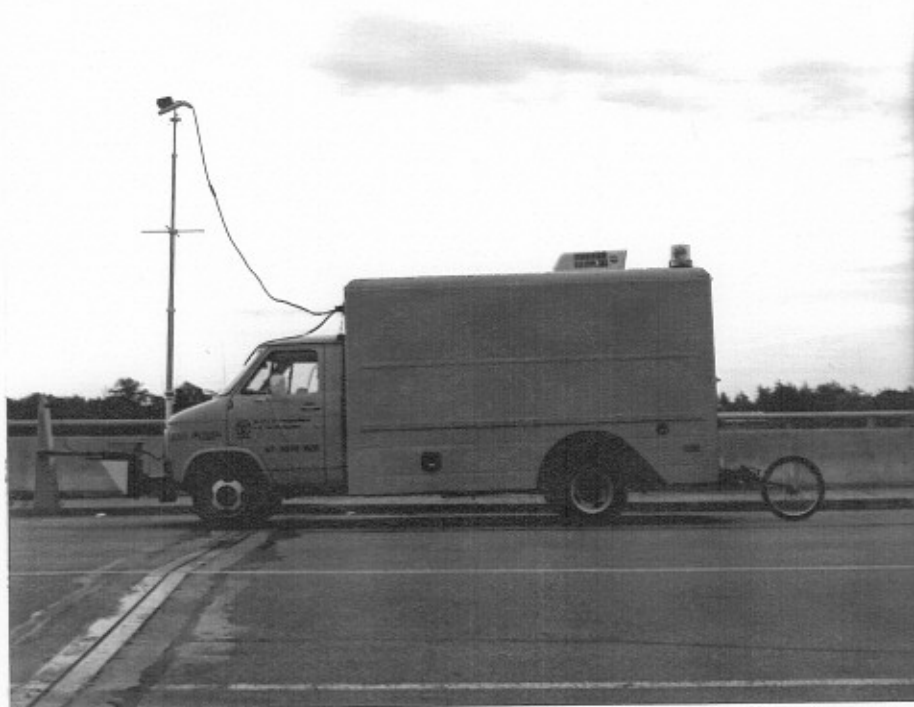
Fig. 1:

(a) DART van at a bridge deck.

(b) Detailed view of the radar system mounted on the front of the vehicle.

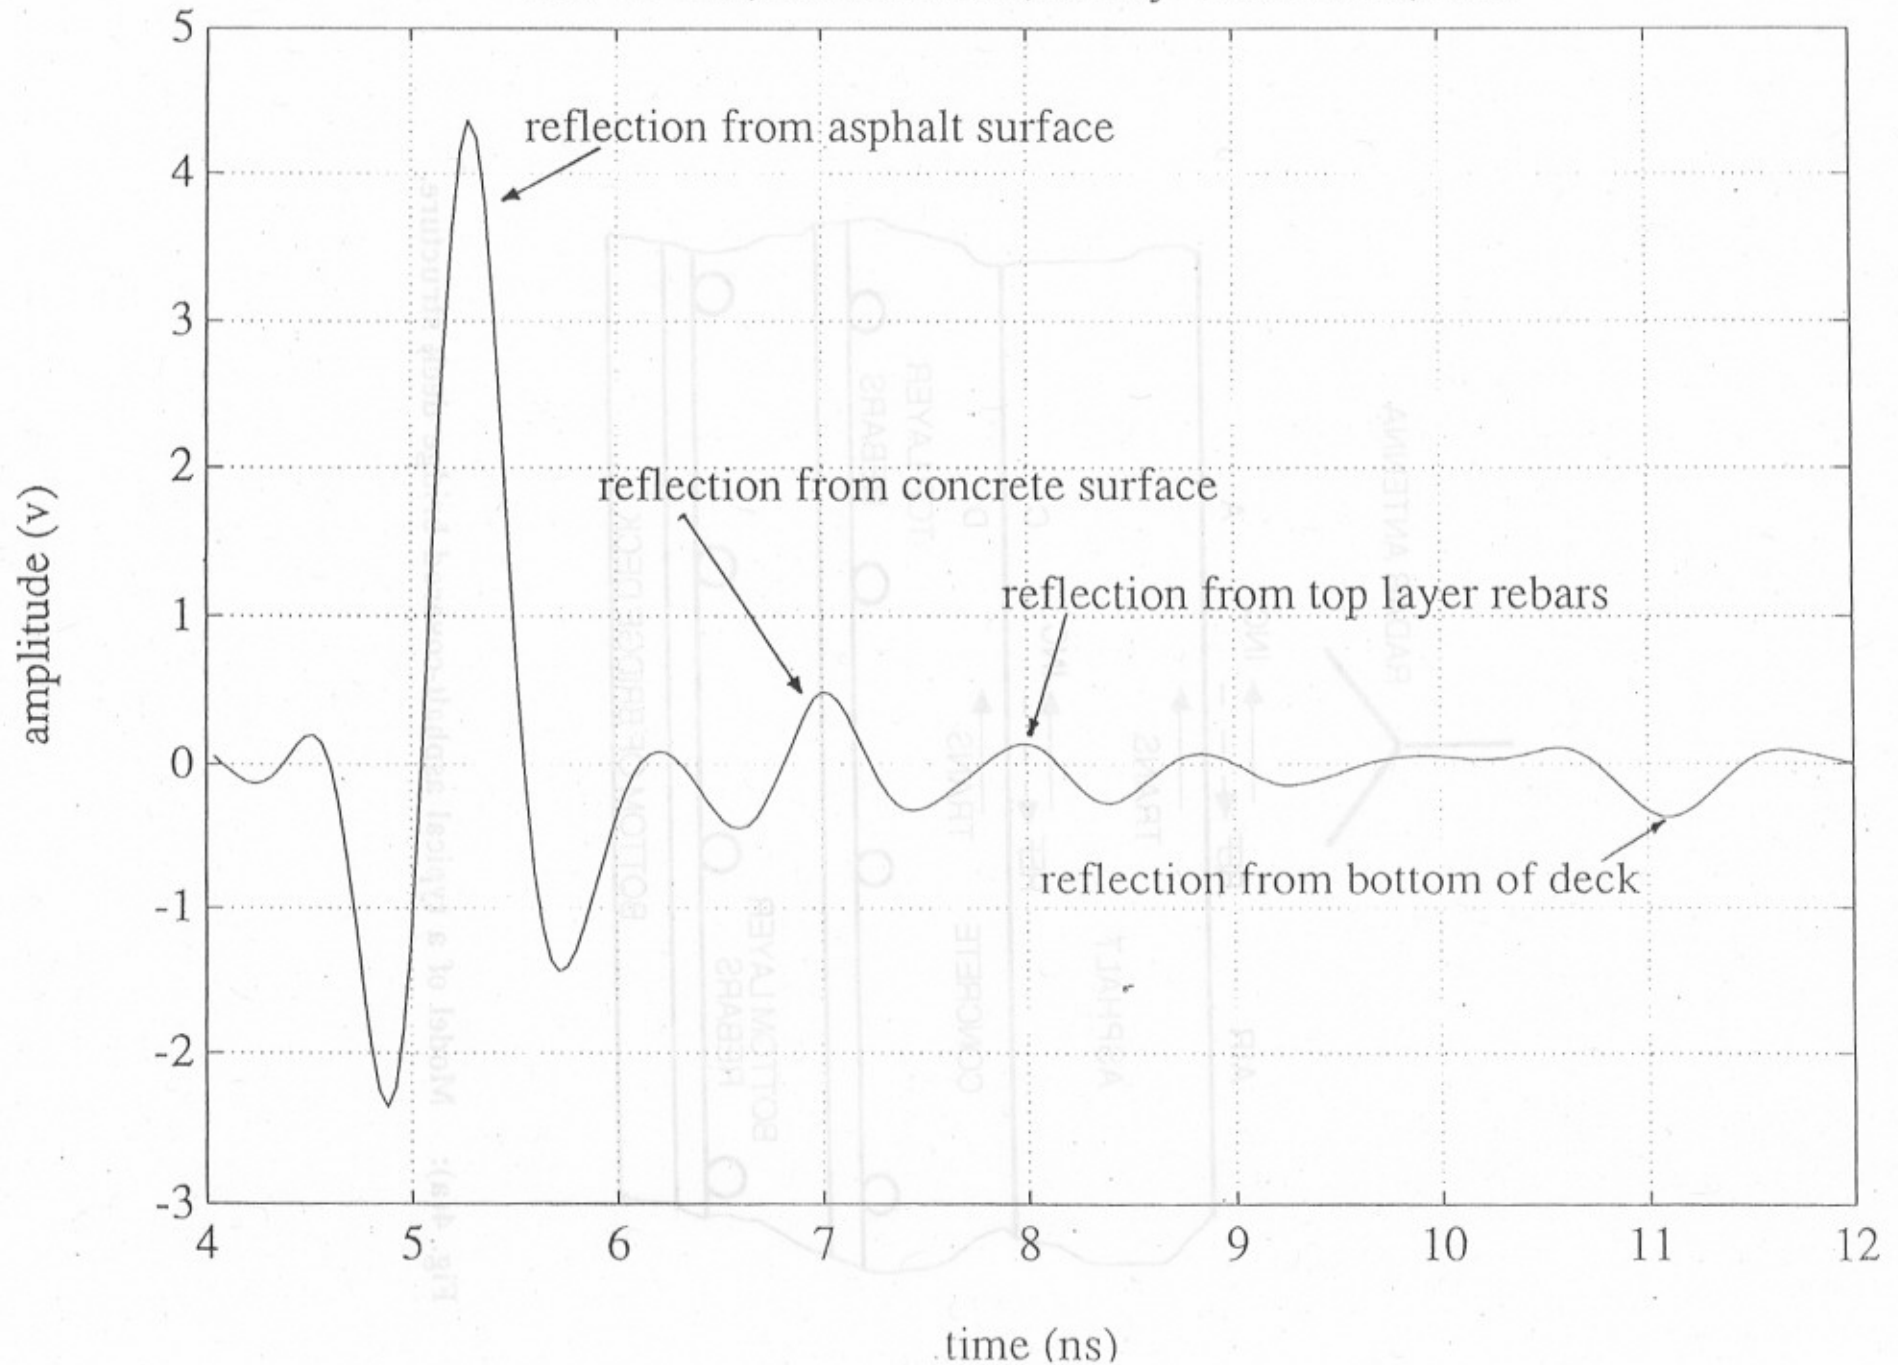
Fig. 4(b): Reflected waveform from a typical asphalt-covered bridge deck.

signal, $r(t)$, it is necessary to consider each layer in turn starting with the surface reflection from the top of the asphalt layer and continuing down to the reflection from the reinforcement. Figure 4(a) illustrates a typical asphalt-covered bridge deck structure with the related reflected impulse radar waveform depicted in Fig. 4(b). The equation describing these reflections is

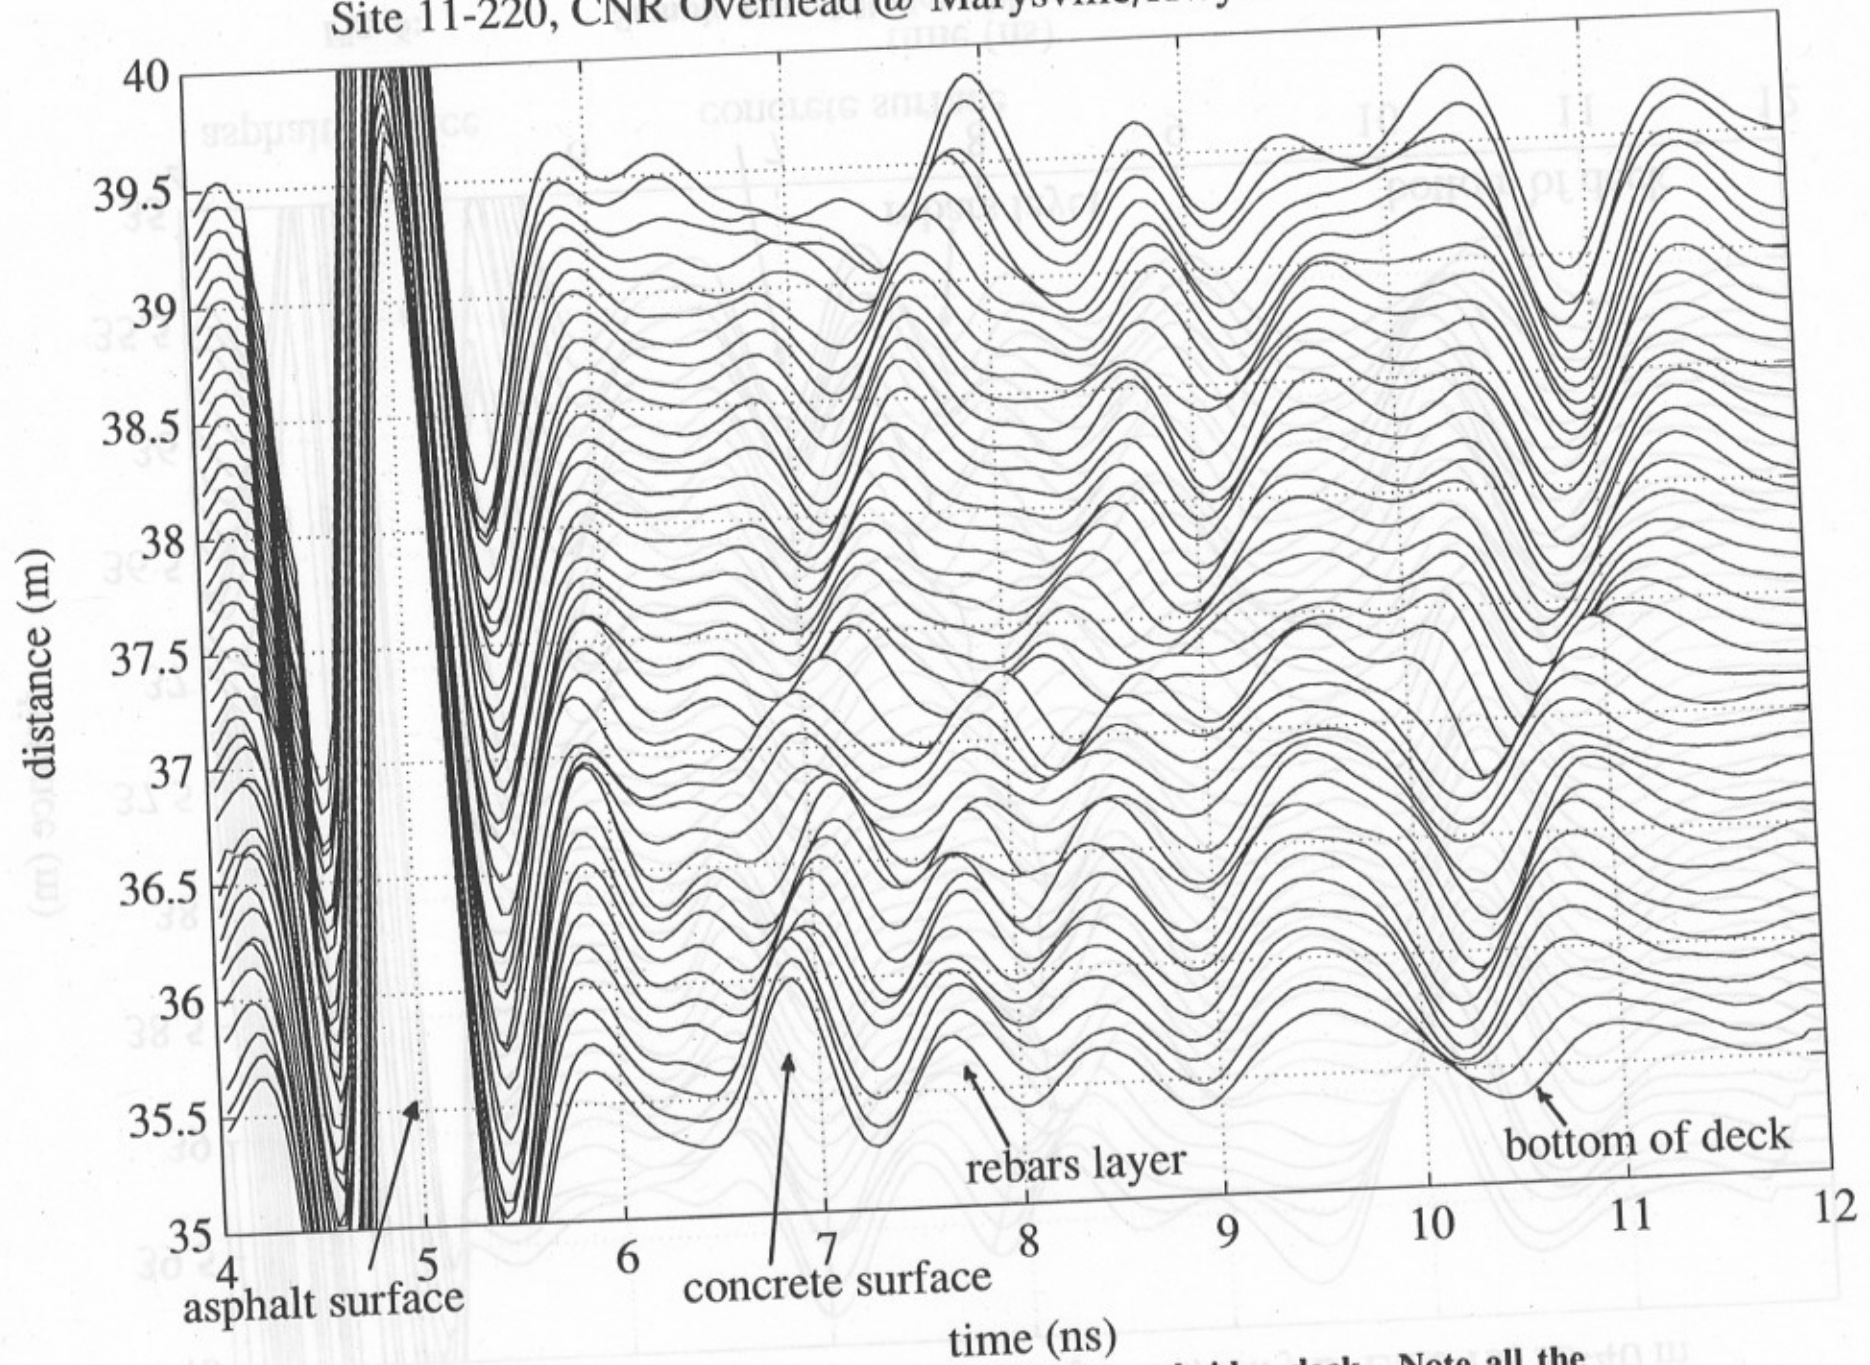
Fig. 5:

Sample waterfall plot from a bridge deck. Note all the radar traces are aligned at the asphalt surface reflection peak.

In normal operation, the vehicle is driven along the length of the bridge deck at approximately 5 km/h and data waveforms are collected at 100 mm intervals along the path. Figure 5 provides an actual waterfall plot of reflected waveforms taken at 100 mm intervals along one line of a bridge deck as measured by the fifth wheel. In this plot, the reflections from the air-asphalt boundary are aligned which then leads to identification of the asphalt-concrete interface, as shown. The top rebar layer can also be seen, although its identification is more difficult than that of the concrete surface. The bottom of the deck is clearly defined by the negative-going peaks near the ends of the traces. Other reflections can be useful, such as the reflection from the lower layer of reinforcement.

Figure 5 demonstrates the strength in presenting large amounts of data by using the waterfall plot technique. An important feature of this method is that it is possible to identify the asphalt-concrete interface peaks and align these traces based on this reflection, as illustrated in Fig. 6. It is then a simple matter to determine the asphalt thickness since the asphalt surface reflection is well-defined and the asphalt-concrete reflection is usually easily detected. The next step is to locate the reflection peak from the top layer of reinforcement which is now simplified as compared to Fig. 5, since alignment of the concrete surface reflections tends to align the rebar reflections. The cover over reinforcement can now be determined since both the concrete and the rebar reflections are available.

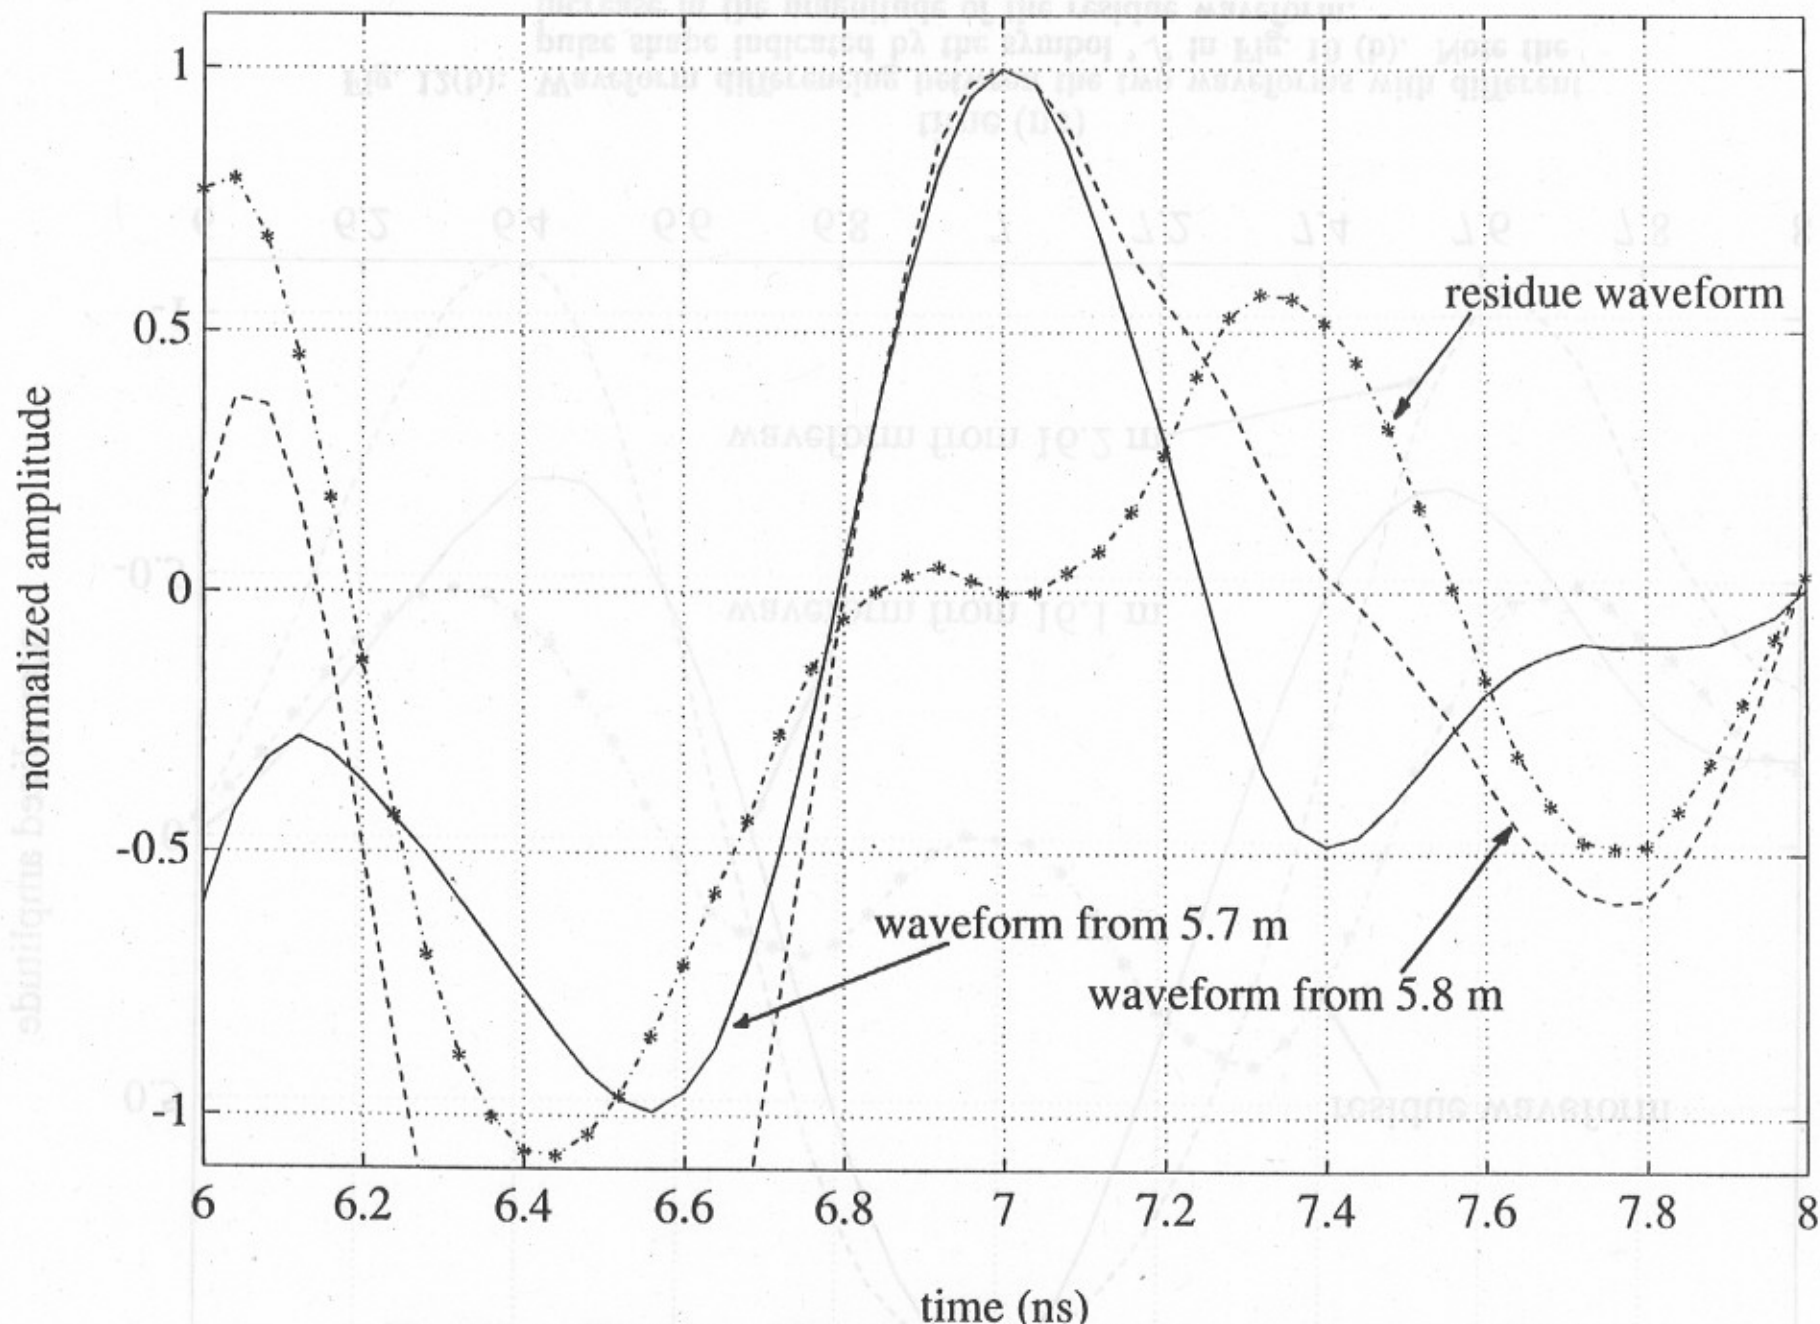
Fig. 12(a): Waveform differencing between the two waveforms with different pulse shape indicated by the symbol '√' in Fig. 10 (a). Note the increase in the magnitude of the residue waveform.

Sample plots are given in Figs. 11, 12(a) and 12(b) to demonstrate the waveform differencing technique. It is noted that different amplitudes among waveforms with similar pulse shape also increase the magnitude of the residue waveform. In order to reduce this secondary effect, all waveforms are normalized with respect to the reflection peak from the concrete surface. The subtraction of waveforms in Fig. 11 yields very low residues which means that the concrete around the area is in good condition. The residue waveforms in Figs. 12a and b show considerable activity which indicates damaged concrete.

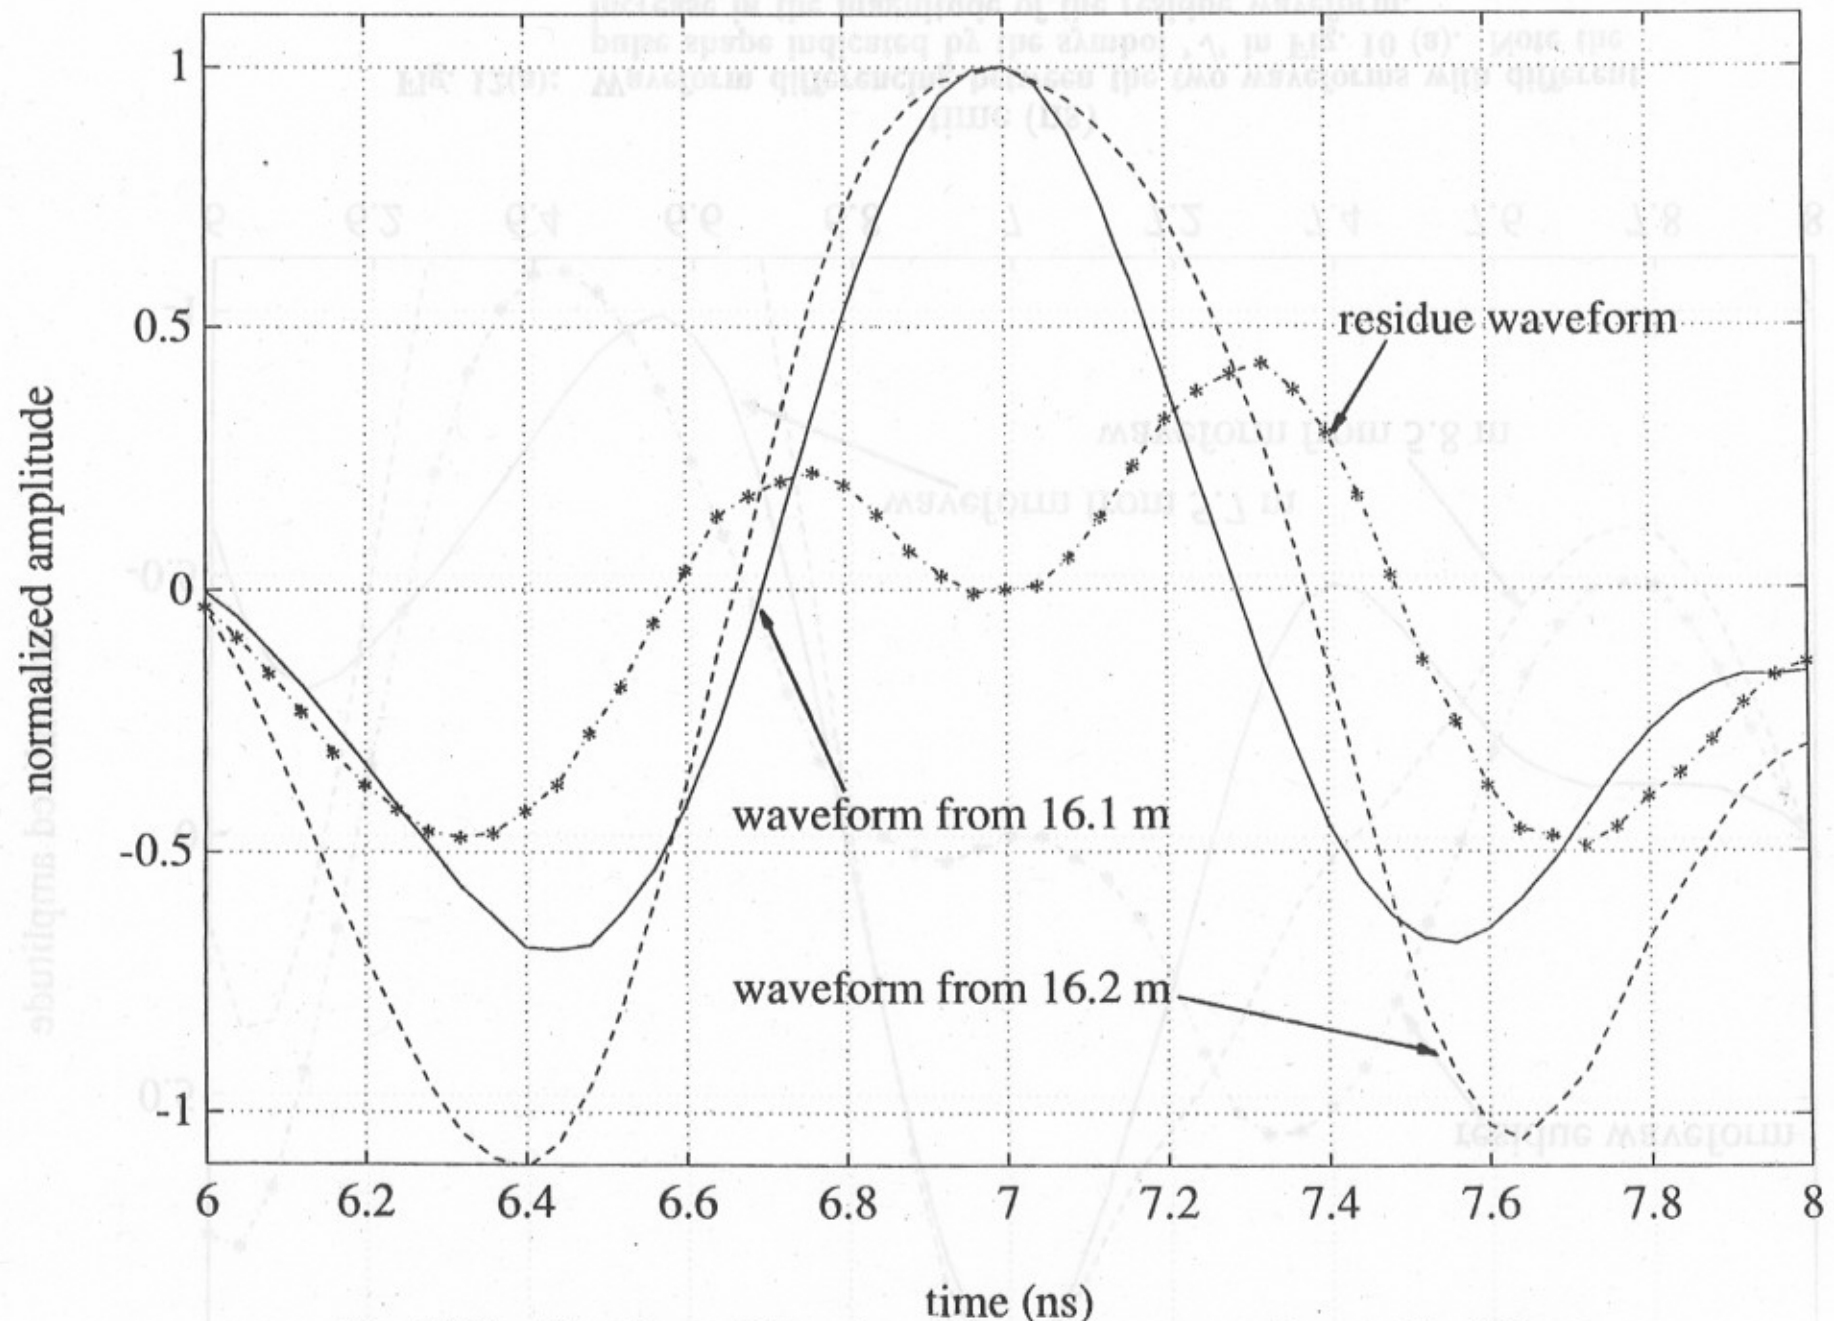
Fig. 12(b): Waveform differencing between the two waveforms with different pulse shape indicated by the symbol '√' in Fig. 10 (b). Note the increase in the magnitude of the residue waveform.

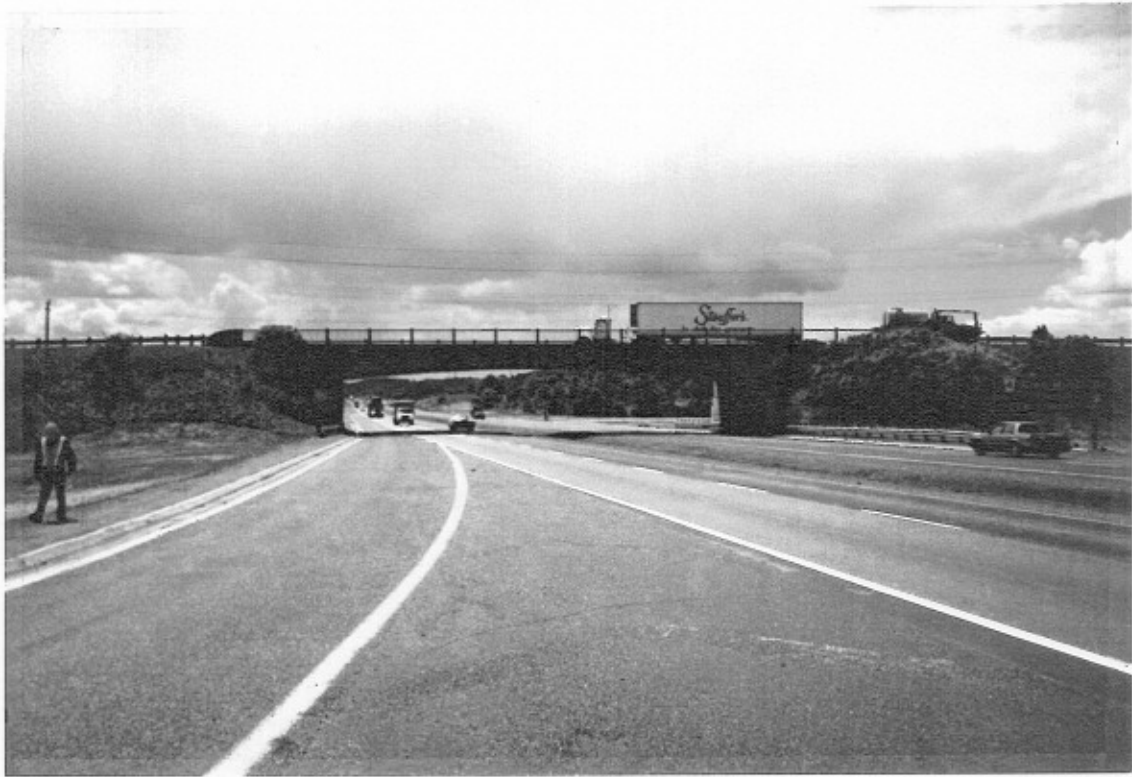
Fig. 13: **Photograph of the bridge deck - Glen Miller Road Underpass/Hwy 401 with the elevation from east.**

The correlation study involved 10 different bridge decks. The bridge deck selected here for illustrative purposes is the Glen Miller Road underpass located on Highway 401, near Trenton, Ontario, and is shown in the photograph of Fig. 13. The deck, 35.9 m in length, was constructed in 1956 and is a single span rigid frame with box beams. The reinforcing details are: 1) over the beams, #11 (30 mm) bars at 300 mm centres within 5 m from the abutment end and #11 bars at 300 mm centres in the rest of the span; 2) between beams, #6 (15 mm) longitudinal bars at 500 mm centres; and, 3) #6 (15 mm) transverse bars at 500 mm centres throughout.

- Fig. 13: Photograph of the bridge deck - Glen Miller Road Underpass/Hwy 401 with the elevation from east.
- Fig. 14: (a) Northbound curb lane looking North. Note surface damage to the asphalt.

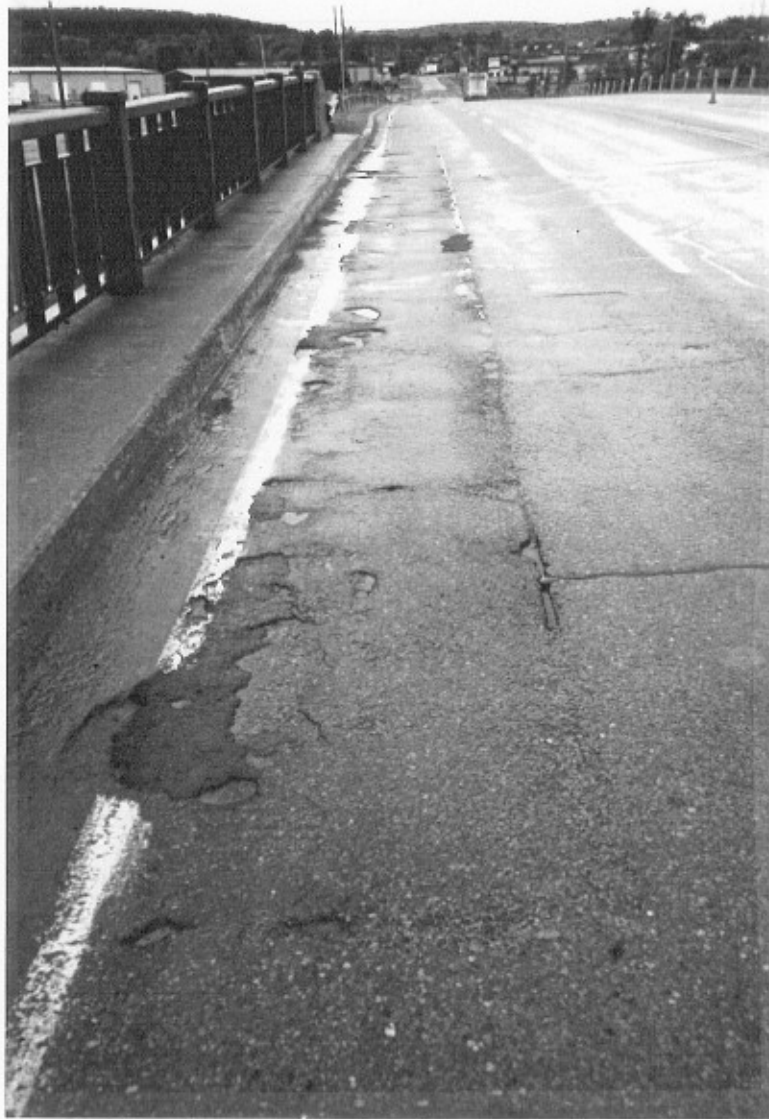
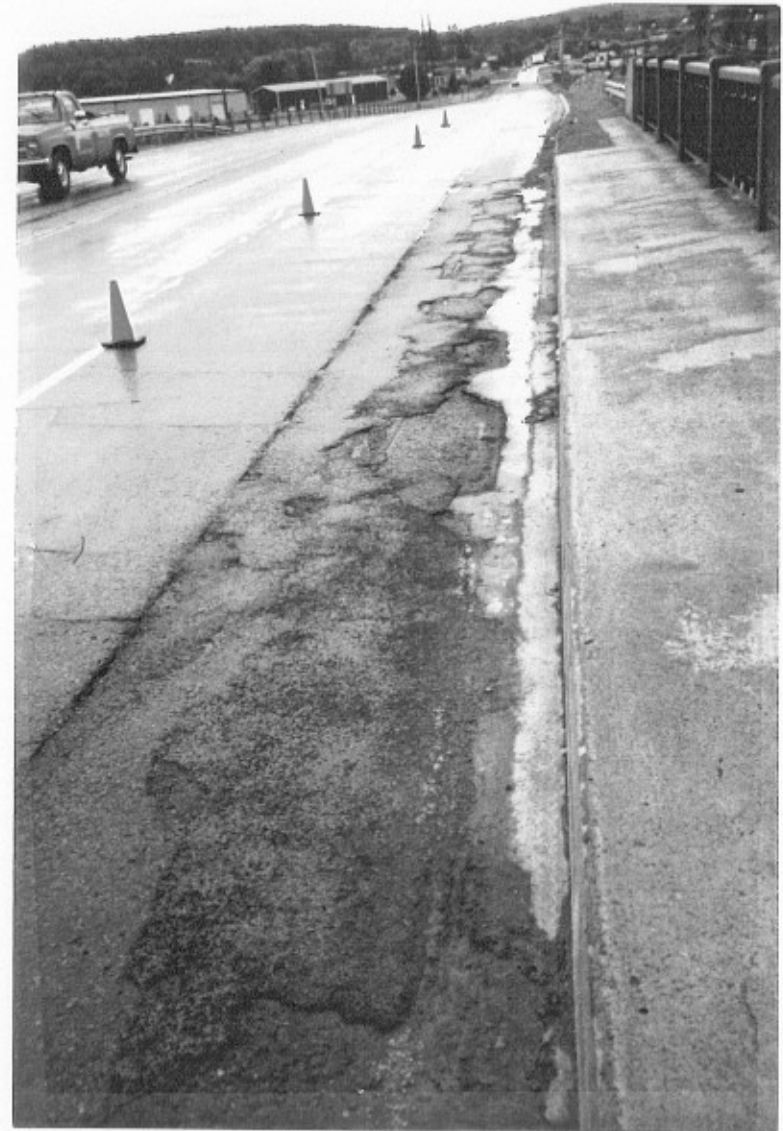
Fig. 14:

(b) Southbound curb lane looking North.

Note surface damage to asphalt on both curb lanes.

Figures 14(a) and 14(b) show photographs of the northbound curb lane looking north and the southbound curb lane looking north, respectively. In both photos, there appears to be considerable surface damage to the asphalt. It was decided to collect impulse radar data with DART along five lines spaced at 0.5 m intervals for each of the two curb lanes.

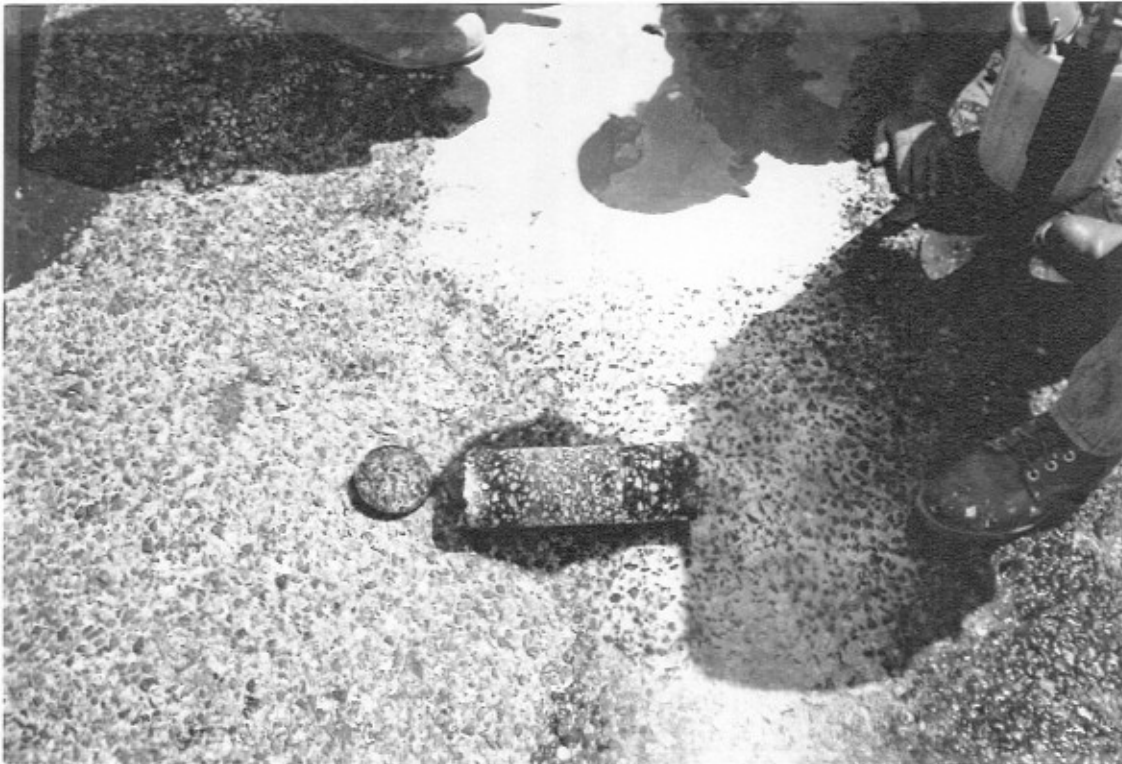
Fig. 15(a)-(b): (a) Photograph of core sample #1 taken at 1 m from the west curb and 8.6 m from the north end joint.
 (b) Photograph of core sample #2 taken at 2 m from the west curb and 18.75 m from the north end joint.

Two core samples were taken on the Northbound lane and one was taken on the Southbound lane (see Fig. 23). These core samples are depicted in the photographs of Fig. 15a, b and c and indicate good bonding at the asphalt/membrane/concrete interfaces. The asphalt thicknesses at core locations 1, 2 and 3 were found from the core samples to be 95 mm, 100 mm and 90 mm, respectively. The top transverse layer of steel was intersected by only the core sample at location 3 and the cover there was found to be 38 mm. This rebar was seen to be slightly rusted which is in agreement with the half-cell readings.

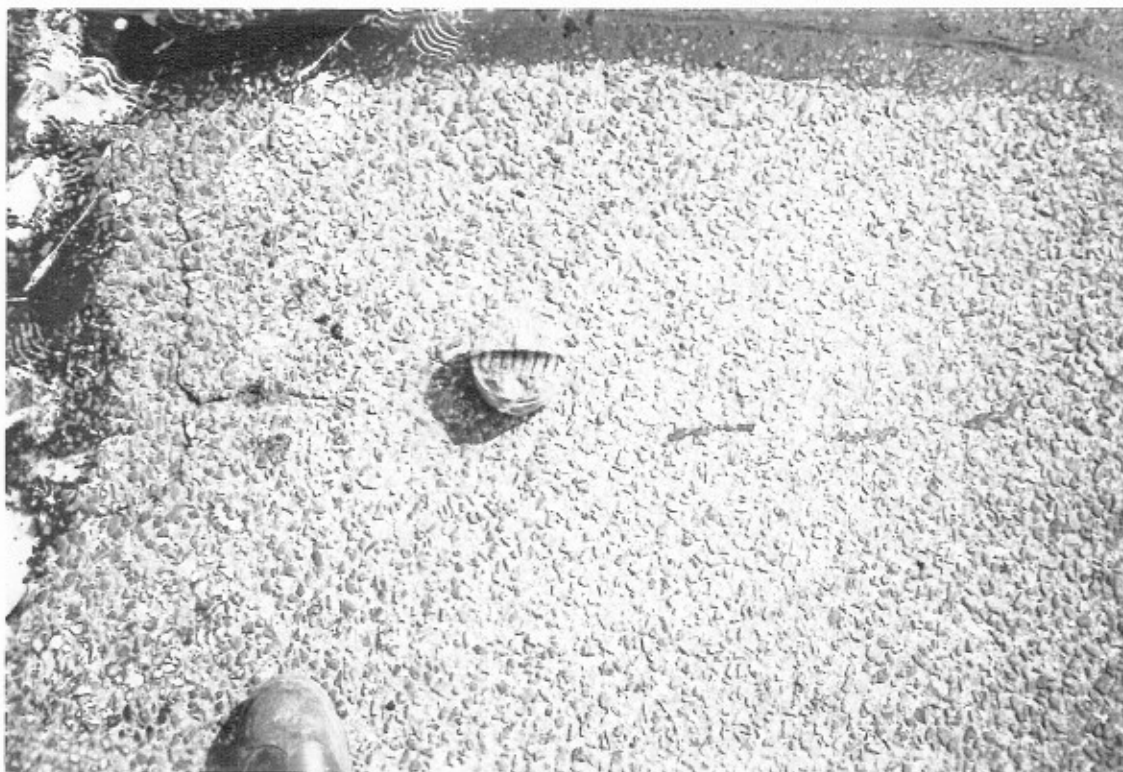
Fig. 15(c):

Photograph of core sample #3 taken at 12 m from the west curb and 13.8 m from the north end joint.

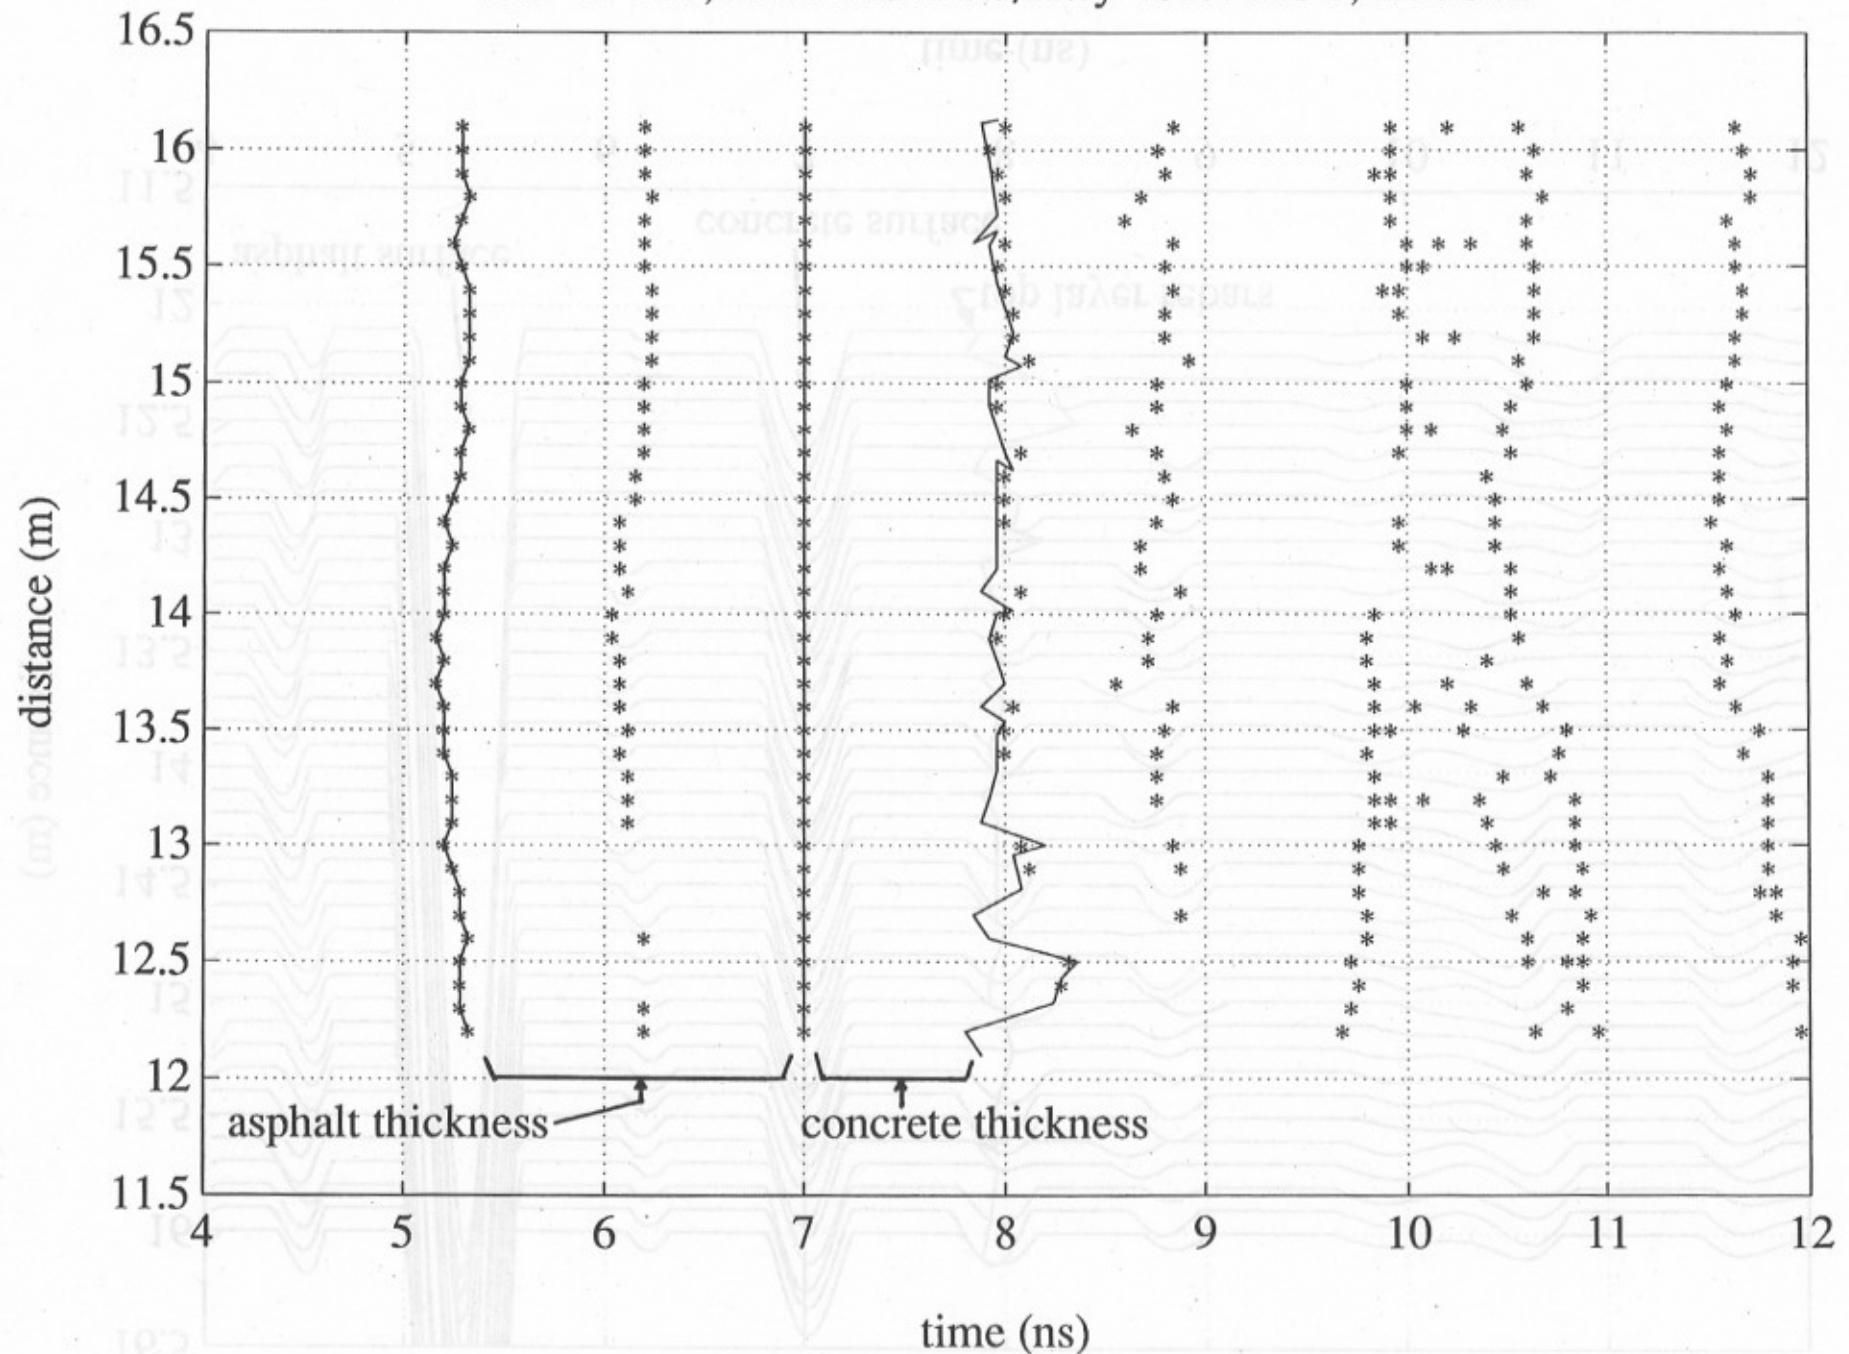
Fig. 18: Strata plots of the set of waveforms given in Fig. 17.

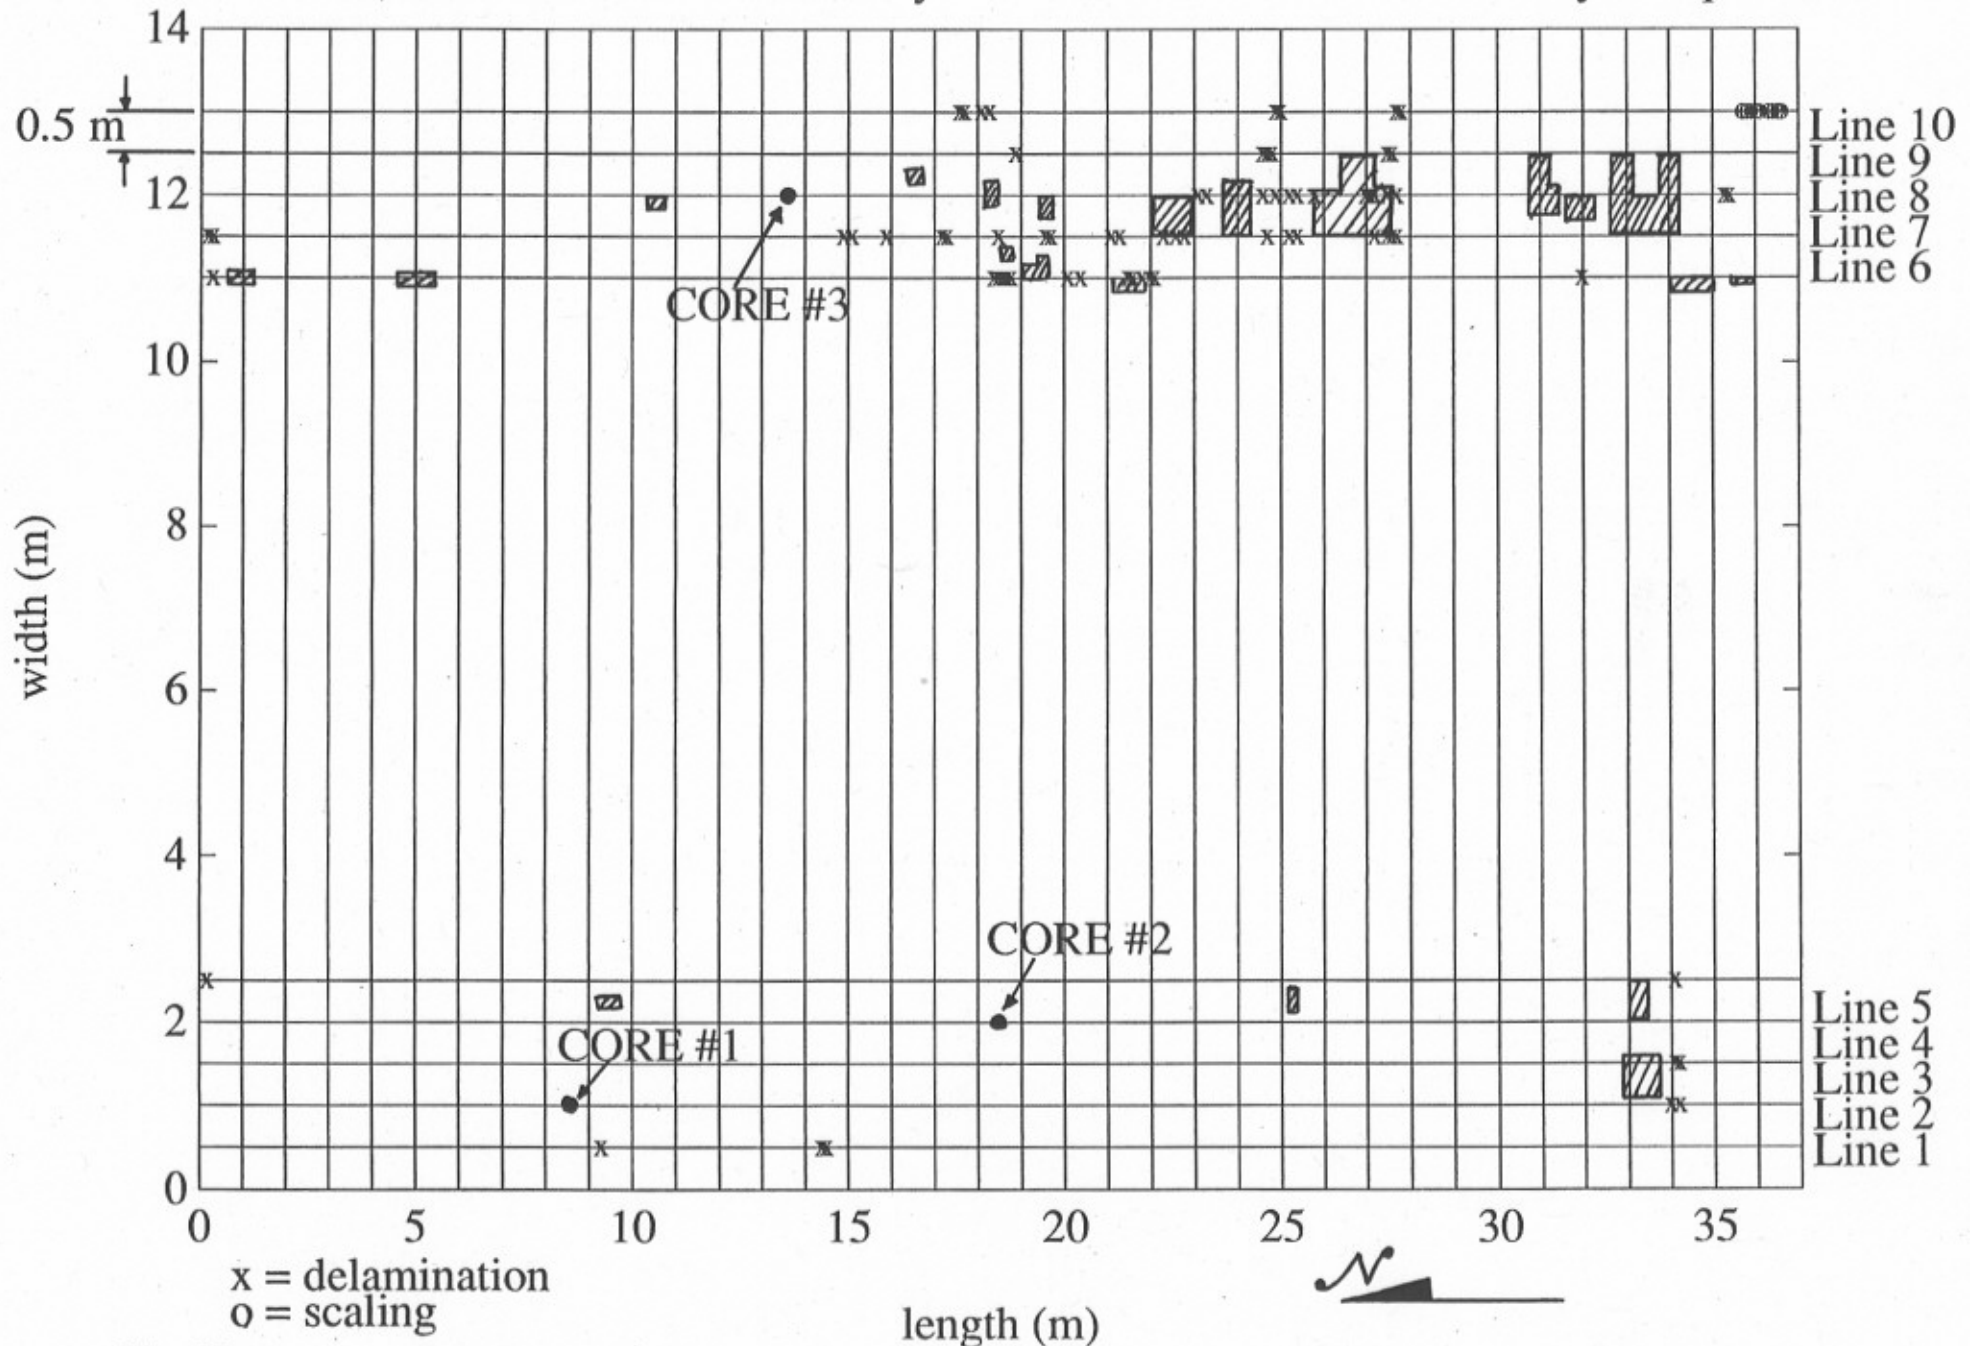
Fig. 23: Grip line map of the bridge deck indicating areas of delamination as predicted by DART survey (symbol 'x') and actual survey (shaded area). Note the locations of the three core samples are also marked on the map.

Table II provides the results of measuring the asphalt thickness (first entry) and the cover over top layer of reinforcement (second entry in brackets) with the line average being given at the bottom of each column. Table III furnishes the final results of concrete deterioration for each of the 10 lines as a percent of the total. Finally, a grid line map of the bridge deck is presented in Fig. 23 locating the areas of damage as indicated by the 'x' symbol.

Figure 24 is a photographic record of the Northbound lane of the bridge deck looking south with the asphalt removed. Details of damaged locations are presented in Fig. 25a, b, c, and d. where it is seen that significant portions of the deck suffer from delamination. Cover over reinforcement was measured for lines 1 to 5 from 25 m to 30 m, at 1 m intervals, using a covermeter and the results are given in Table IV. The areas of delamination obtained by using the chain drag method are represented in Fig. 23 by the shaded areas.

Comparison of the predictions of the DART and the actual damaged bridge deck for lines 1 to 10 is provided in Fig. 23. It is seen that there is good agreement except for the region between 30 m and 33 m on lines 7 to 9.

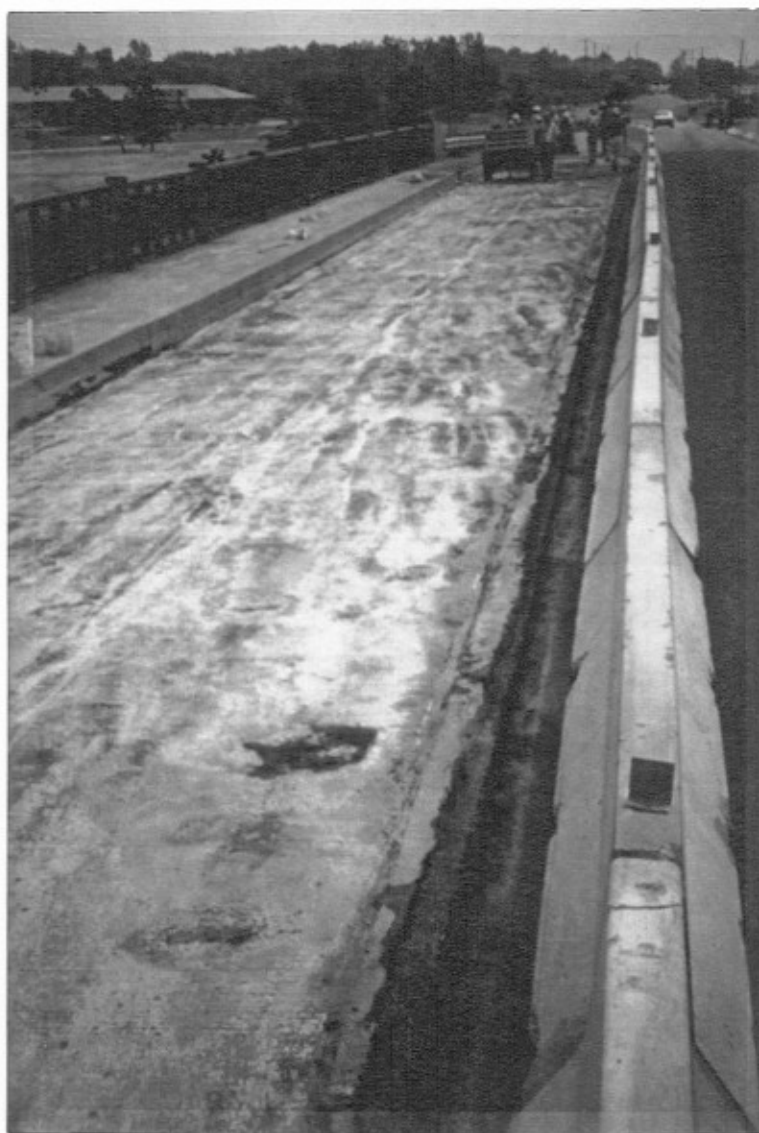
Fig. 24:

Photograph of the exposed concrete deck (with asphalt cover removed) along the Northbound lane looking south.
