Report SO 93-08

IMPULSE RADAR STRATEGIES

FOR BRIDGE DECK ASSESSMENT

March 1993

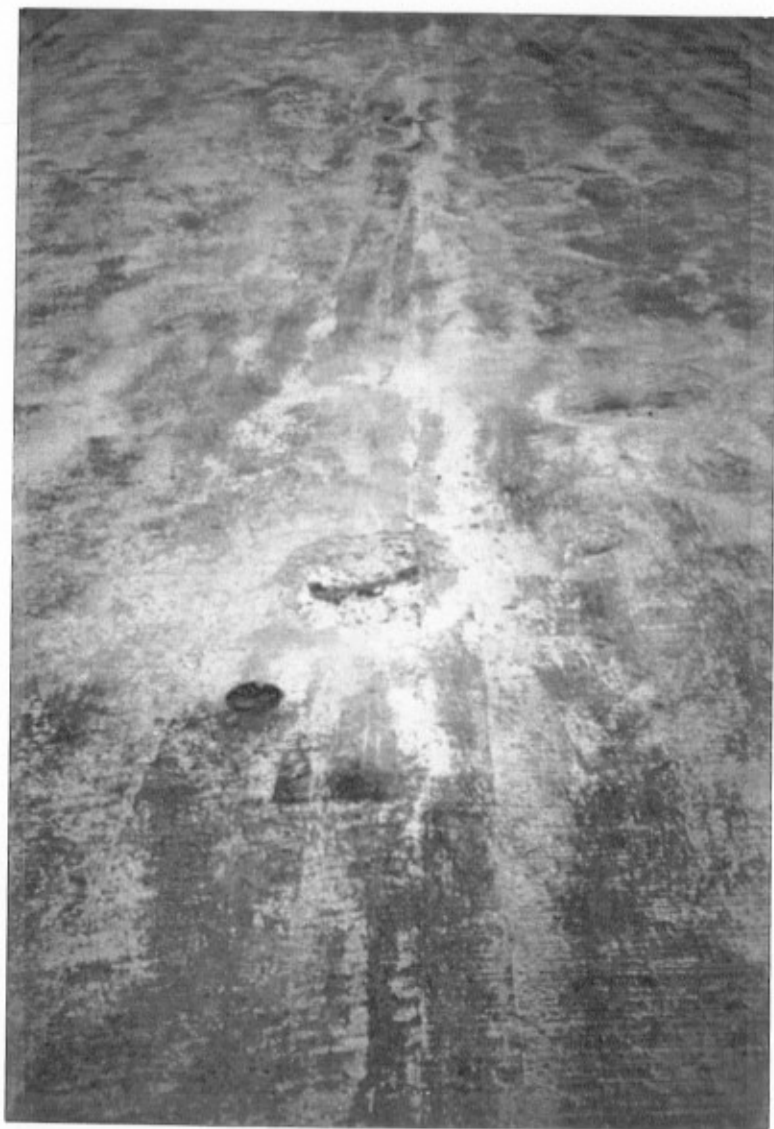
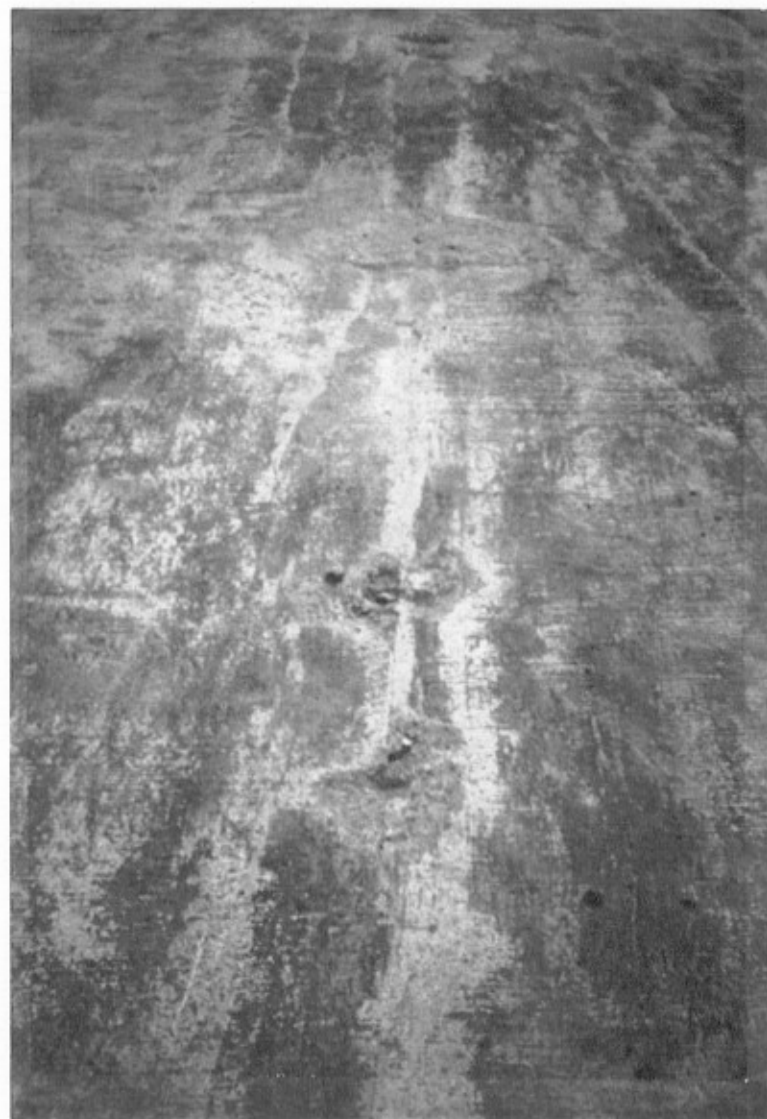
Fig. 25(a)-(b): Photographs of the exposed concrete deck (looking south) along line 7.
(a) from 18 m to 22 m from the north end joint.
(b) from 22 m to 26 m from the north end joint.

Figure 24 is a photographic record of the Northbound lane of the bridge deck looking south with the asphalt removed. Details of damaged locations are presented in Fig. 25a, b, c, and d. where it is seen that significant portions of the deck suffer from delamination. Cover over reinforcement was measured for lines 1 to 5 from 25 m to 30 m, at 1 m intervals, using a covermeter and the results are given in Table IV. The areas of delamination obtained by using the chain drag method are represented in Fig. 23 by the shaded areas.

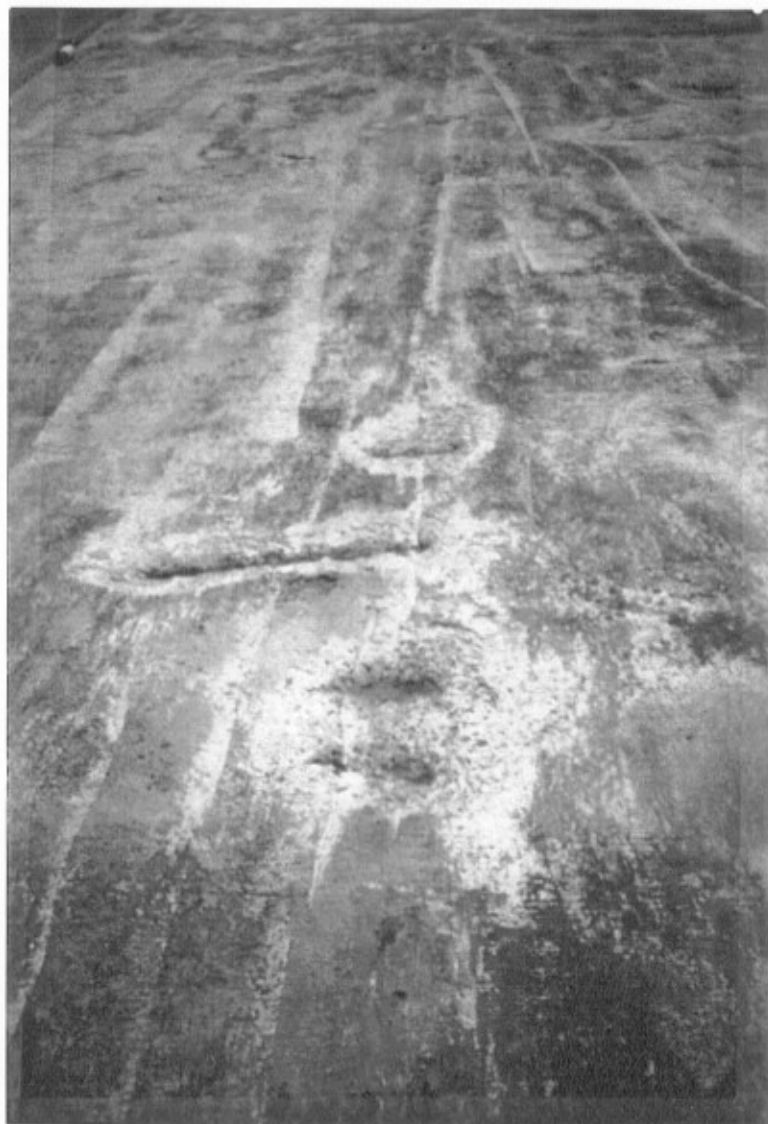
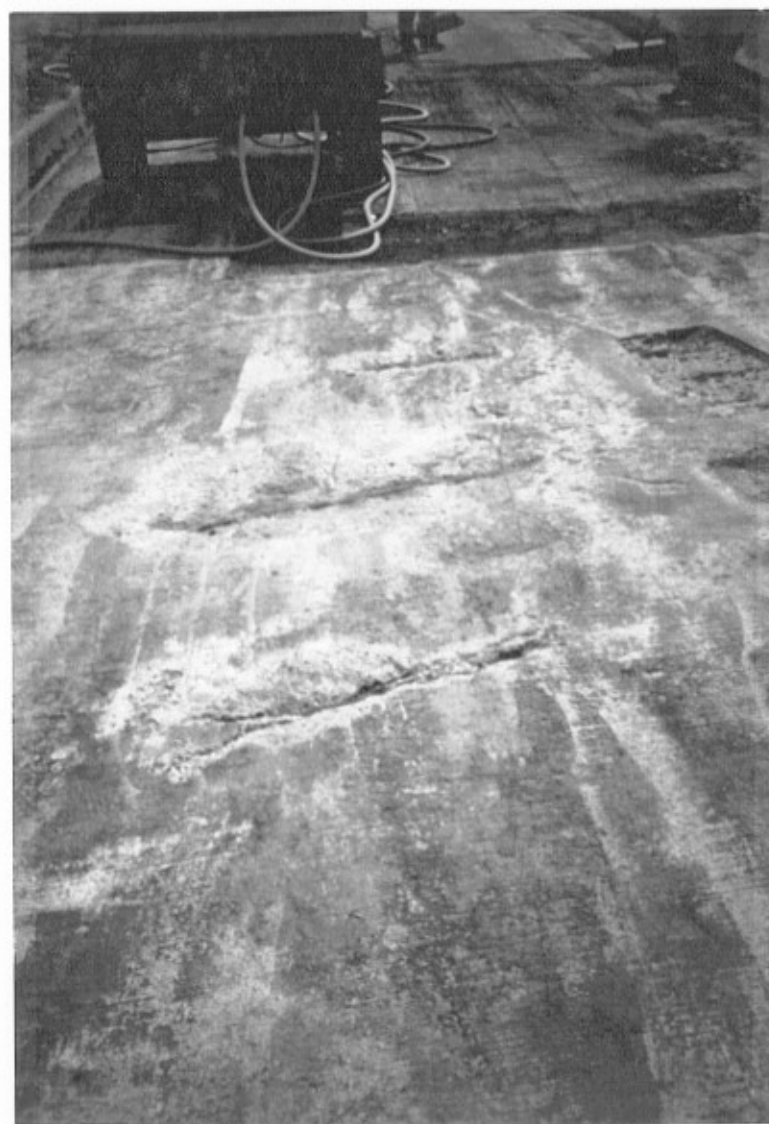
Fig. 25(c)-(d): Photographs of the exposed concrete deck (looking south) along line 7.
(c) from 26 m to 28 m from the north end joint.
(d) from 33 m to 35 m from the north end joint.
