Ministry of
Transportation and
Communications

REPORT EM- 50

INVESTIGATION OF
PERFORMANCE OF GRANULAR BASE AGGREGATES
FROM THE
DUNDEE & DETROIT RIVER CARBONATE ROCKS
IN ESSEX COUNTY

by
Z. Koniuszy, P. Eng.
Geologist
and
Z.L. Katona, P. Eng.
Senior Aggregate Resources Engineer

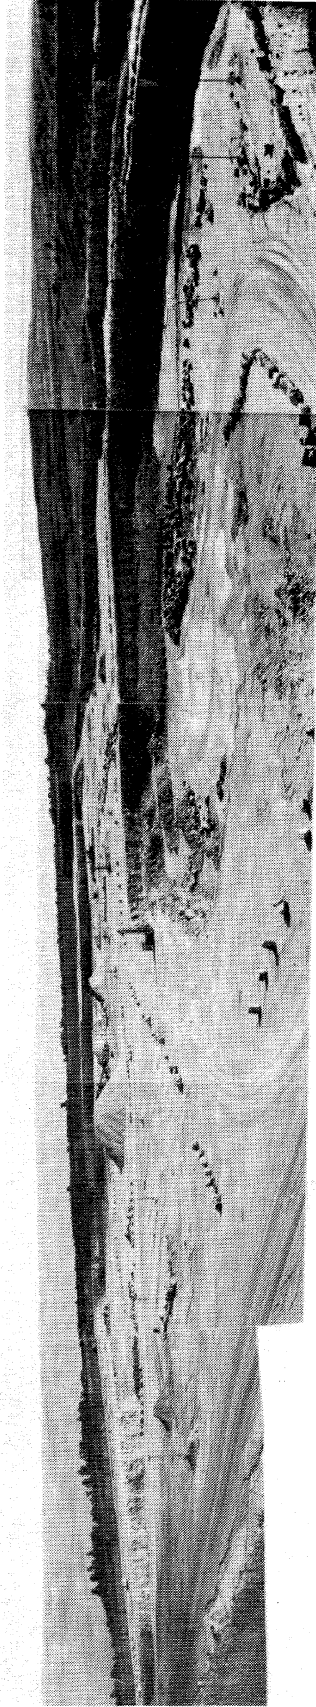
Photo 1

General view from the north

The McGregor Quarry is located on Lot 10, Concession VI and VII of Anderdon Township, about 9 km south of Windsor city limits on the west side of Essex County Road No. 9. A general view of the quarry from the north is presented on Photo 1.

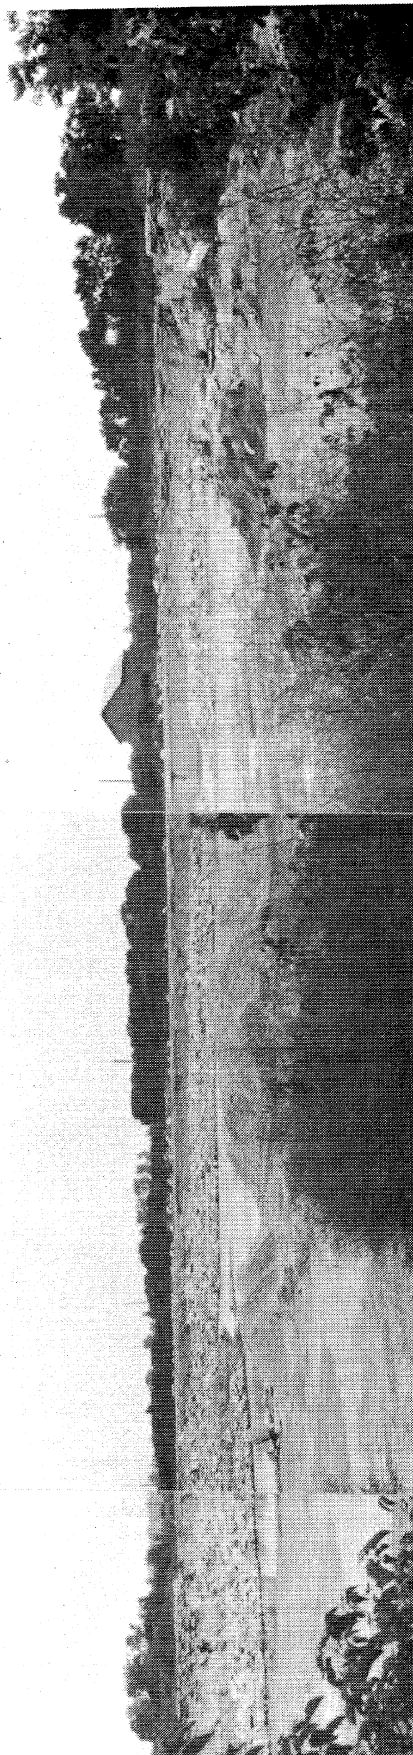
Photo 3

General view from the west

The quarry is located in the northern part of Pelee Island in lots 1 and 2. A general view of the quarry from the west is presented on Photo 3.

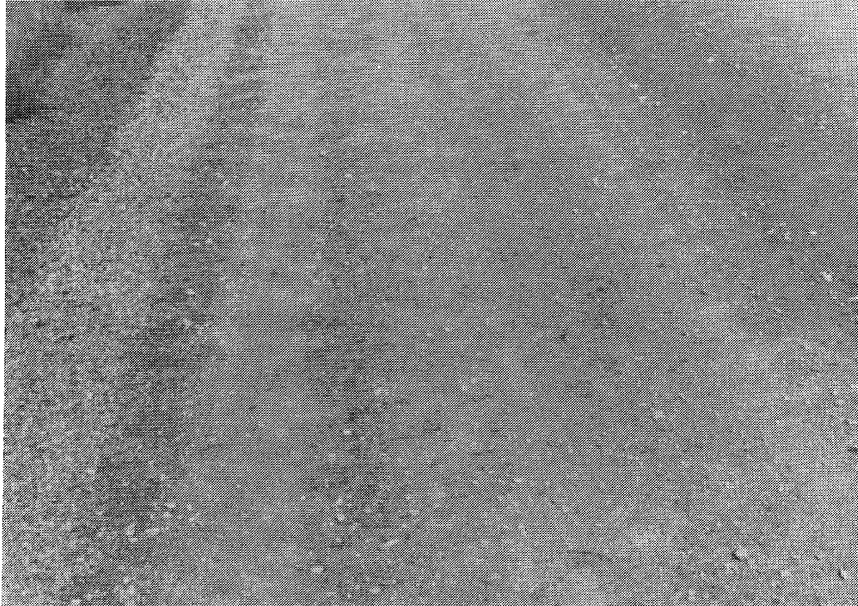
Photo 4

TYPICAL PERFORMANCE OF GRANULAR A
FROM ALLIED CHEMICAL LTD. MCGREGOR QUARRY
(upper level)

Unpaved road surface after one year of service.

Note:
The well com-
pacted relatively
smooth surface.

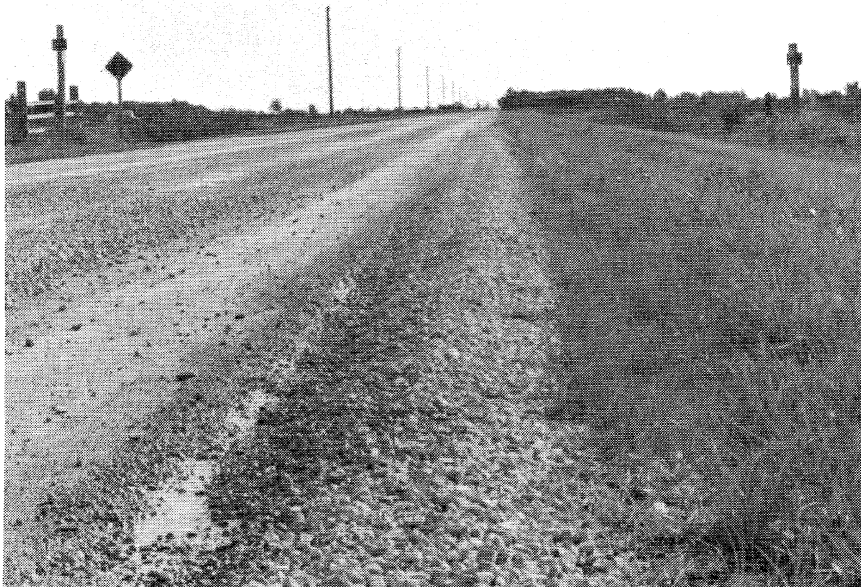
Photo 5

Note:
The numerous
stones ravelled
from the road
surface and
deposited on the
shoulder.

- 10.4 THE UPPER LIFT OF THE ALLIED CHEMICAL LTD., MCGREGOR QUARRY CONTAINS ROCK OF HIGH QUALITY SUITABLE FOR ALL AGGREGATE USES. THE LACK OF FINES FROM THIS LIFT CAUSES SOME DIFFICULTY IN COMPACTION AS WELL AS LOSS OF STONES WHEN USED ON UNTREATED OR UNPAVED GRANULAR SURFACE ROADS.

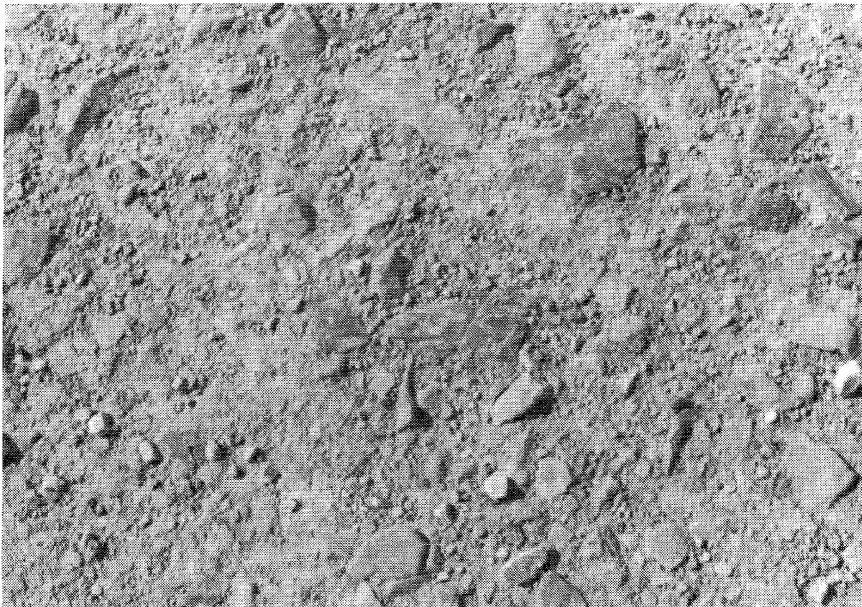
Photo 6

Close up of road surface. Note the edges of stones also the well compacted nature of the surface.

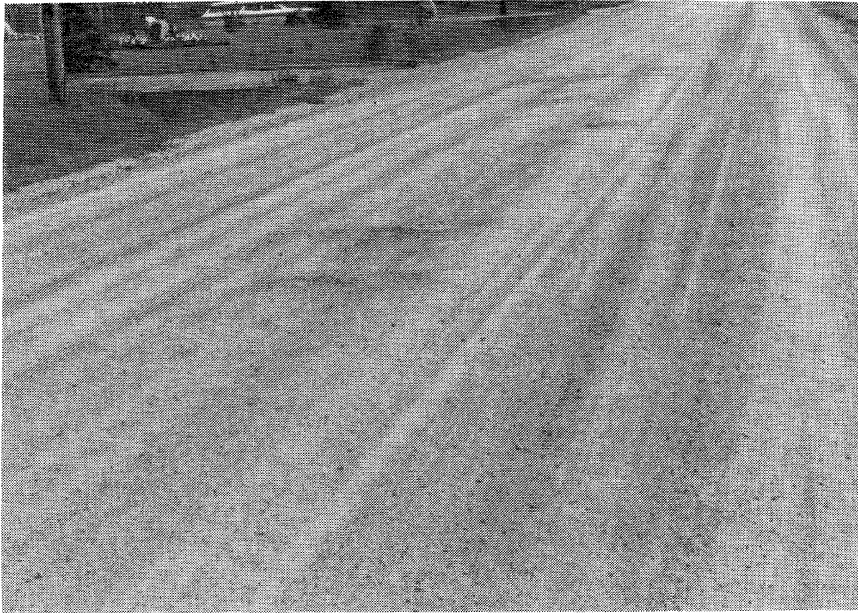
Photo 7

TYPICAL PERFORMANCE OF GRANULAR A
FROM AMHERST QUARRIES (1969) LTD.

Unpaved road surface after one year of service.

Note:
The well
compacted relative-
ly smooth surface.

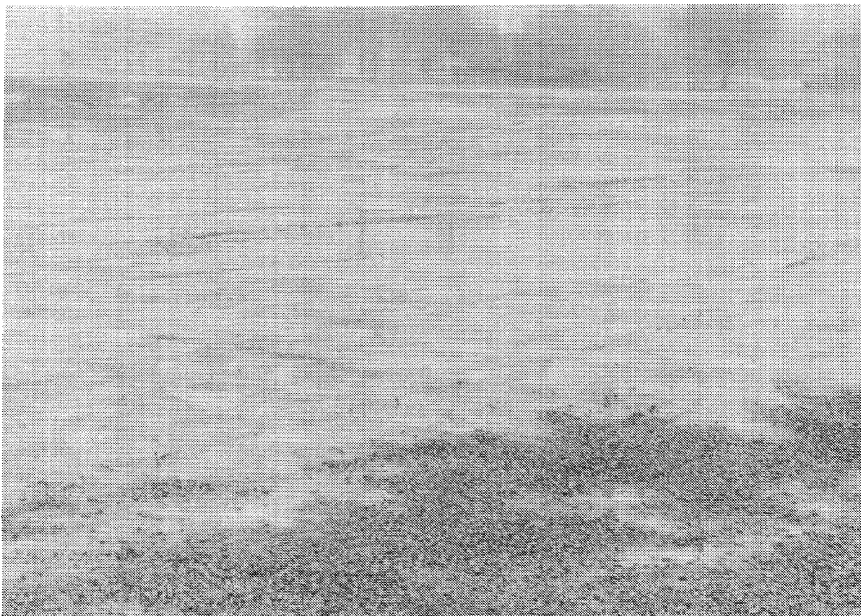
Parking lot of Malden Township office.

"Soupy" over-saturated condition of the granular surface during spring melting.

Due to the prevailing flat terrain, this condition is especially severe during the spring thaw when the subgrade and earth material underneath the surface are still frozen. Photo 10 of the parking lot of the Malden Township Office illustrates this.

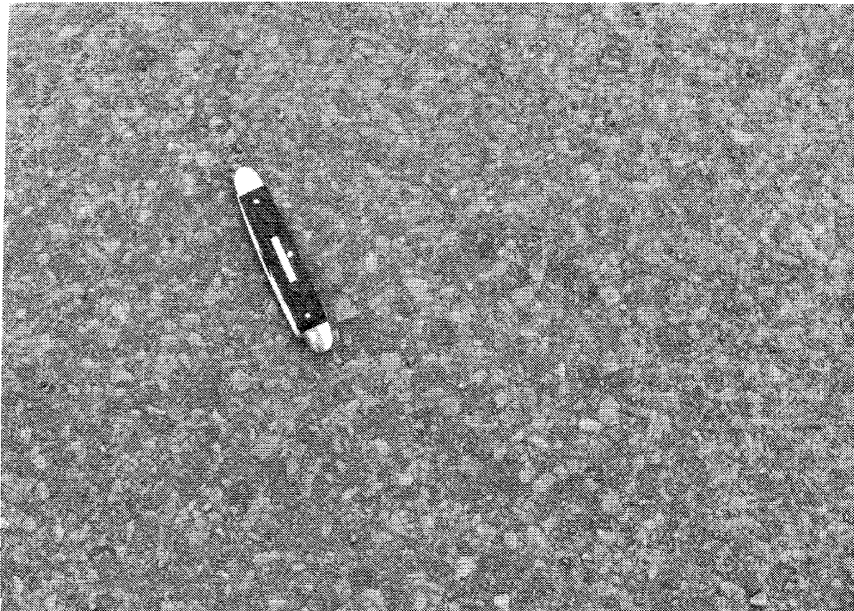
TYPICAL PERFORMANCE OF GRANULAR A
FROM PELEE ISLAND QUARRIES INC.

Location - Pelee
Island, main road,
north of the
village.

as above
- close up

Pelee Island
surface treated
road in front of
restuarant at
west dock.

loose stone on the shoulder. The stone particles are slightly worn but do not show any deterioration. It should be noted that the performance exhibited was the result of relatively light traffic and a very limited use (if any) of de-icing road salts. The average performance is illustrated on Photos No. 11 to 13.

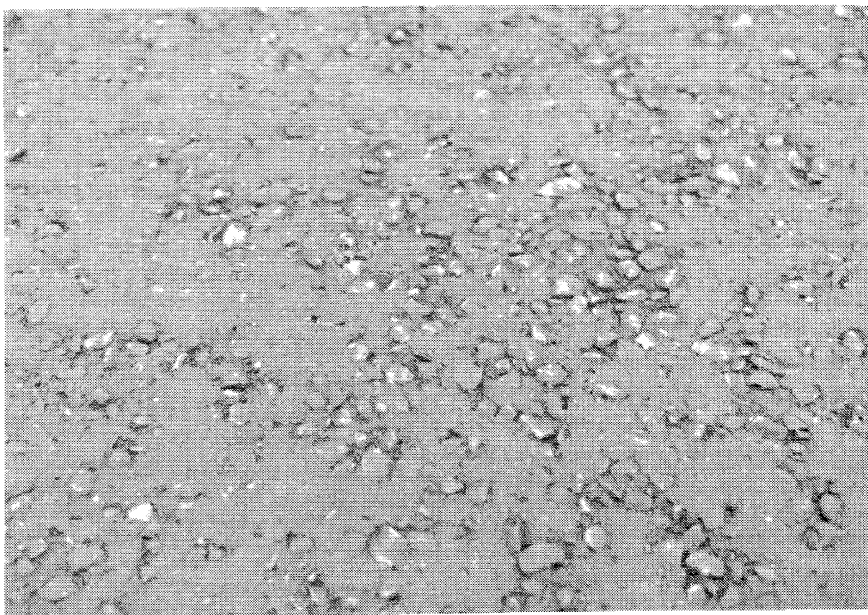
Average pavement condition.

Close up of average pavement.

Note:
Loss of
coarse aggregate.

was also inspected. It was found that the particles were only very slightly affected by the traffic wear. In areas, the pavement shows loss of stones but it was observed to be the result of ravelling caused by excessive speed in paving in order to meet the designated completion date last fall. The pavement condition is shown on Photos No. 14, 15 and 16.

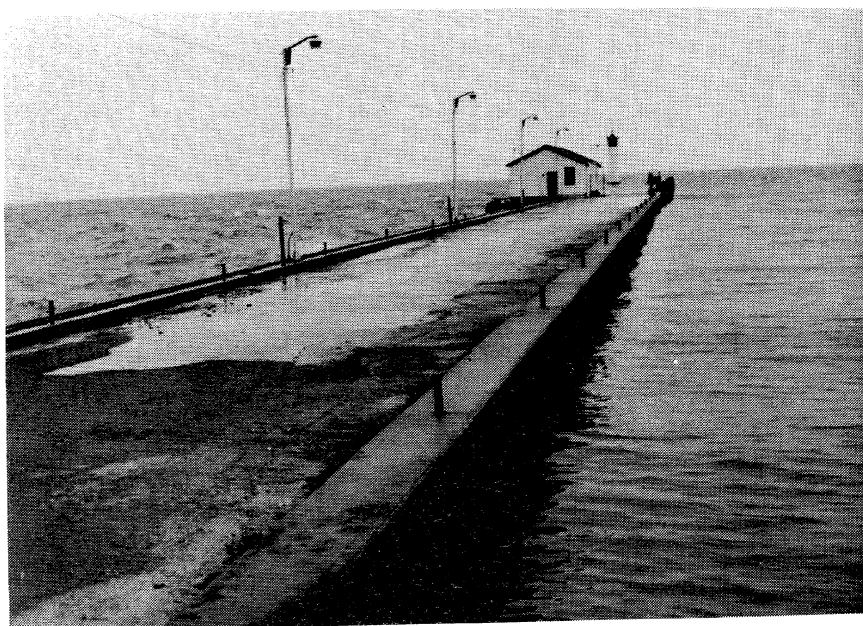
Photo 17

WEST DOCK, PELEE ISLAND

Looking west from
main road.

M.T.C. investigation of the west dock on Pelee Island in the fall of 1980 found that the 20 year old concrete using coarse aggregate produced from the Pelee Quarries Inc. exhibits satisfactory durability in wetting and drying and freezing and thawing conditions in a salt free environment. This performance is illustrated on Photos No. 17, 18 and 19. The dock was built before the '30s and was reconstructed several times - 1935 and 1959 to 1961.
