Maintenance of the Highway Infrastructure: Cathodic Protection of Bridges

Author(s)	D.G. Manning
Report Number(s)	ONT-022
Date of Publication:	March 1985
Ministry Contact:	Materials Research Office 235-4740
Published by:	R&D
Abstract	<p>The corrosion of embedded reinforcement caused by the presence of chloride ions in the concrete causes serious deterioration in highway structures. Cathodic protection is the only method currently available of arresting active corrosion. It consists of applying sufficient electrical current to the surface of the reinforcing steel to prevent it from discharging ions so that corrosion does not occur.</p> <p>The technology for the cathodic protection of steel in concrete is relatively new. Ontario is the only jurisdiction to utilize this method routinely in the rehabilitation of corrosion-damaged bridge decks. The system which is used consists of cast iron anodes positioned in recesses on the deck and a secondary anode of electrically conductive bituminous concrete over the entire deck surface. Current is supplied to the deck anodes by a transformer-rectifier.</p> <p>Research studies were initiated in 1981 to develop a viable method of applying cathod

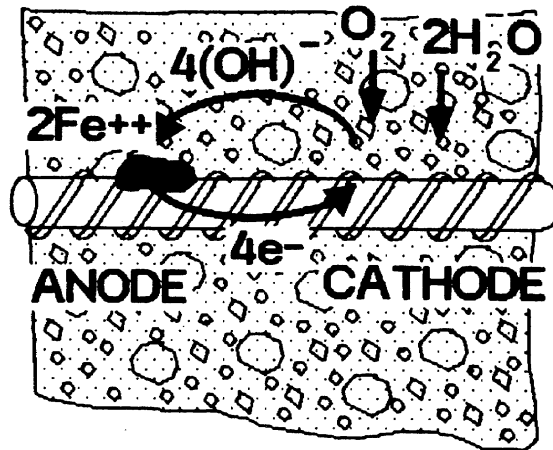
Figure 1/ Simplified Model of the Corrosion of Steel in Concrete

Corrosion is an electrochemical process and, for an electrochemical cell to function, four basic elements are necessary: an anode, where corrosion takes place; a cathode, which does not corrode but maintains the ionic balance of the corrosion reactions; an electrolyte, which is a solution capable of conducting electric current by ionic flow; and a conductor which connects the anode and cathode. In the case of steel in concrete, the anodes and cathodes occur on the reinforcing steel, which also acts as the conductor; moist concrete acts as the electrolyte. This is illustrated schematically in Figure 1. Figure 2 shows the distinct anodes and cathodes which are visible when corroding reinforcing steel is exposed.

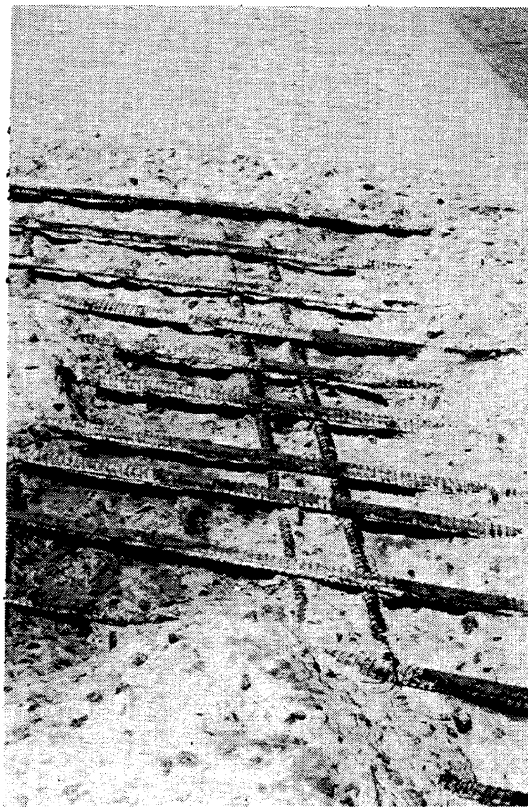
Figure 2/ Corrosion of Steel in Concrete Showing Anodic (Rusted) and Cathodic Areas

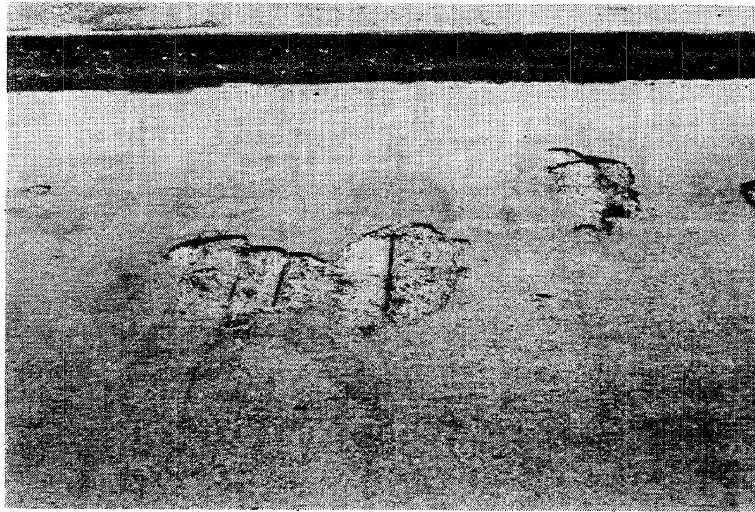
Figure 3/ Typical Corrosion-Induced Distress in a Bridge Deck

As the steel corrodes, the corrosion products (rust) occupy more volume than the parent iron, thereby exerting stresses on the concrete. This results in cracking of the concrete. The cracking often causes a fracture plane or delamination at or near the level of the reinforcement. As the corrosion processes continue, delaminated concrete eventually becomes detached from the concrete member, resulting in a spall. Typical examples of corrosion-induced distress in bridge decks and in substructure components are shown in Figures 3 and 4 respectively.

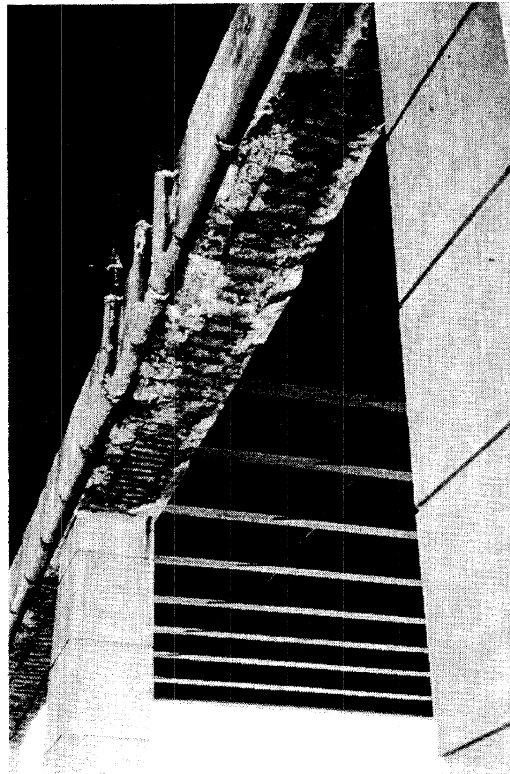
Figure 4/ Typical Corrosion-Induced Distress in Bridge Columns

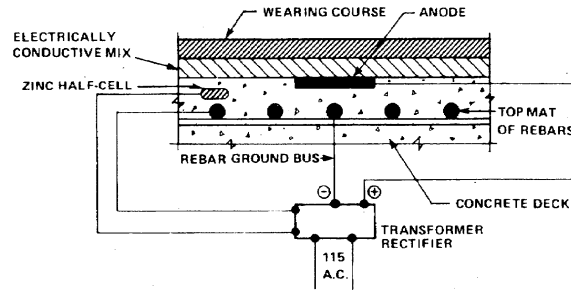
Figure 5/ Cathodic Protection Circuit Schematic Representation of Bridge Deck

A schematic representation of the cathodic protection system used by the Ministry is shown in Figure 5. The essential components of the cathodic protection system are:

- i) A dc power supply (rectifier).
- ii) Current distribution system (anodes).
- iii) Electrical connections to protected metal (rebar grounds).
- iv) Evaluation and control devices (probes, reference cells, controllers).

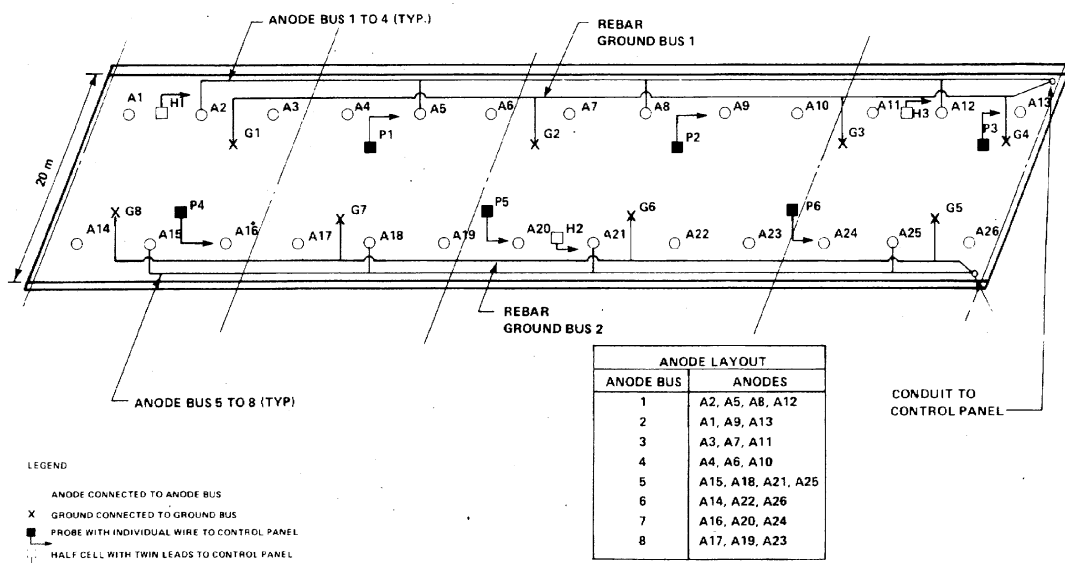
Figure 6/ Typical Placement of Anodes, Rebar Grounds, Probes and Half-Cells on a Wide Bridge

A typical placement of the components on a bridge between 10 and 20 m wide is shown in Figure 6. Current flows from the rectifier to the anodes

and through the concrete to the reinforcing steel. A connection between the reinforcing steel and the rectifier completes the circuit.

The primary anodes are disc-shaped cast-iron anodes which are embedded in the deck surface. One anode is provided for each 50 to 75 m² of deck area. The anodes are placed in lines with normally not more than 15 m between lines. A 40 mm thick layer of electrically conductive asphalt is placed over the entire deck surface and acts as a secondary anode. The conductive layer is covered with a 40 mm thick wearing surface of bituminous concrete.

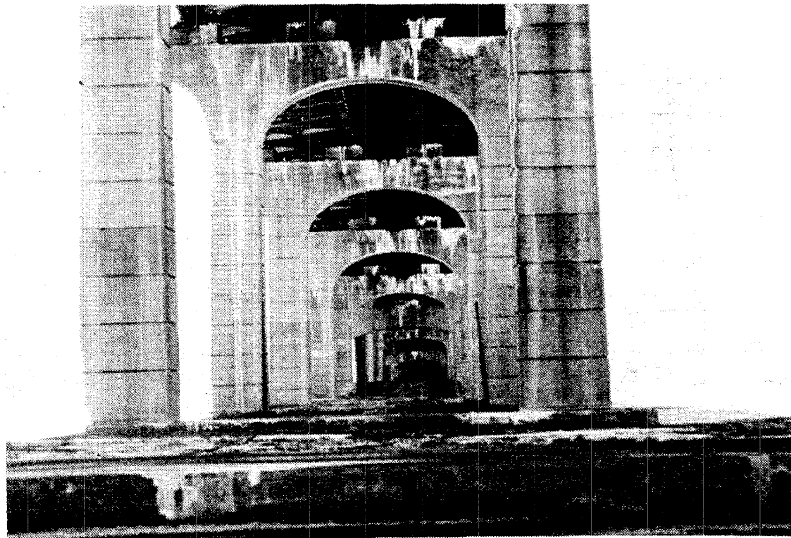
Figure 8/ Salt Staining on Pier Bents, Burlington Bay Skyway

The Burlington Bay Skyway bridge is a multiple span, high level structure over the entrance to Hamilton Harbour in Southern Ontario. It was selected as a test site because corrosion was occurring in the columns as a result of exposure to surface run-off, containing deicing salts, from the deck. Salt-staining is frequently visible in the winter months as shown in Figure 8.

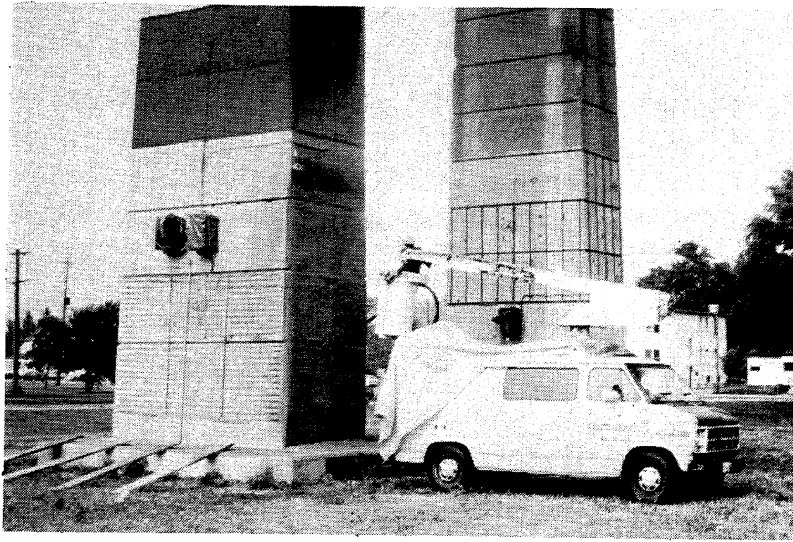
Figure 9/ Systems 1, 2, and 3 Under Construction, August 1982
System 1 is on the right column; System 2 (upper) and
3 (lower) are on the left column

Figure 9 shows Systems 1, 2, and 3 under construction. Systems 5, 6, and 7 are shown in Figures 10, 11, and 12 respectively.

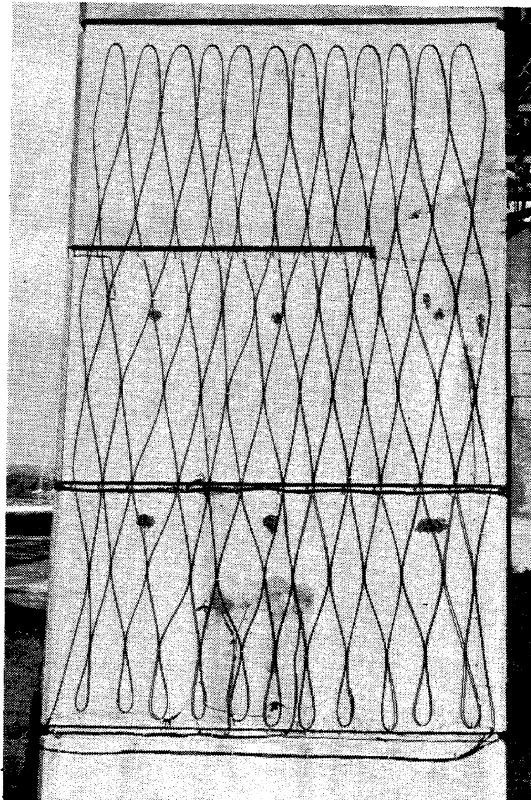
Figure 10/ System 5 Prior to Shotcreting

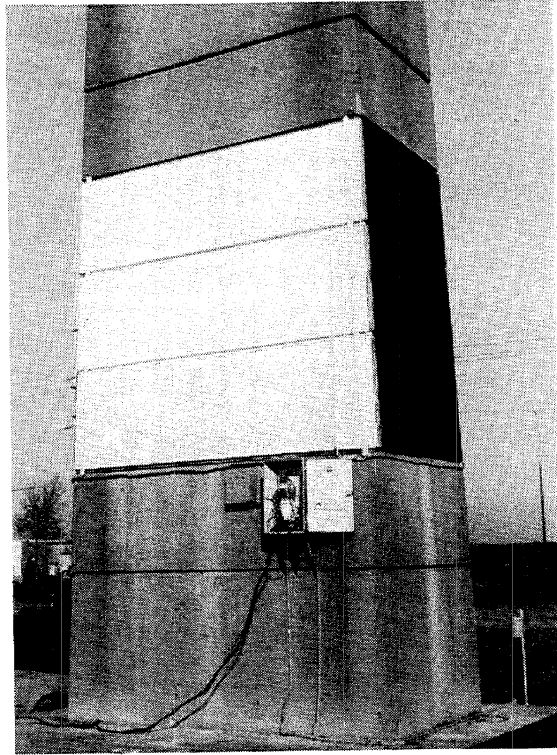
Figure 11/ System 6 Showing the South Face with Exposed Conductive Paint and the West Face with a Latex Paint Overcoat

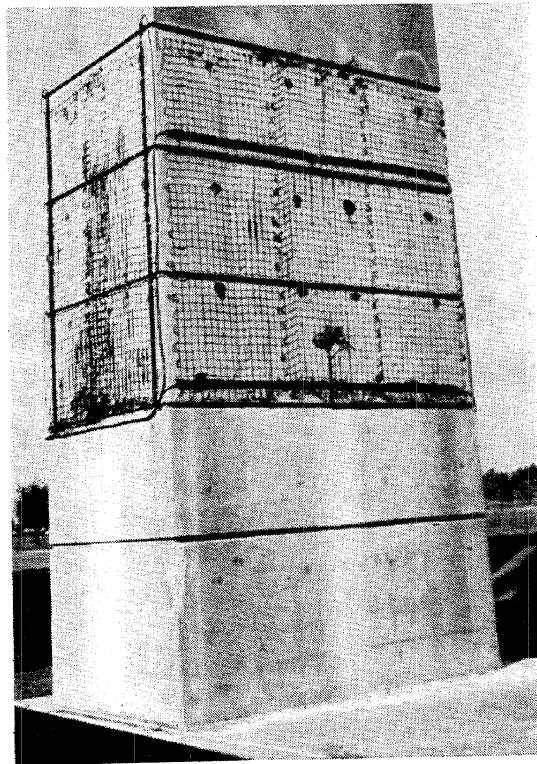
Figure 12/ System 7 Prior to Shotcreting

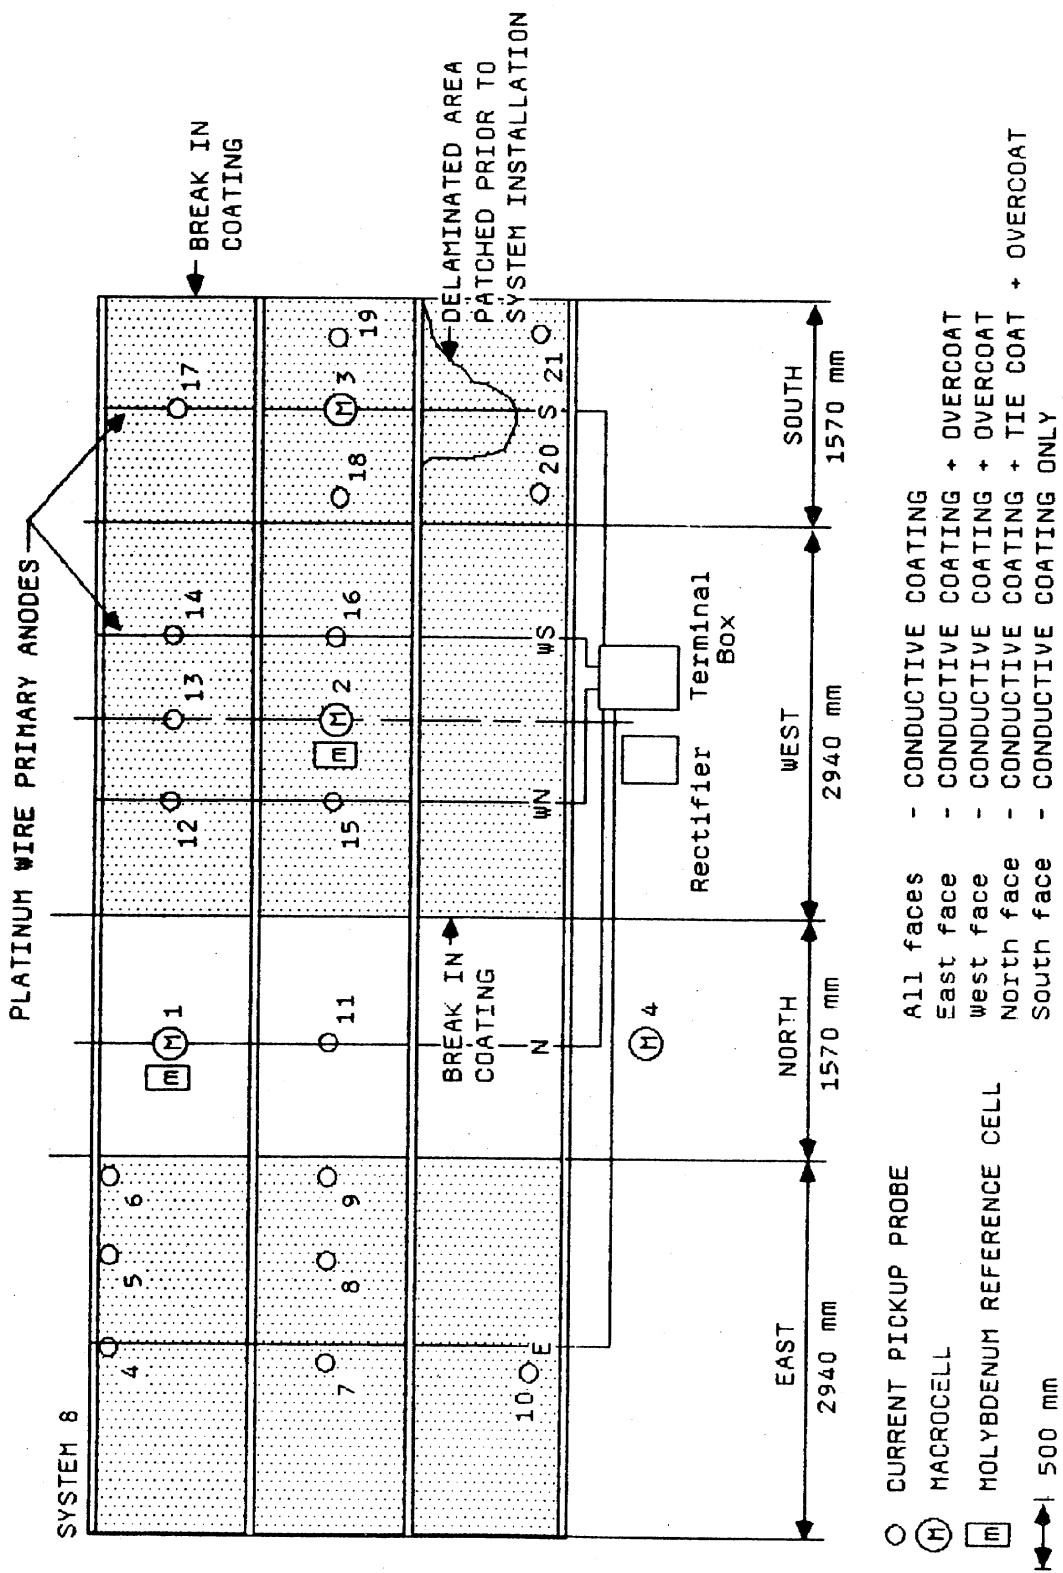
Figure 13/ Typical Anode and Instrumentation Placement (System 8)

- 1/ The electrical resistance probes did not function satisfactorily in Systems 1 to 4 and were not used.
- 2/ The current distribution probes in Systems 1 to 4 gave very consistent data. It was decided there was no reason to repeat the measurements in Systems 5 to 8.
- 3/ Fewer macrocells were constructed in order to reduce installation costs.
- 4/ In addition to the zinc-zinc sulphate reference cells, molybdenum-molybdenum oxide, silver-silver chloride, lead, and carbon cells were installed in System 5. Silver-silver chloride and molybdenum-molybdenum oxide cells were also installed in System 6 and Systems 7 and 8 respectively. In all cases, the additional reference cells were installed adjacent to the reinforcing steel, but not adjacent to the macrocells. The number and location of the various types of instrumentation for a typical system are shown in Figure 13.

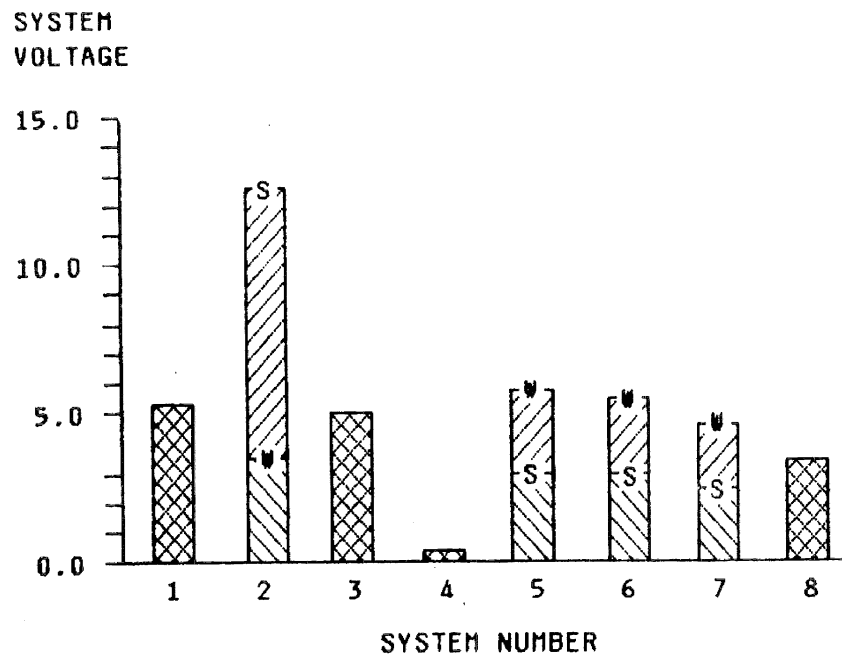
Figure 14/ Typical Operating Voltages

One requirement for the satisfactory performance of a cathodic protection system is that the protection current be maintained at an acceptable voltage level. Typical operating voltages for all eight systems are shown in Figure 14. Where the voltage levels during summer and winter differed significantly, average voltages for each period are shown in Figure 14. Voltage levels were found to vary in response to changes in temperature and humidity. Those systems with shotcrete overcoats exhibited the least fluctuation in voltage. Slightly higher voltages were generally recorded in the winter months, corresponding to increases in anode-to-reinforcing steel resistance. However, System 2 exhibited large increases in driving voltage in the summer months as a result of poor contact between the primary anodes and the paint, and drying of the concrete surface below the paint. The other paint systems, 5 and 8, showed little change in voltage requirements during periods of hot, dry weather.

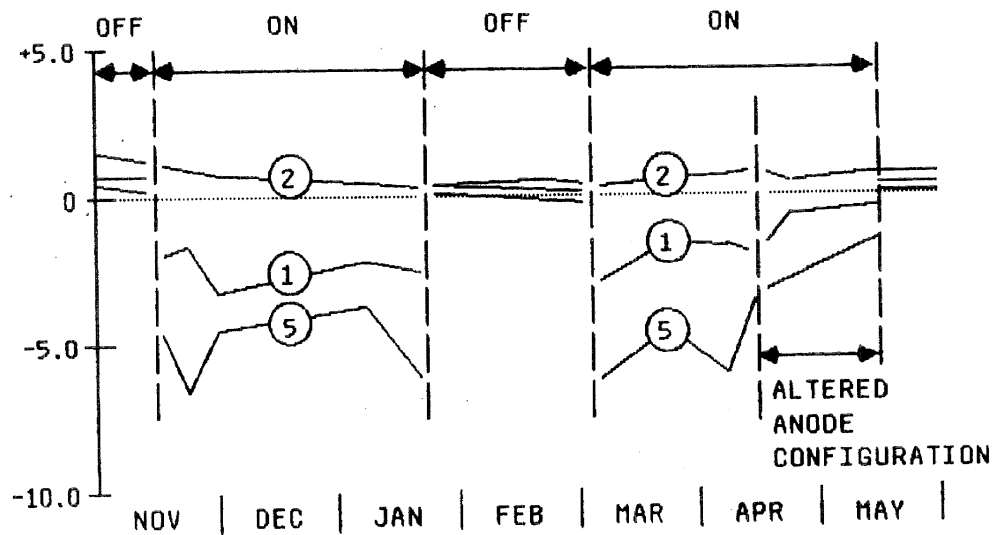
Figure 15/ Current density on Macrocell Probes: System 2, Probes 1, 2, and 5 During the Period November 1982-May 1983

Typical macrocell data is shown in Figure 15, which is a plot of the current density on three of the macrocell probes in System 2 as a function of time during the seven months following cell installation. Probe 2 was located outside the protected area and served as a control, remaining anodic through the monitoring period. In contrast to it, Probes 1 and 5 were cathodic during periods when current was applied but shifted in the anodic direction when the power was switched off.

The current density of 13 mA/m^2 applied to the concrete surface corresponded to an average of approximately $2.8 \text{ } \mu\text{A/cm}^2$ on the surface of the reinforcing steel. Current densities in all the impressed current systems on probes embedded at the level of the first layer of reinforcement were typically in the range of -2 to $-6 \text{ } \mu\text{A/cm}^2$ during periods when power was applied. During "off" periods, current flow to or from the current pick-up probes was essentially zero. The pick-up probes were also found useful in measuring the uniformity of current flow, since uniformity is an important requirement for a successful system. They could be used to investigate the effects of varying anode spacing to optimize the design of each system.

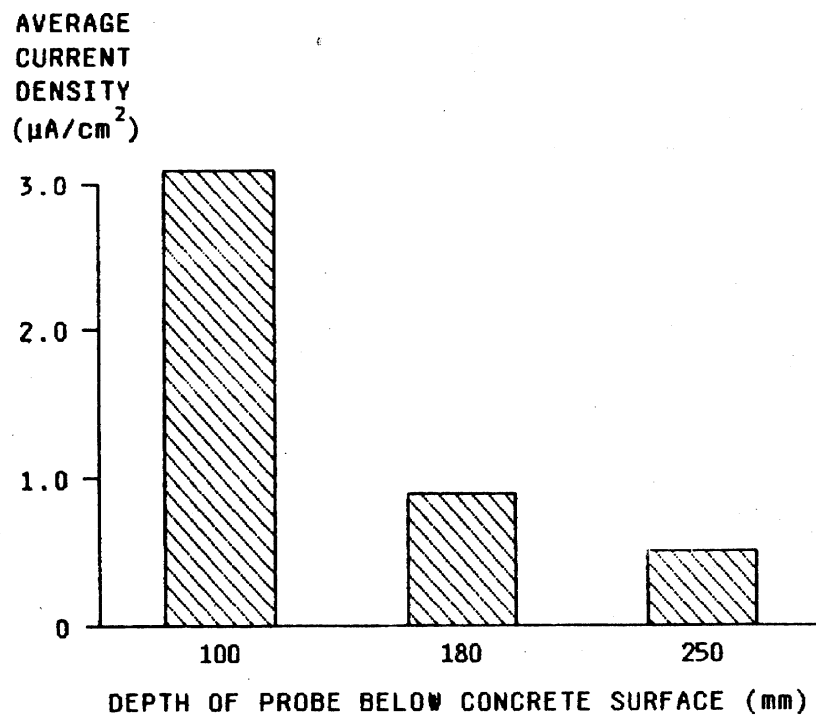
Figure 16/ Variation of Current Density with Depth of
Probe Below the Concrete Surface

The current distribution probes installed in Systems 1, 2, and 3 were designed to measure the variation of current density with depth as compared with the pick-up probes which were used to measure the uniformity of current over the concrete surface. The average results for the period October 1982-April 1983 for all the probes embedded at the 100, 180, and 250 mm depths are shown in Figure 16. The results show that even though the deepest probes were embedded at a greater depth than the two layers of reinforcement in the column, they received some beneficial effects from cathodic protection.

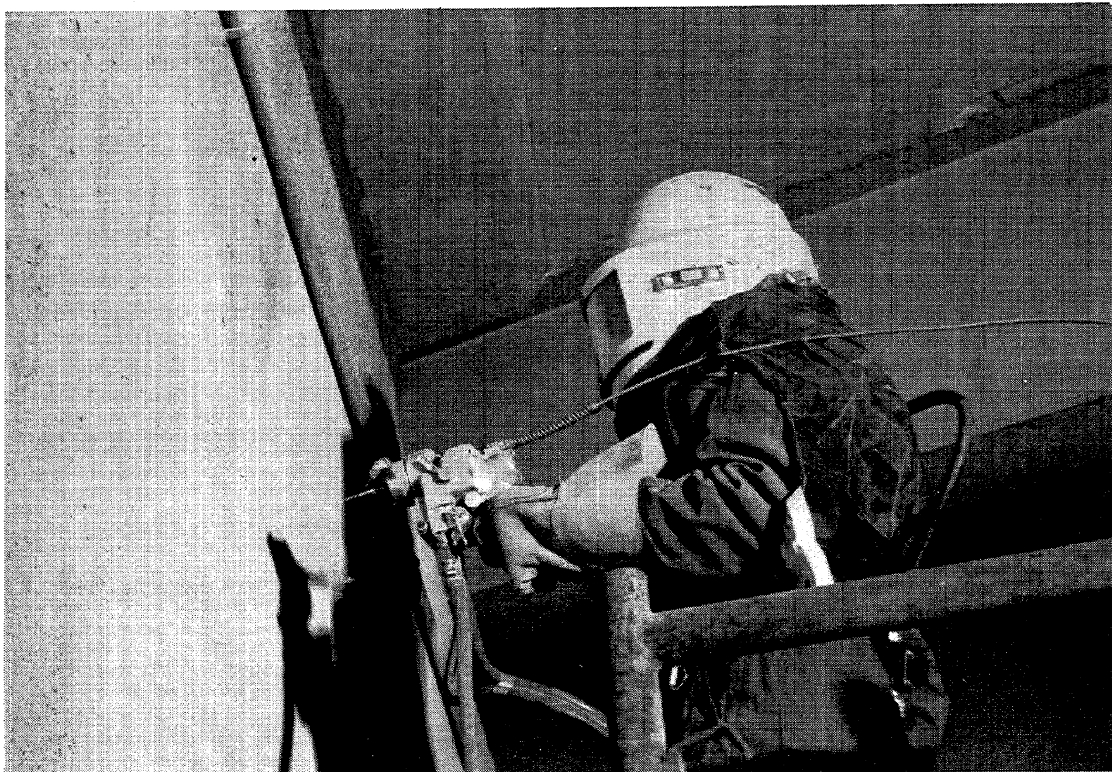
Figure 17/ Application of Flame-Sprayed Zinc Anode

One of the systems installed was the same as System 6 in the previous study. The other was a flame-sprayed zinc system which had been developed in California (12) while the Burlington study was in progress. The process consists of applying molten zinc to the entire surface of the concrete as illustrated in Figure 17. However, the zinc is not used for galvanic cathodic protection, since connections are made at several locations on the concrete surface such that the zinc acts as the primary anode in an impressed current system. The experience gained in the previous study was also used to reduce the amount of instrumentation necessary and also to investigate unresolved problems. A wide variety of reference cells were installed and probes were fabricated to investigate the distribution of current around a bar.
