Automated Data Collection for Bridge Decks

Workshop Paper

**Presented by the Ontario Ministry of Transportation and Communications
April 13-15, 1985. Riyadh, Saudi Arabia**

D.G. Manning

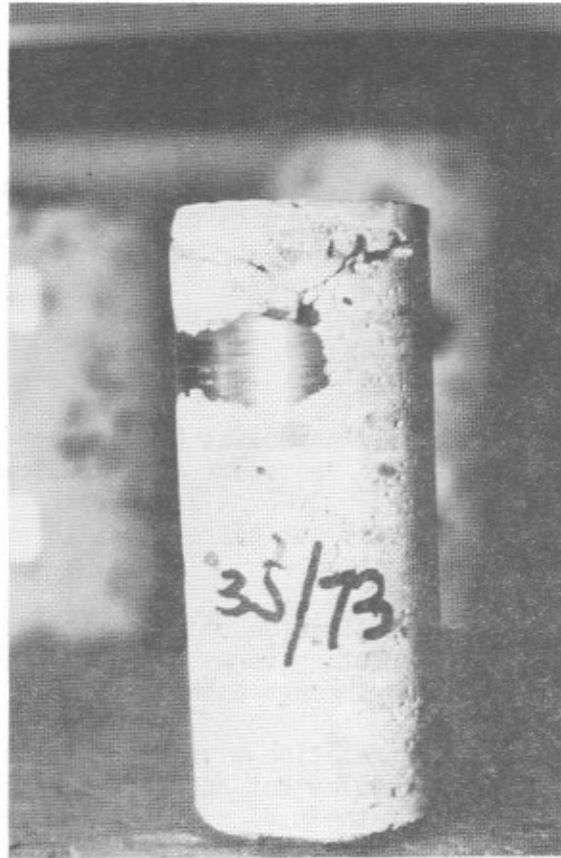
Figure 1/ Corrosion-Induced Delamination in a Concrete Core

As the reinforcing steel corrodes, it expands and creates a crack or subsurface fracture plane in the concrete at or just above the level of the reinforcement. This is illustrated in Figure 1. The fracture plane, or delamination, may be localized or may extend over a substantial area, especially if the concrete cover to the reinforcement is small. It is not uncommon for more than one delamination to occur on different planes between the concrete surface and the reinforcing steel. Delaminations are not visible on the concrete surface. However, if repairs are not made, the delaminations progress to open spalls and, with continued corrosion, eventually affect the structural integrity of the deck. Spalls on exposed concrete decks seriously impair the riding quality of the deck.

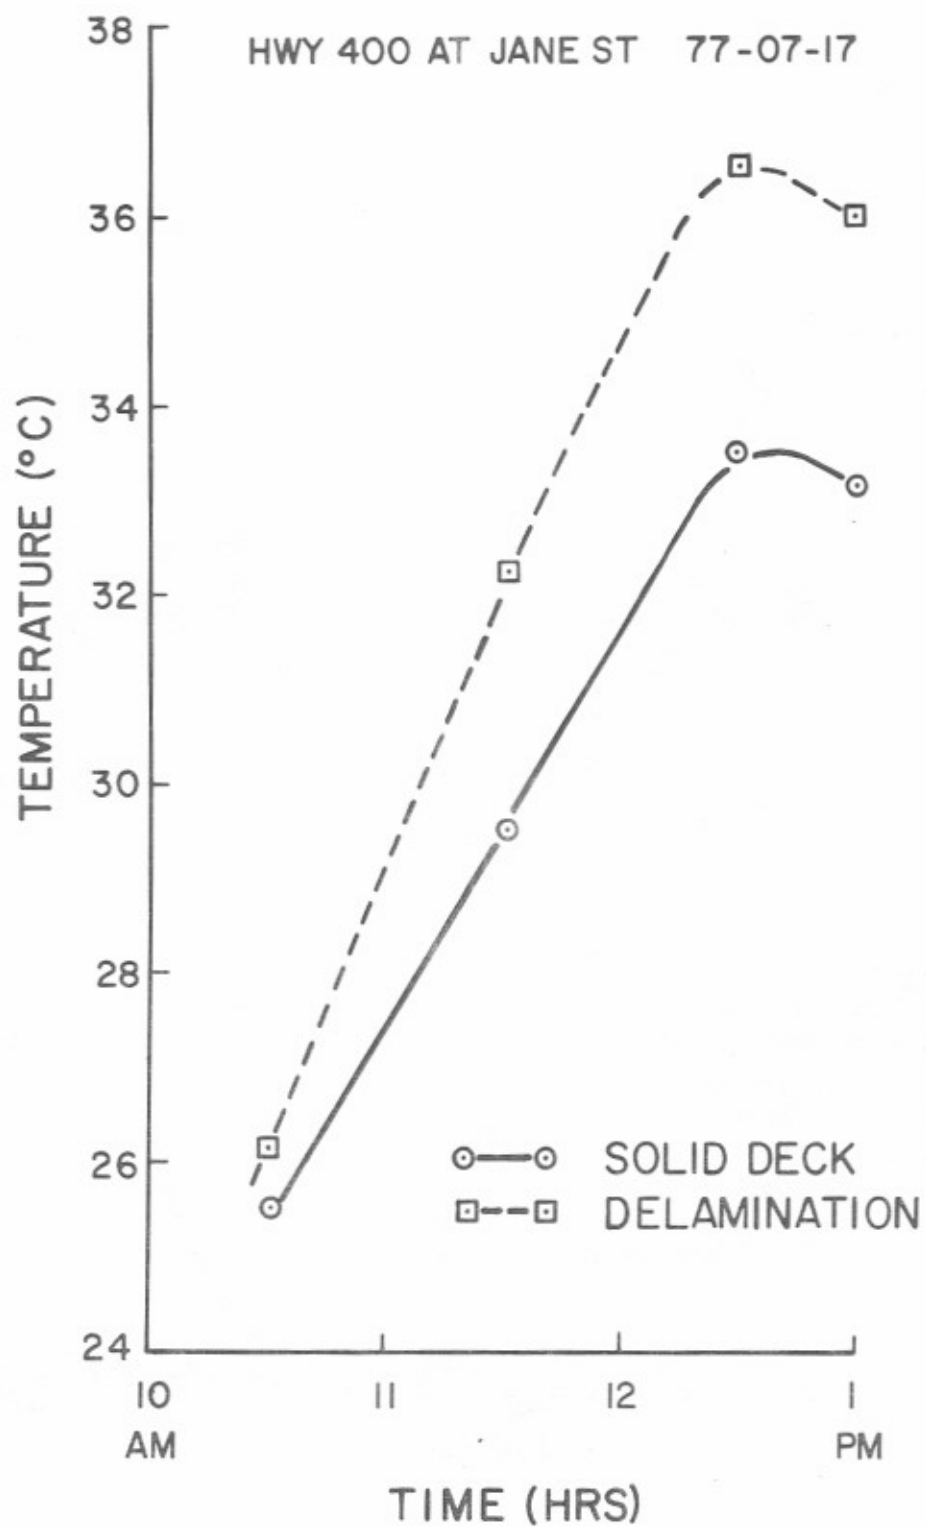
Figure 3/ Difference in Temperature Between Solid and Delaminated Concrete on a Thin Slab Deck

temperature decreased with the depth below the deck surface and at night the situation was reversed. Similar temperature distributions have been recorded on thin slab decks in both summer and winter, though the temperature gradient was less in winter. Figure 3 shows the temperature variation in sound and delaminated concrete measured by thermocouples installed 6 mm below the surface. During the test period the difference in surface temperature between the solid and the delaminated concrete reached 3°C.

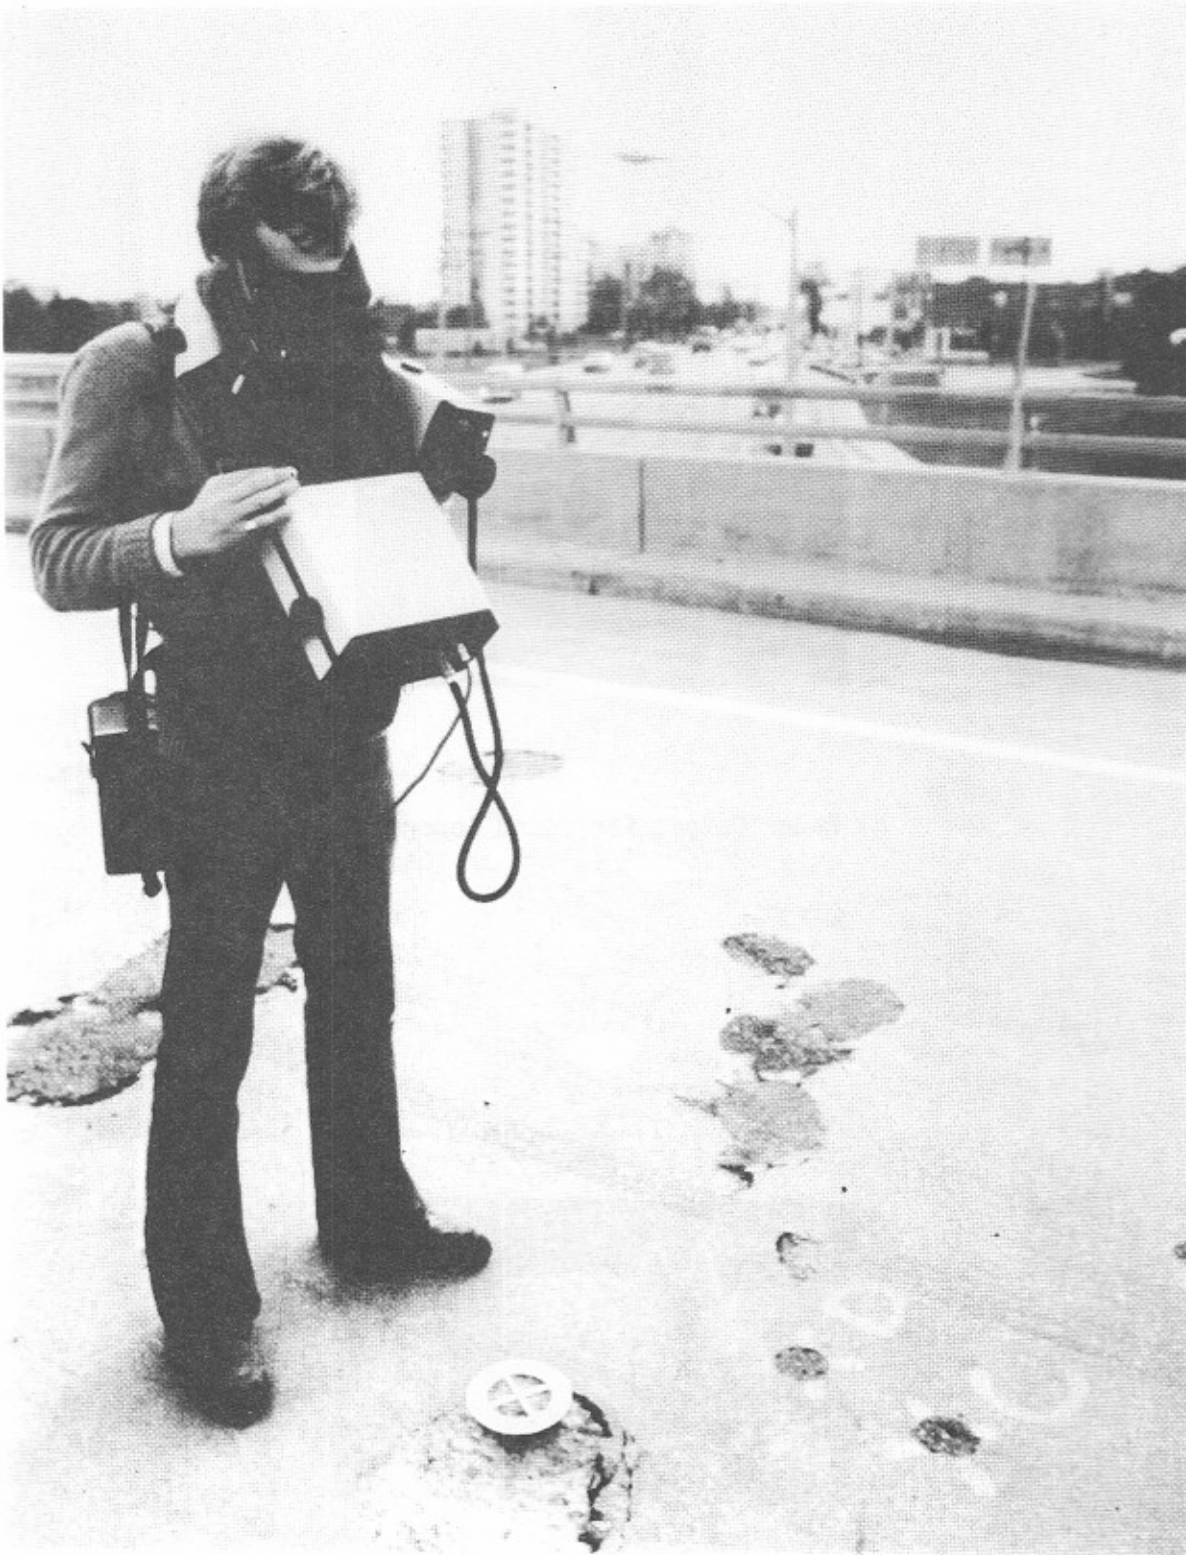
Figure 4/ Infrared Thermovision Equipment Being Operated at
Ground Level]

The first series of tests were made at ground level using targets to locate the position of the image. This is illustrated in Figure 4. Although the delaminations were easily identified, the method was impractical because of the limited field of view and the difficulty of constructing a plan of the deck from photographs taken at an oblique angle.
