ERDC/CRREL TR-00-4

Evaluation of Photovoltaic Panels at the South Pole Station

Christopher R. Williams and John Rand

April 2000

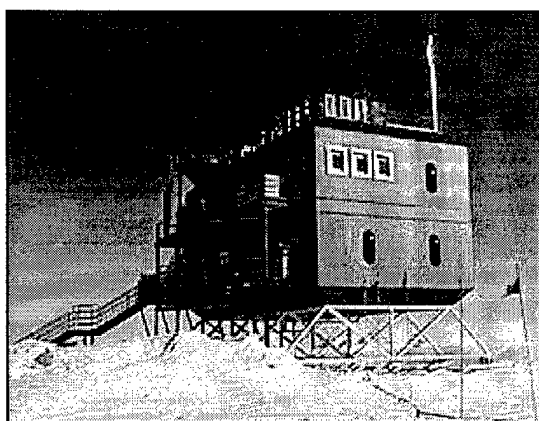
Figure 1. Atmospheric Research Laboratory (25 November 1997).

The evaluation platform was the four sides of the new ARO building (Fig. 1) at the South Pole Station, Antarctica. The PV panels from the four manufacturers are approximately the same physical size and shape, which facilitated easy comparison. In addition, the method of attachment to the exterior surface of the ARO building allowed for easy installation, removal, and structural evaluation.

a. Southeast corner.

b. Northwest corner.

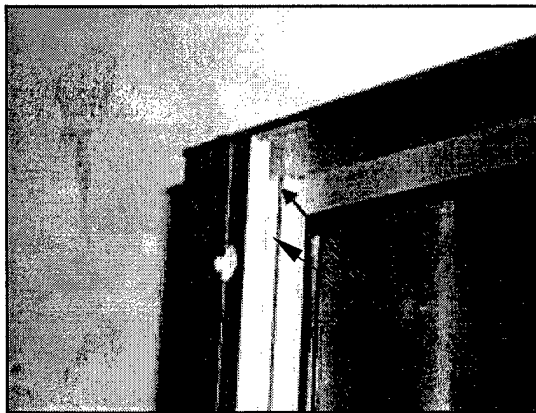
Figure 4. Details of PhotoComm, Inc., panel.

a. Top view of corner connections (pan head sheet metal screws).

b. Front view of corner connections.

c. Back view of corner connections (arrow points to sheet metal screw in open extruded channel).

On all four of the PhotoComm, Inc., panels that we inspected, the gasketed seal between the glazing and aluminum frame showed signs of failure. The gasketed seal was pulling out of the corners between the glazing surface and aluminum frame. Each panel showed some signs of aluminum frame weakness. The corner connections of the frame were loose and allowed considerable movement when a twisting motion was applied. Three of the frames showed signs of abuse; they had dents and or were bent. The glazing, panel back, and junction box were all free of defects.

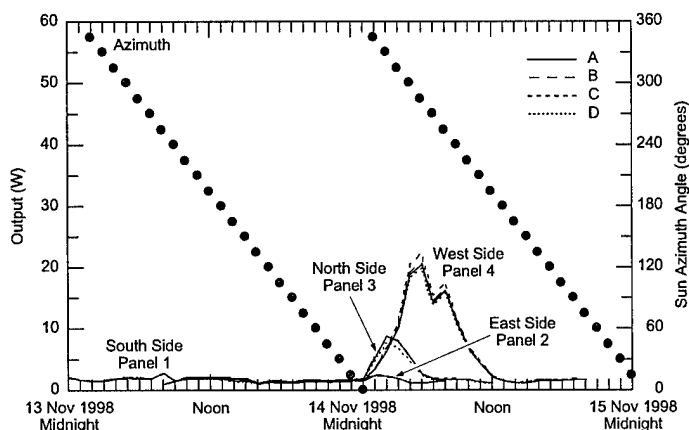
A 24-hour period on a low-visibility day (13–14 January 1998) was also selected to compare the PV panels' performance (Table 6). During this 24-hour period, the visibility at the south pole was recorded as being 0.25 miles or less. Figure 12 begins with the south side of the ARO receiving the obstructed sunlight. The available output power of all the PV panels remained low during this period. Because of the low visibility, it was difficult to identify any particular PV panel as outperforming the next. At the end of the 24-hour period, when the visi-

bility increased and sun faced the north side of ARO, there was greater available output power from the PV panels. PV panel C produced the highest available output power, while PV panel D produced the lowest. PV panels B and A came in second and third.

Figure 12. PV panel performance on the low-visibility day (13 to 14 January 1998) over 24 hours.

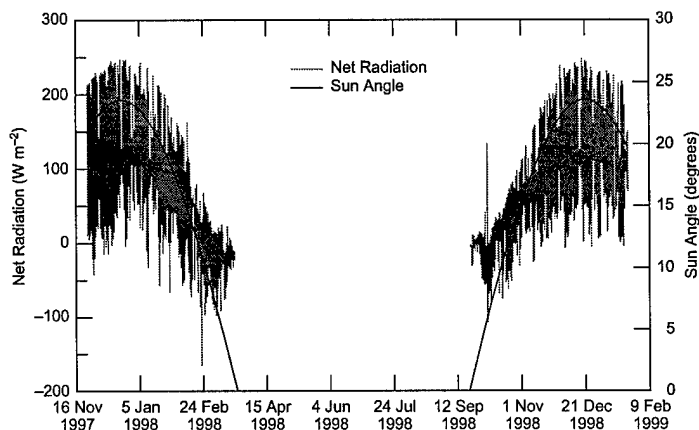
To get an understanding of the amount of potential power available for the PV panels, the net radiation values were measured. The intensity of the available potential power depends on the sun declination angle and visibility. At the highest sun declination angle, net radiation values reached a potential of 250 W m^{-2} in the horizontal position. Figure 13 shows the net radiation values during the austral summers.

Figure 13. Net radiometer readings from 25 November 1997 to 23 January 1999.

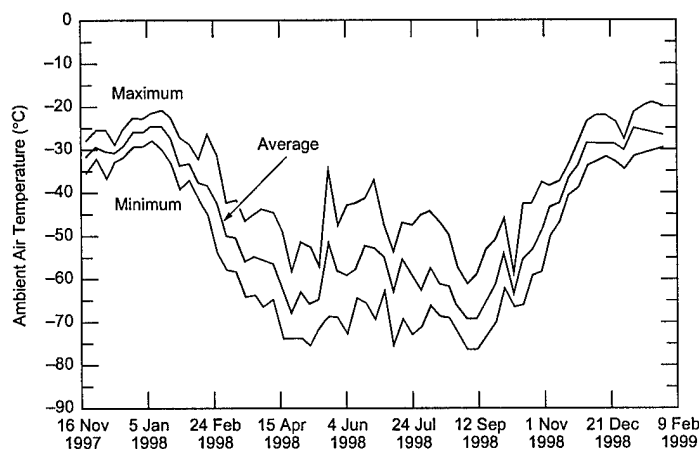
The source of the SITREP98 data was the South Pole weekly climatological summary, which provides uninterrupted temperature and wind speed data from 22 November 1997 to 12 December 1998. Figure 14 depicts the extreme temperatures to which the PV panels were exposed. Temperatures ranged from approximately -20 to -70°C .

Figure 14. Temperatures experienced by ARO from 16 November 1998 to 9 February 1999.
