Internal post-tensioning tendons : many problems and sometimes solutions

Ir Pierre GILLES, Ingénieur des Ponts et Chaussées, Direction de l'Expertise des Ouvrages, Service Public de Wallonie, Belgium

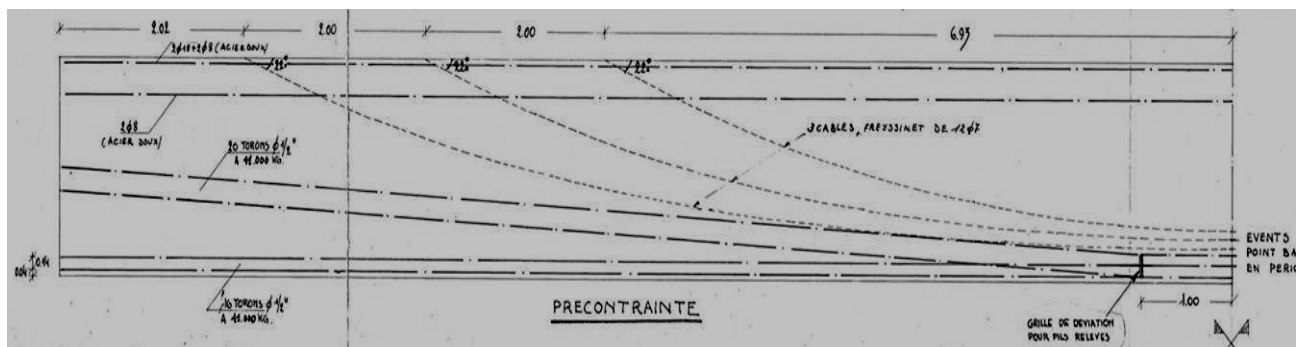
Figure 1 : Post-tensioned beam : half longitudinal cross section

Bridge A is a beam bridge 600 length with a double deck. Beams were built on site and post-tensioned. Several tendon anchorages are present in the upper face of the deck slab (figure 1). At the construction time (middle 60's), it was a kind of challenge to design the beam with a very low reinforcement versus post-tensioning ratio.

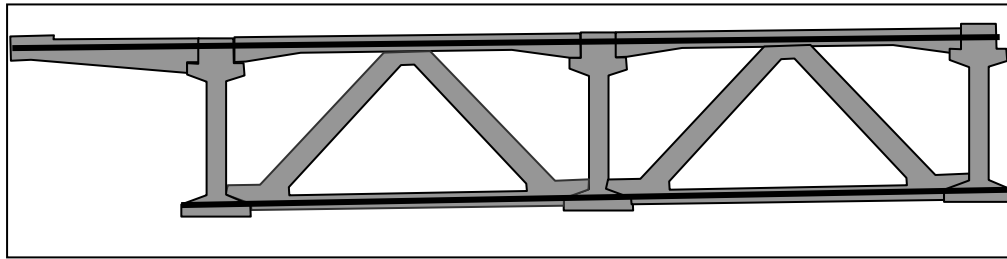
Figure 2 : Bridge deck : half transversal cross section

The deck is composed with these beams and with prefabricated transversal beams (figure 2), assembled by post-tensioning tendons (1/m in the slab and 1/transversal beam in the lower part).

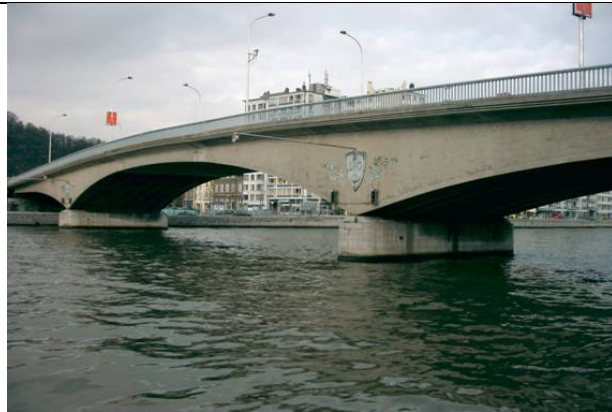
Figure 7 : Bridge B

Bridge B is a cantilever box girder bridge built in 1951 (figure 7). The external post-tensioning was renewed in 1991 with wax sheathed monostrands. In the transversal beam, at the cantilever girder hinge, post-tensioning became internal up to the anchorage (figure 8). Strands are placed in a plastic duct with wax injection.

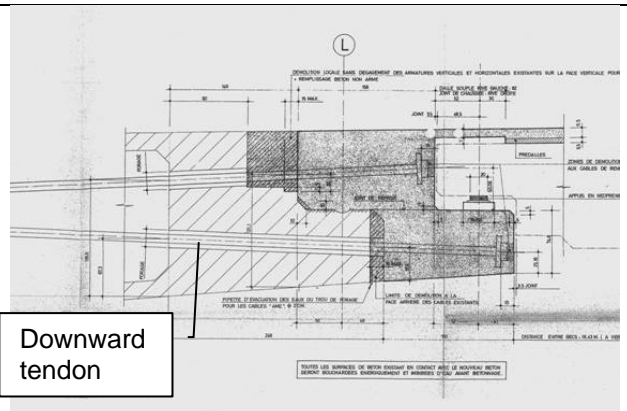
Figure 8 : Tendon anchorage at cantilever hinge. The dark part was added in 1991.

In regards of rupture increasing risk, it was decided to replace all downward (relatively to position at hinge area) tendons which represent half of bridge post-tensioning.

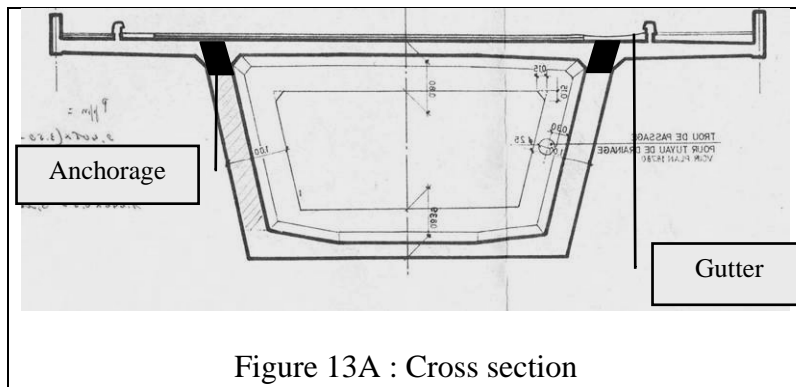
Near the mid pier, anchorages are positioned in the upper face of the deck. Half of the 44 deck anchorages are placed just under the gutter (figure 13).

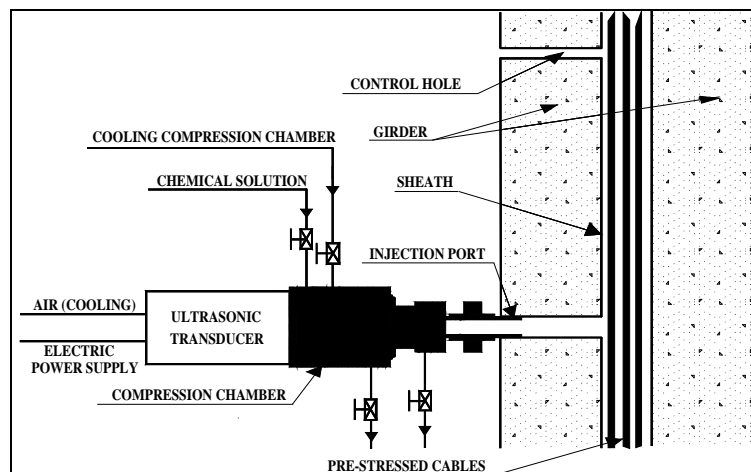
Figure 16

Holes are drilled at regular intervals along the cable path through the concrete and the duct (figure 16). A tube is tightly sealed inside each hole to permit the fitting of a reciprocating pump. The pump's compression chamber is then filled with the inhibitor solution.

The high frequency compression and depression created by the reciprocating pump forces the liquid to penetrate the grout within the duct.

Control holes on both sides of the injection hole permit the technician to monitor the movement of the inhibitor solution inside the duct. When the liquid overflows through both control holes, the pump is moved to the next injection hole.

Corrosion was moderate but without any action; ruptures may appear due to chloride pollution. It was decided to inject an inhibitor solution in the grout. This is possible using the patented PMD/ATEAV process[©] based on power ultrasonic technology. The calcium nitrite has been selected due to his well known effect against chloride induced corrosion [5].
