# To all users of the: PERFORMANCE OF INTEGRAL ABUTMENT BRIDGES MANUAL

(S)	Ministry of Transportation	Report BO-99-04
Ontario	Bridge Office	
Performance of Integral Abutment Bridges		
ISBN 0-7778-9265 © The Queen's Pri Reproduced with p	nter for Ontario, 2000.	By: Iqbal Husain, P. Eng. Dino Bagnariol, P. Eng.

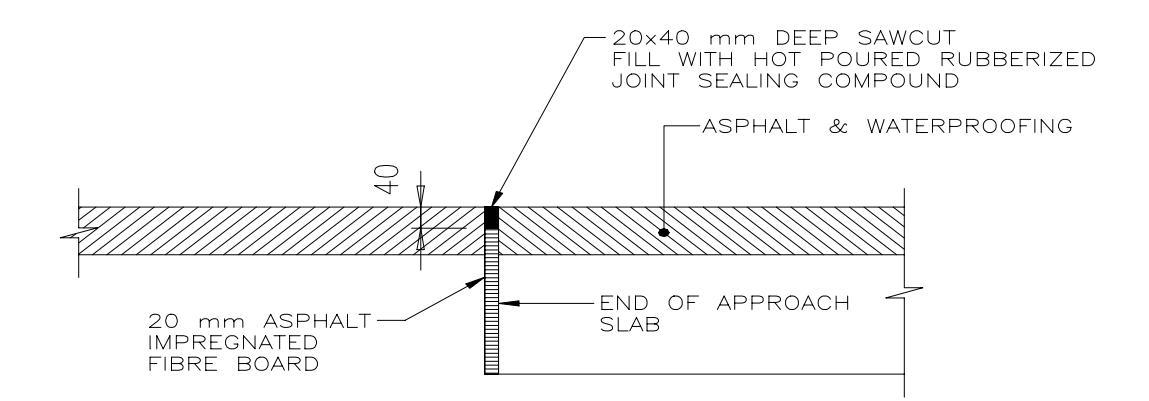
FIG. 1

The isolation joint detail as shown in Fig 1 works well where the total length of the structure is less than 75m for steel structure and 100m for concrete structure. The gap widens in the winter and the edges of asphalt pavement appear to separate from the sealing compound, see Fig 2.

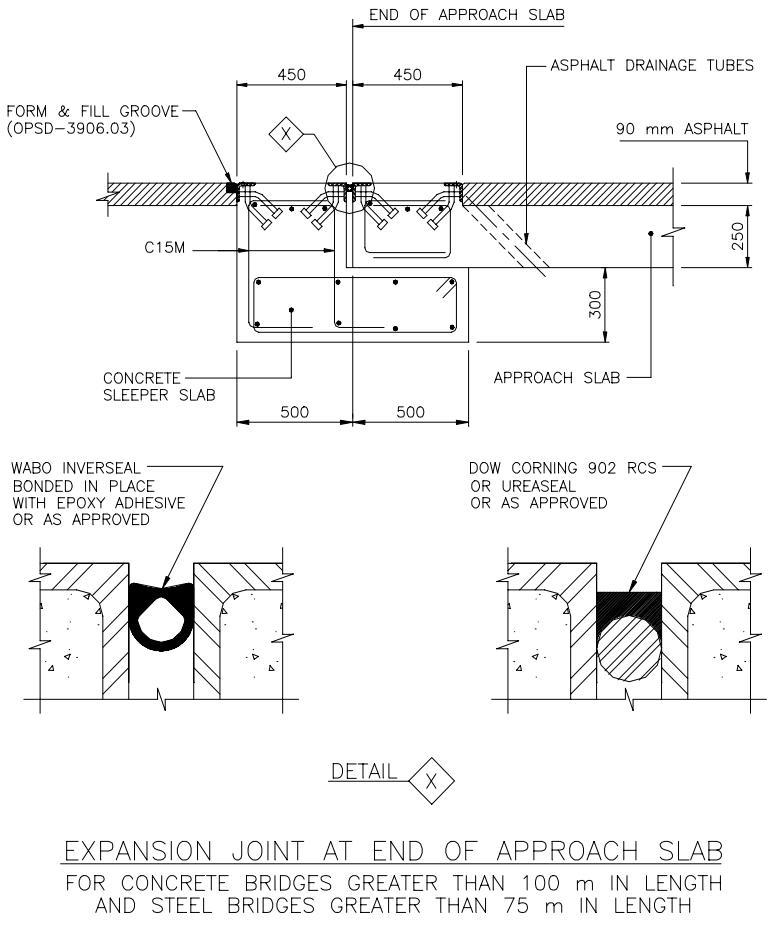
FIG. 4

It is felt that this may cause a reduced quality of ride and may require more frequent repair. As a result, MTO has developed a more elaborate movement joint detail for bridges where the total length is more than 75m for the steel structures and 100m for the concrete structures as shown in Fig 4.

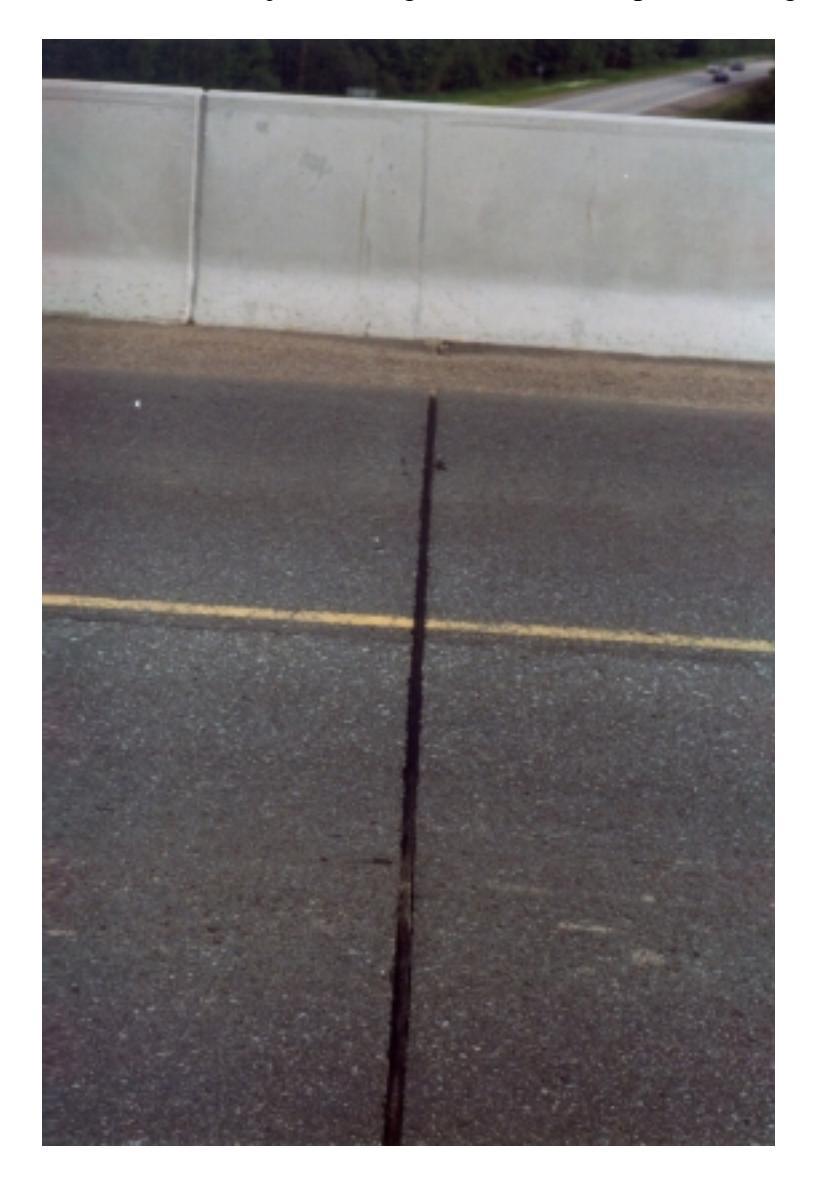
The quality control during the construction of isolation joints and the preparation of the sub-base, greatly influences the durability and effectiveness of the joint. A well made joint should be placed on a well compacted sub-base between straight sawn cut edges as shown in Fig 5. A carelessly made joint and deficient compaction of the sub-base in the vicinity of the joint, as shown in Fig 6, may result in early deterioration of the pavement and may need more frequent maintenance. It is recognised that even a well made joint will, deteriorate in time and would require maintenance (Fig 7,8,9). The Maintenance crews should be fully aware of the need and function of these rather simple looking joints. In some cases the lack of awareness has resulted in partial or complete elimination of the joint during a maintenance operation (Fig 10).
