# Load Test and Evaluation of the 18th Avenue Bridge

Ministry  
of  
Transportation

Research and  
Development  
Branch

**Author(s):** J. Maheu - Associate Research Engineer  
A.C. Agarwal - Research Engineer

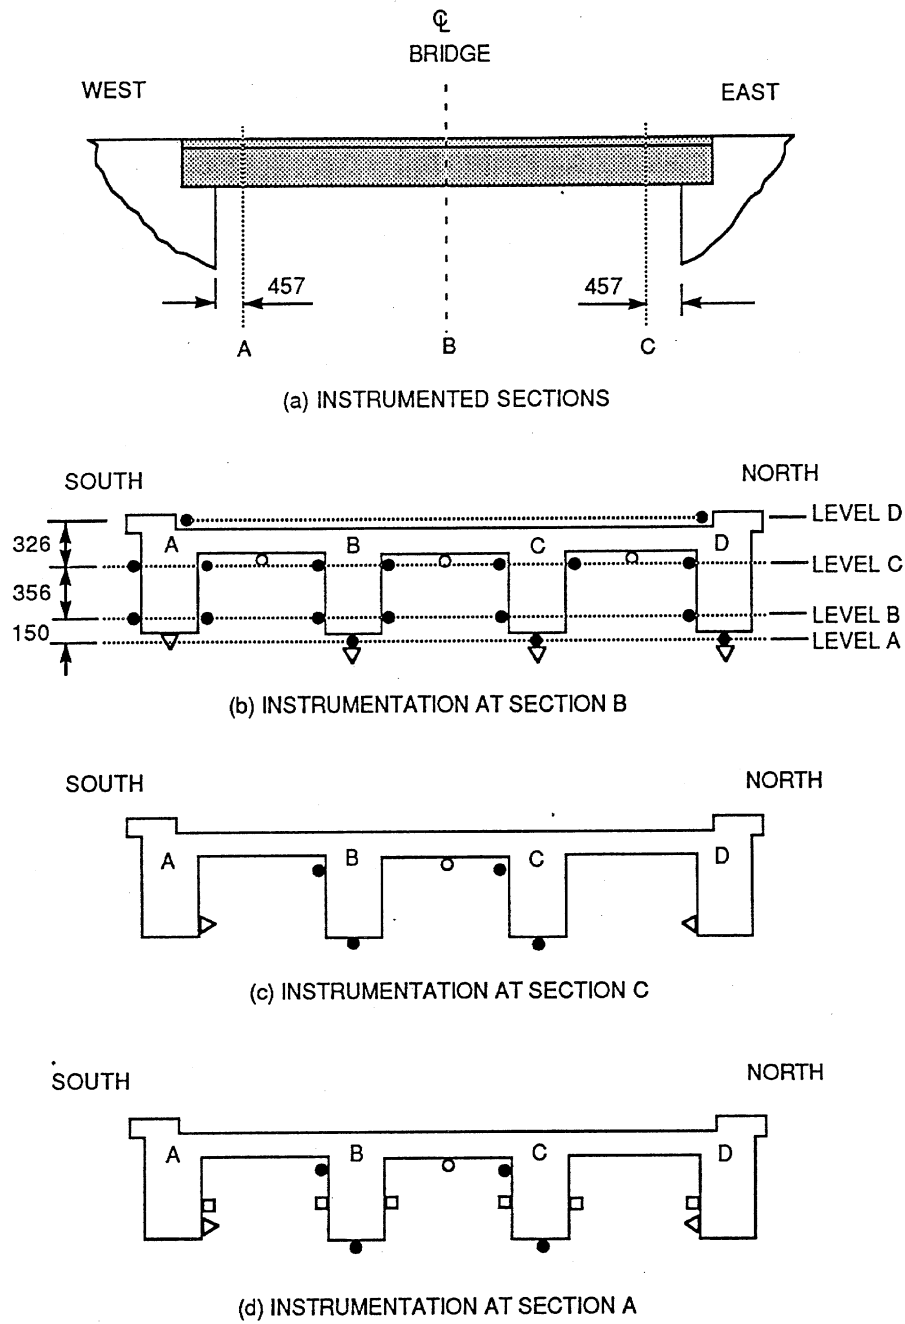
Figure 4/ Details of Instrumentation

The bridge was instrumented to measure longitudinal strains, transverse strains, crack openings, vertical deflections and horizontal displacements at various locations. Figure 4(a) identifies those sections at which transducers were mounted. Section B, the midspan section was heavily instrumented to monitor the longitudinal flexural strains at various levels in the girders and deck slab at the locations shown in Figure 4(b). Transducers at the top of the slab were limited to those locations near the curb which would not interfere with the movement of the test vehicle. A strain transducer could not be mounted at the bottom of girder A due to the poor condition of the concrete and steel. Transverse strains in the bottom of the slab were measured midway between the girders. Vertical deflections of each girder were also measured at this midspan section.

Strains were also measured in the interior girders at Sections A and C near the abutments. These were intended to measure the degree of fixity or bearing restraint, as were the horizontal movements of the exterior girders at the abutments. The locations of these transducers are shown in Figures 4(c) and (d). In addition, strain transducers were mounted at right angles across the diagonal cracks near the west abutment at the locations shown in Figure 4(d).

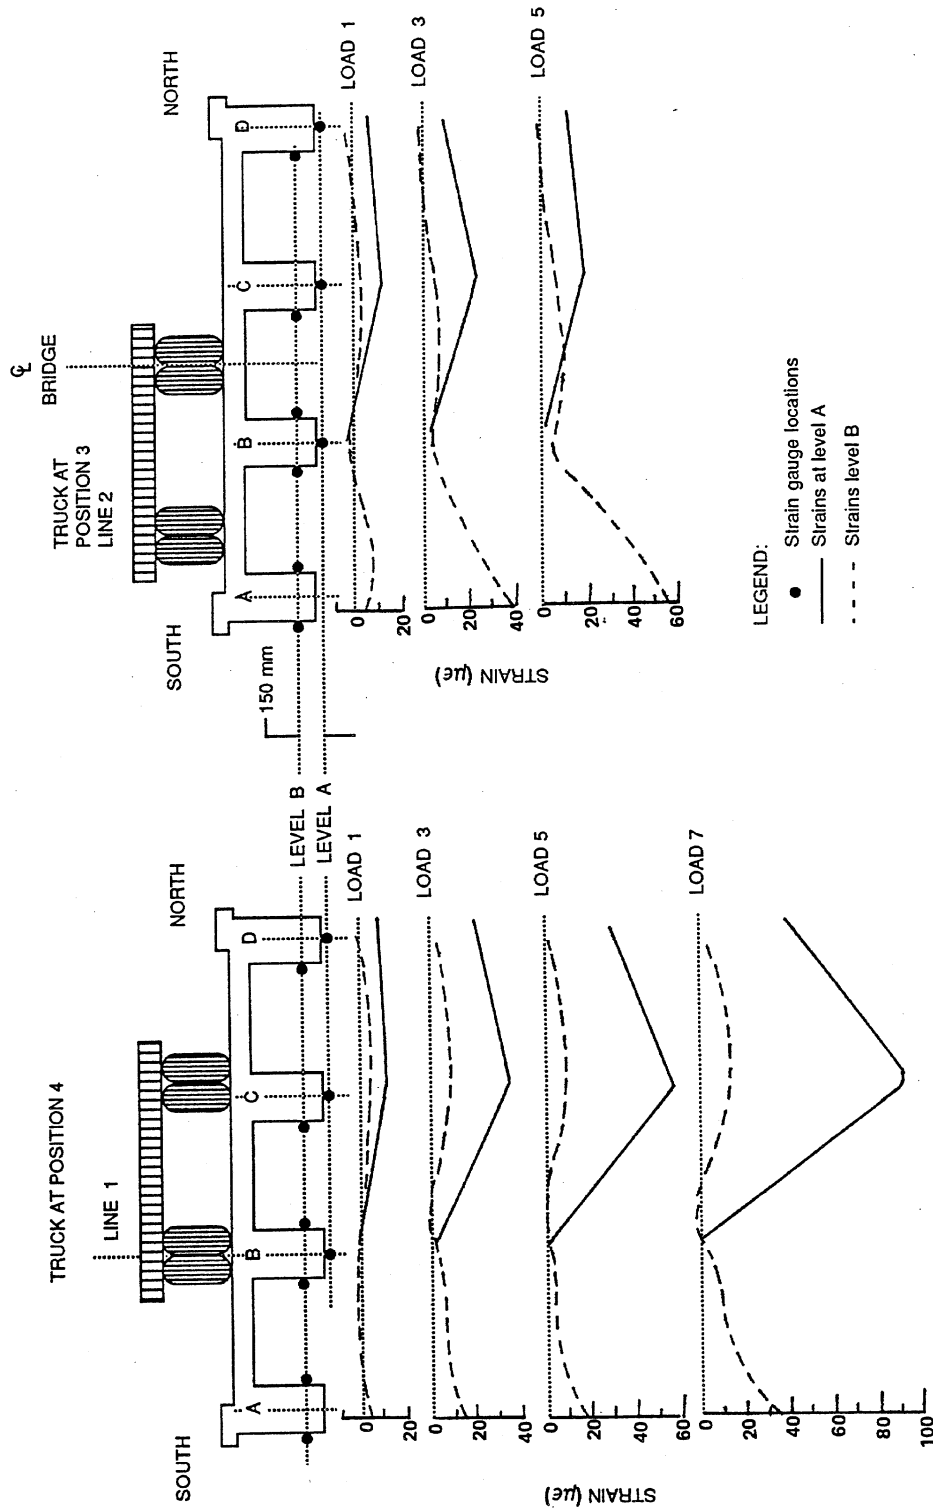
Figure 6/ Transverse Distribution of Tensile Longitudinal Strains at Midspan

An indication of the transverse distribution of load is given by the plots of tensile strains in Figure 6. These suggest a highly irregular distribution, with girder B registering negligible strains under all loading configurations. Measurements of tensile strains in concrete may be misleading since cracks may or may not be included in the distance covered by the strain transducers, and tensile strains would be larger at crack openings. However, the only midspan location where significant compressive strains were measured was on the top of the deck near the south exterior girder as seen in Figure 7.

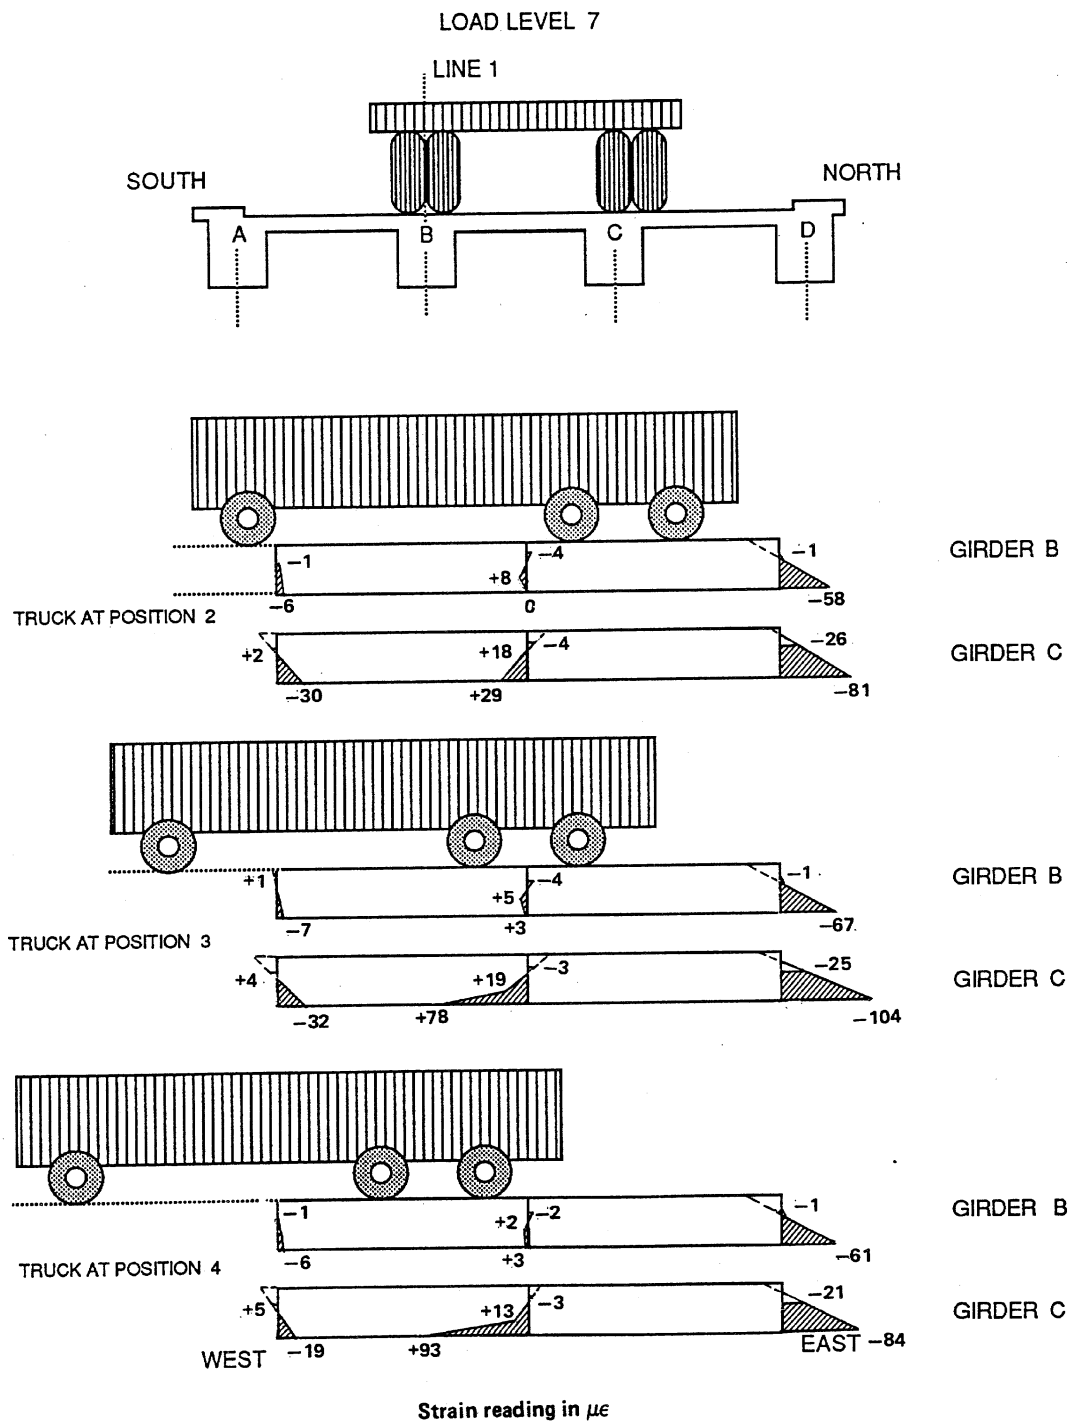
Figure 8/ Longitudinal Strains Along Interior Girders

In contrast, the largest flexural strains in the interior girders were measured in girder C, the northerly girder. However, these were tensile strains only and a direct comparison may not be valid. Longitudinal strains were also measured in the interior girders near the abutments. These are plotted with the midspan strains in Figure 8. Both girders resisted negative bending moments at the supports with larger strains measured in girder C than in girder B, and in both cases, larger strains at the east abutment than at the west. These indicate some rigidity against rotation. The cracking observed at the west abutment would provide a partial release from this rigidity, explaining the smaller strains developed at that end. Measurements of horizontal movement of the exterior girders at the abutments were negligible under all loading conditions, providing further evidence of the support rigidity.

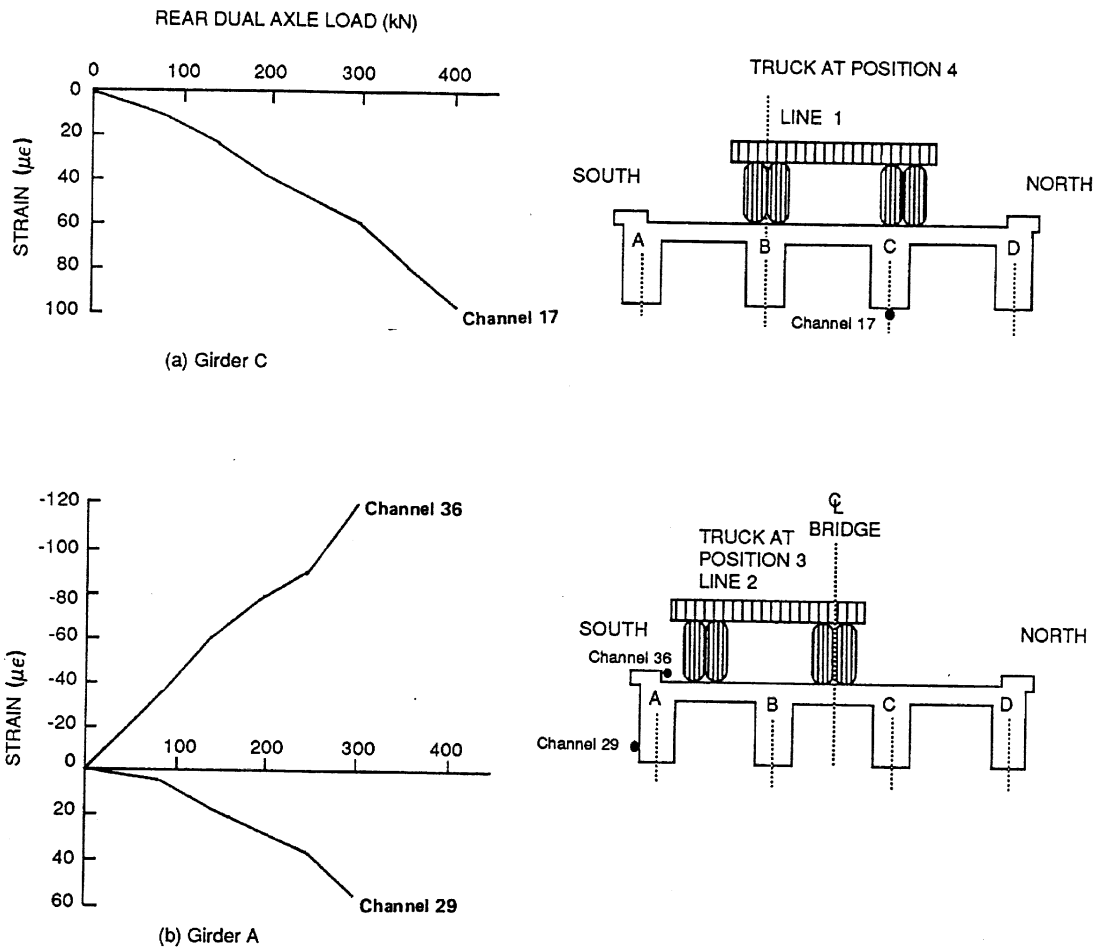
Figure 9/ Longitudinal Strains vs. Applied Load

The largest longitudinal strains are plotted against applied load in Figure 9. The maximum strains in interior girder C occurred under central loading, while those in exterior girder A occurred under eccentric loading. In each case the tensile strains become non-linear at higher loads, but were mostly recoverable. The largest tensile strain measured was  $93 \mu\epsilon$ , and the largest compressive strain  $-114 \mu\epsilon$ .
