Evaluation of Crack Sealing Compounds for Asphaltic Pavements

EMO PROJECT NO. 33

Final Report

Oct. 1983

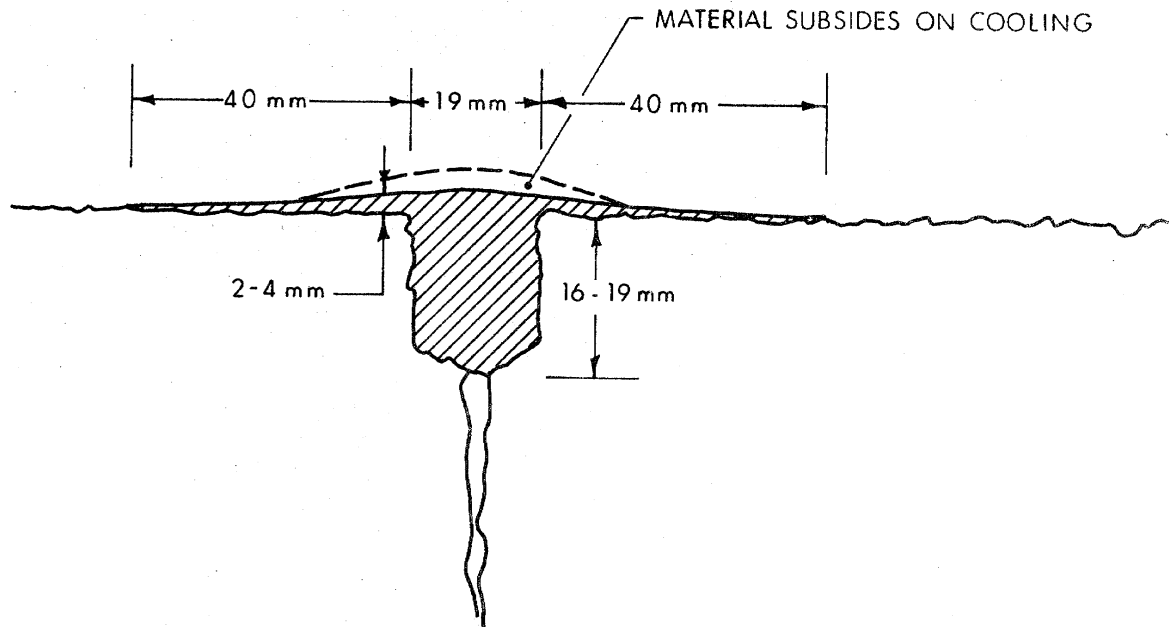
FIGURE 2

The desired cross section of seal in a routed groove is as shown in Figure 2. Most of the strike off devices used just levelled the sealant but the "U" and "V" shaped squeegees with a crescent cut out of the rubber at the back gave the desired cross section to the sealant. The sealant needs to be struck off so as to leave a bead of material over the routed groove with the edges of the material feathered out. The bead of material will flatten out considerably after subsiding into the crack and through thermal shrinkage. If the sealant stands too proud of the surface, it is subject to snow plough damage. Due to either inappropriate strike off devices or lack of operator skill, lumps of sealant were left proud of the pavement surface at the ends of cracks or where a crack changed direction. This material created a noticeable bump which will likely be cut off in the winter by snow plowing operations, with the risk that additional material may be pulled out of the sealed crack.

DESIRED CROSS-SECTION OF ROUTED AND SEALED CRACK

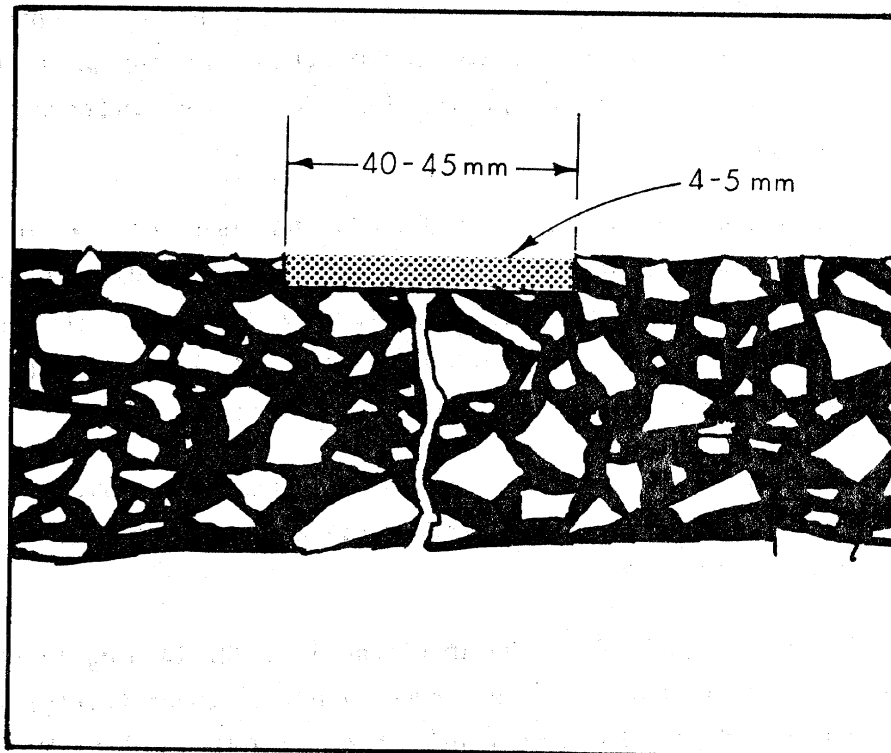
FIGURE 4

Several trial installations have been constructed in 1983 using a method introduced to the Ministry by Klaruw of Holland (Fig.4). This method has the advantage of the overband seal without the hazard of snow plow damage. These installations will be reviewed over the winter of 83-84.

KLARUW METHOD
