Report No. ABTR/RD/TM –02/06	Subject Area	Project No.	Report Date February 2006
Title Study of Snowplowable Raised Pavement Markers			Type of Report Final
Author(s) Joe Filice, R.E.T. , Materials Technologist			No. of Pages 75
Performing Organization Name and Address Avery Dennison Highway Safety Division 6565 West Howard Niles, Illinois 60714, USA		Sponsoring Agency Name and Address Alberta Transportation Technical Standards Branch 2 nd Floor, 4999 – 98 Avenue Edmonton, AB T6B 2X3	
Supplementary Notes The author would like to thank the following individuals who assisted in this study: Roger Skirrow, Director, Geotechnical and Material Section, Alberta Infrastructure and Transportation Richard Chow, Traffic Operation Specialist, Alberta Infrastructure and Transportation Beata Bielkiewicz, Traffic Standards Engineer, Alberta Infrastructure and Transportation			
Abstract Traffic markings used in Alberta consist primarily of alkyd and waterborne paint. Supplemental delineation such as Snowplowable Raised Pavement Markers (SRPM) may improve driver preview distances at night and in adverse weather conditions in high collision rate areas. A study of SRPM's was undertaken to determine the

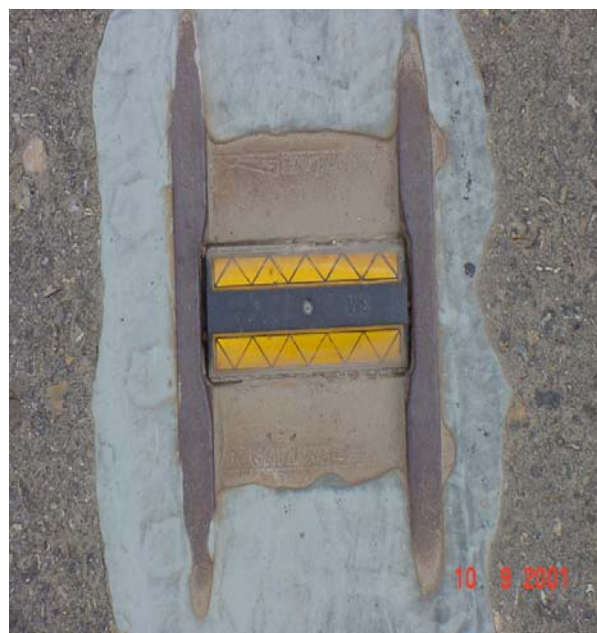
3M Marker in good shape

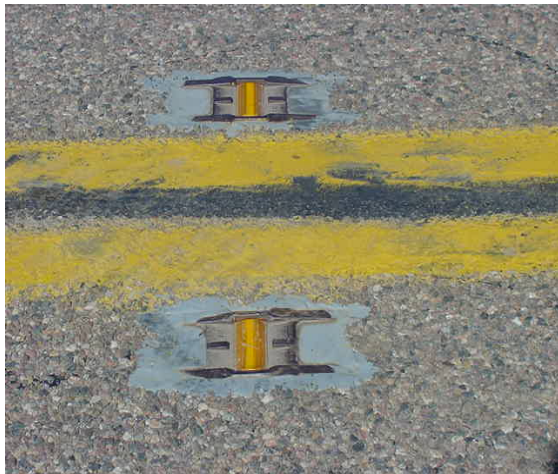
Intact Stimsonite markers at centerline

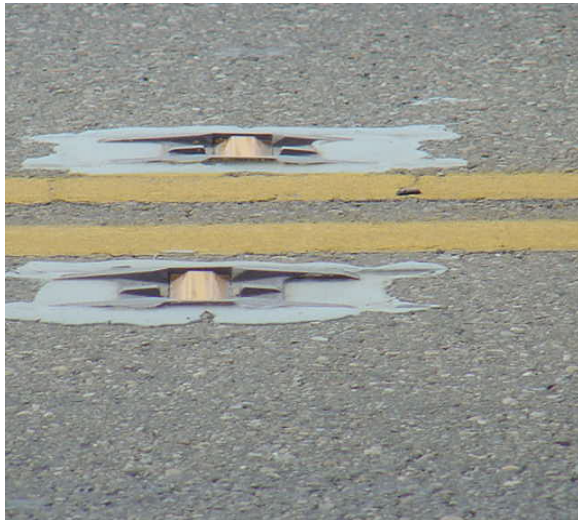
Centerline markers

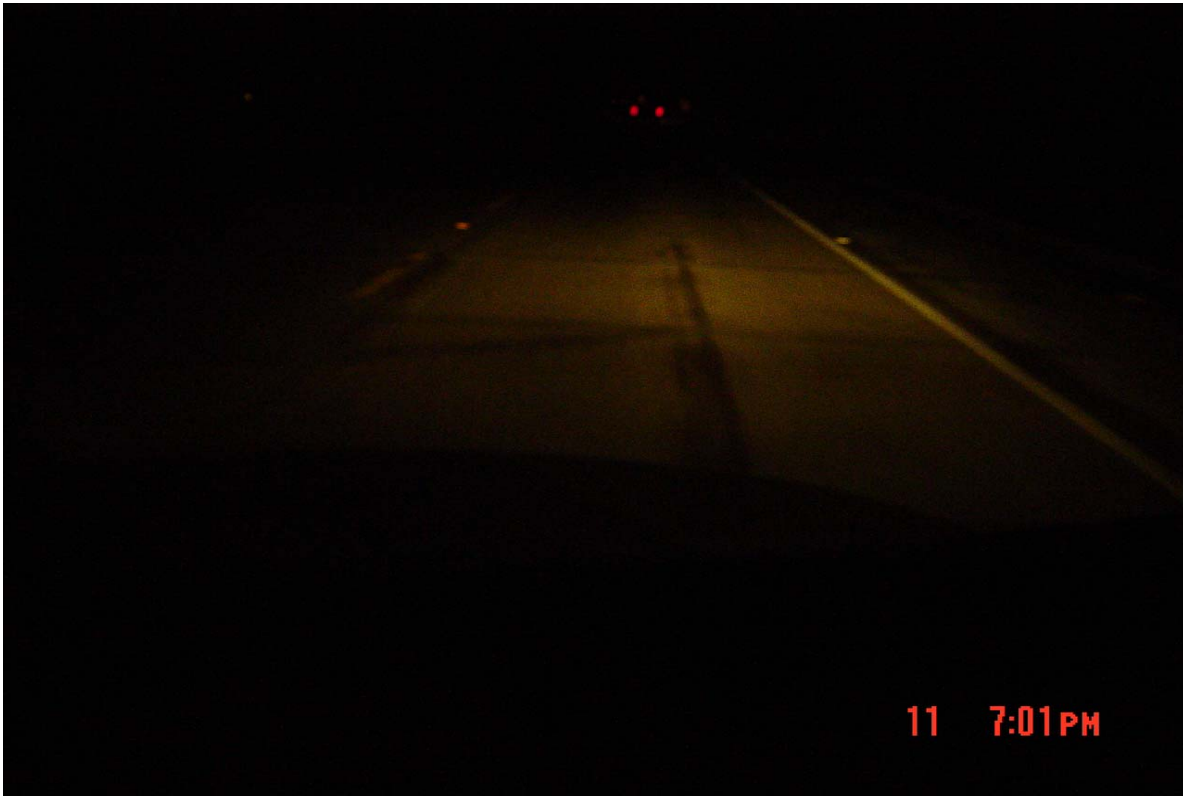
Hwy. 28 – Centerline and shoulder markers are visible.

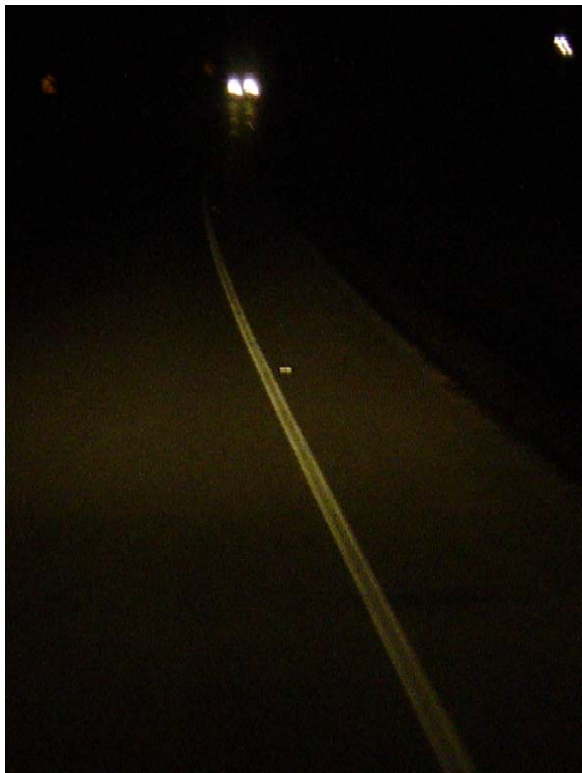
Reflectors are providing positive delineation at night.

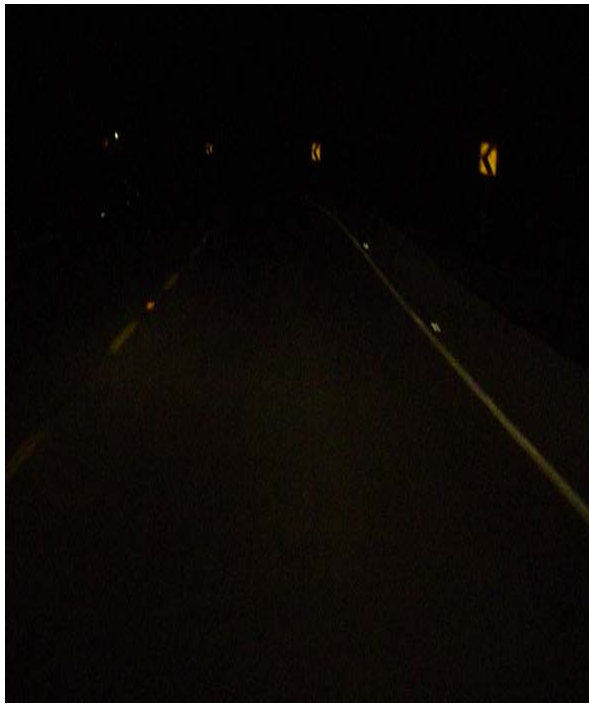
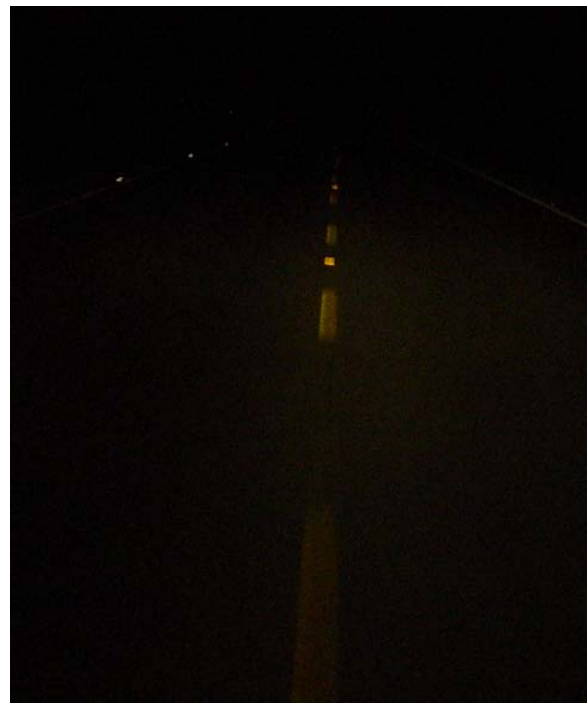
It is evident that when driving through this stretch of highway 21, the raised pavement markers are providing very good retro reflectivity which assists the motorists in maneuvering around curves in low light conditions.

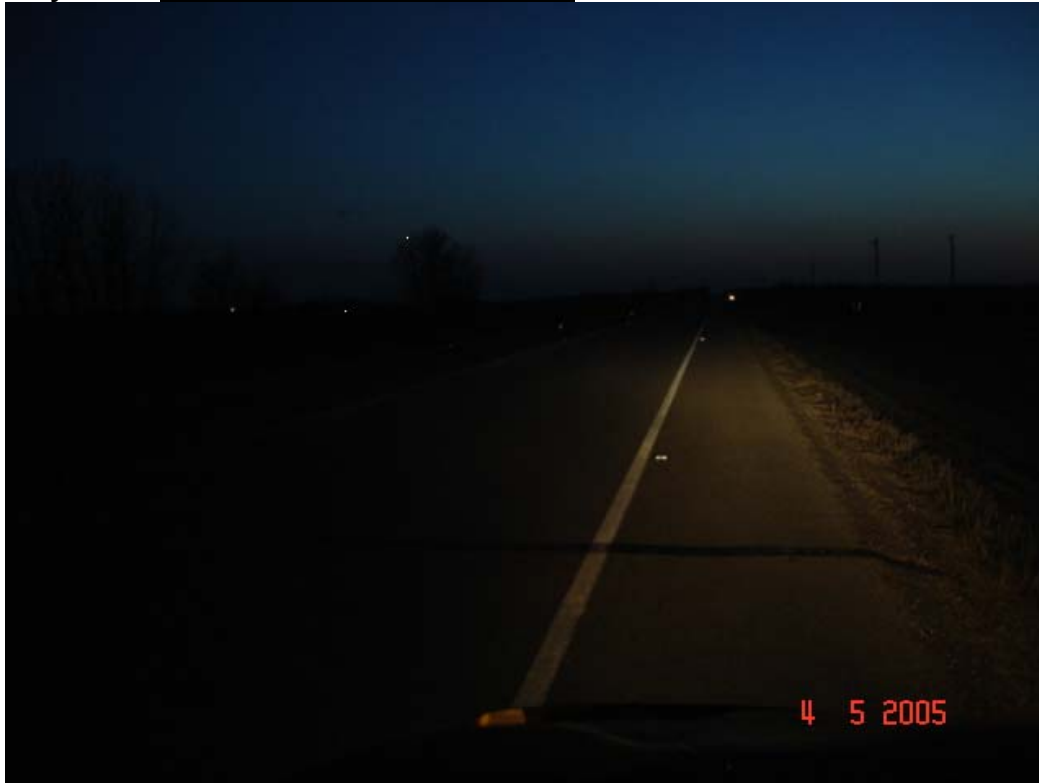
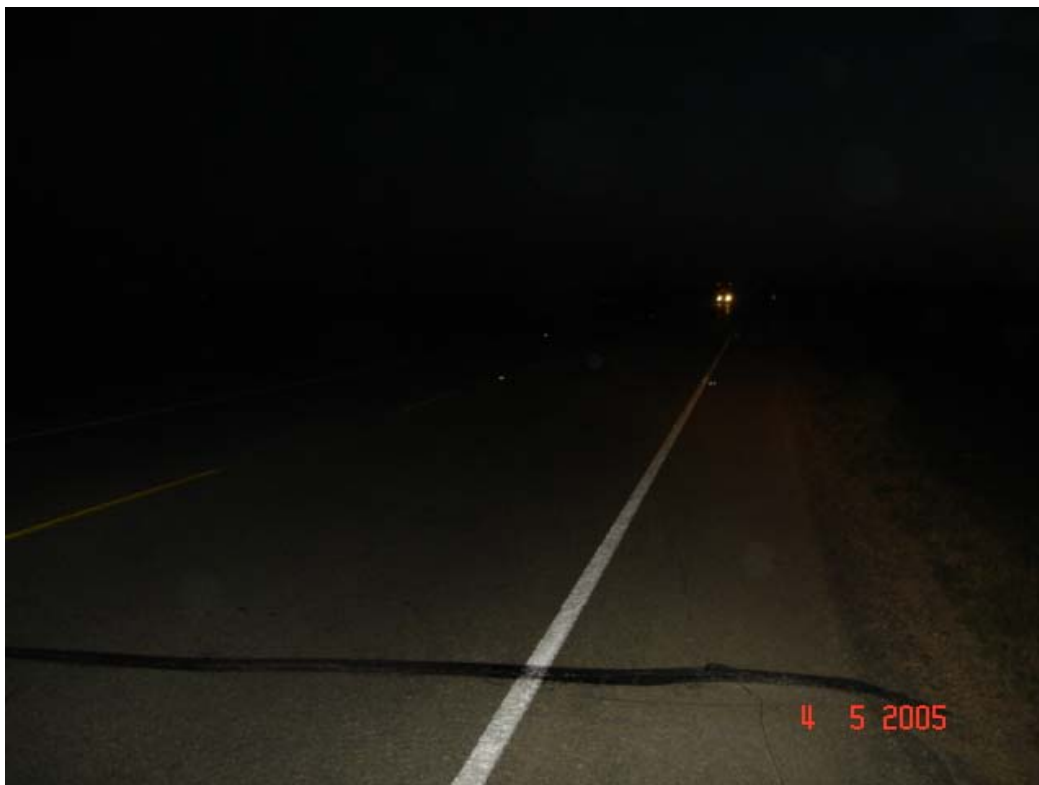
SRPM are providing good additional delineation on the highway 21 trial section. Majority of the Markers are reflective with the exception of some of the broken markers. When compared to normal paint line delineation the SRPM markers definitely improve preview distances and guidance to motorist in low light conditions. Photographs are not providing a true representation of the reflectivity of the SRPM's.

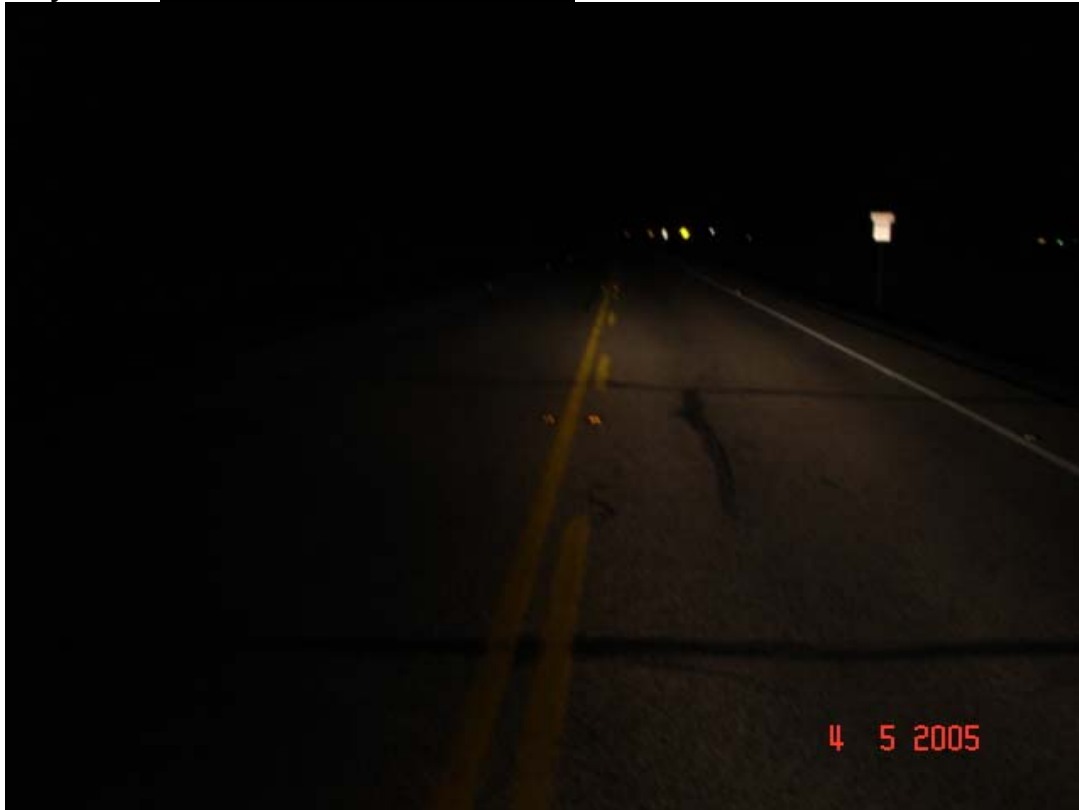
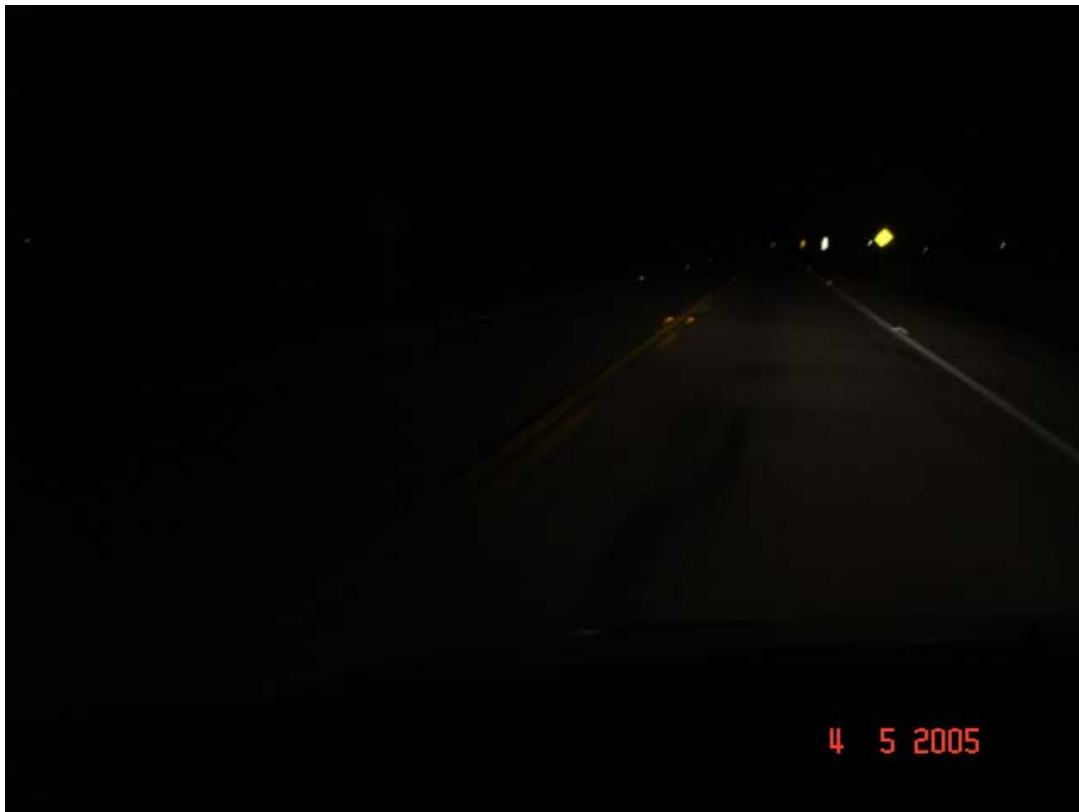
SPRM on centerline and edge line are providing very good additional delineation on this trial section. Markers are highly visible as you approach this trial section. Photographs are not providing a true representation of the reflectivity of the SRPM's.

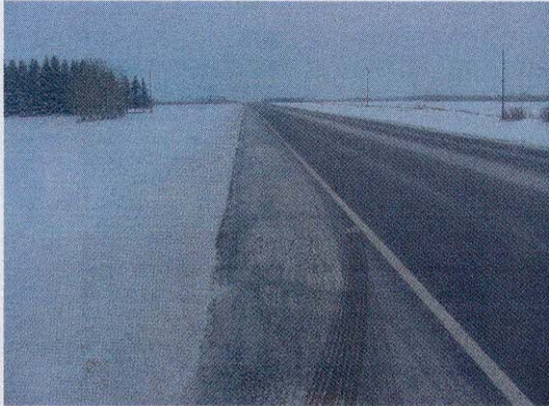
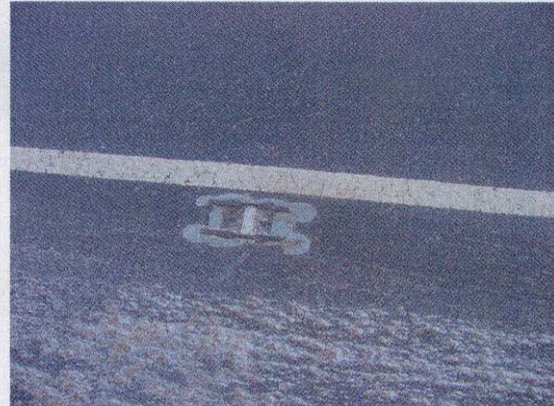
Markers are clear of snow

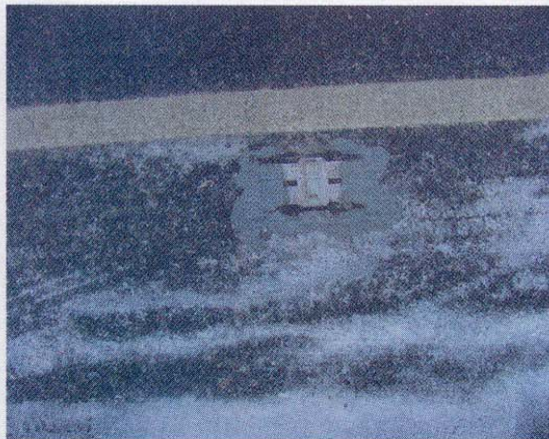
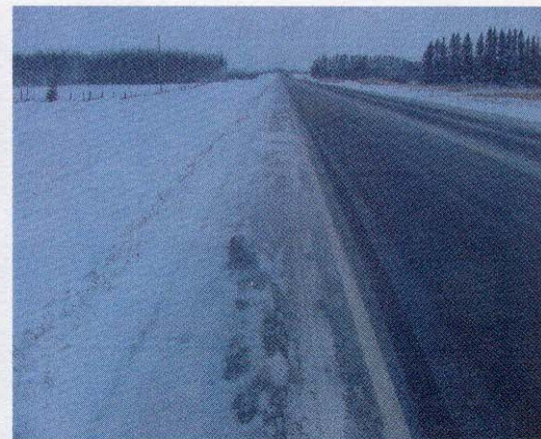
Snow along edge of markers
Reflectors are visible

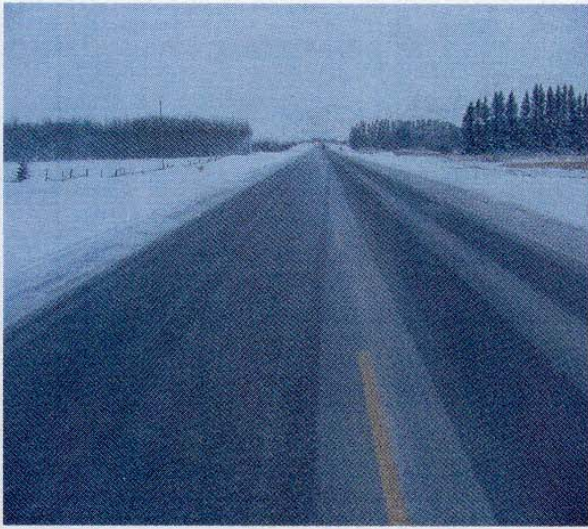
Centerline markers are clear
